GROUP Body	MODEL 2017-2018MY Niro (DE) 2018 Stinger (CK)
	NUMBER PS552	DATE April 2018

SUBJECT: CALIBRATING THE COMPASS IN THE ACCESSORY REAR VIEW MIRROR

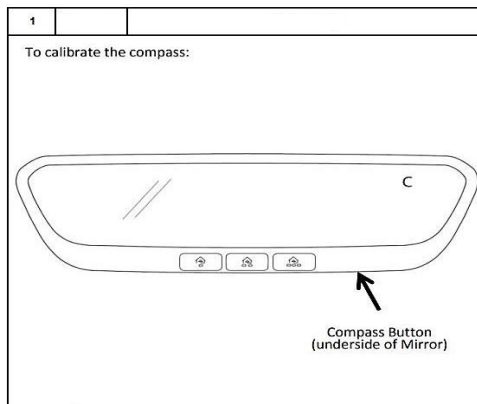
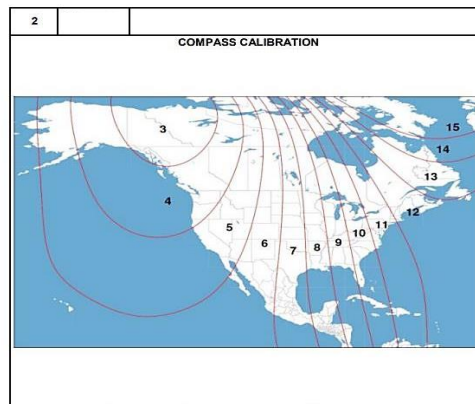
1. Identify your approximate compass region (variance zone) on the map shown below.
2. Using a paper clip through the hole, press and hold the compass button for more than six (6) seconds and the current compass region code will display.
3. Press the compass button until the correct region is displayed. Release the button and the correct compass region will appear.
