Service Bulletin

Bulletin No.: 16-NA-172

Subject: Information on Removal of Wheel Washers Prior to Installation of Outer Dual Rear Wheel

Brand:	Model:	Model Year:		VIN:		Engine:	Transmission:
		from	to	from	to		
Chevrolet	Express	2016	2018			All	All
GMC	Savana	2016	2018			All	All

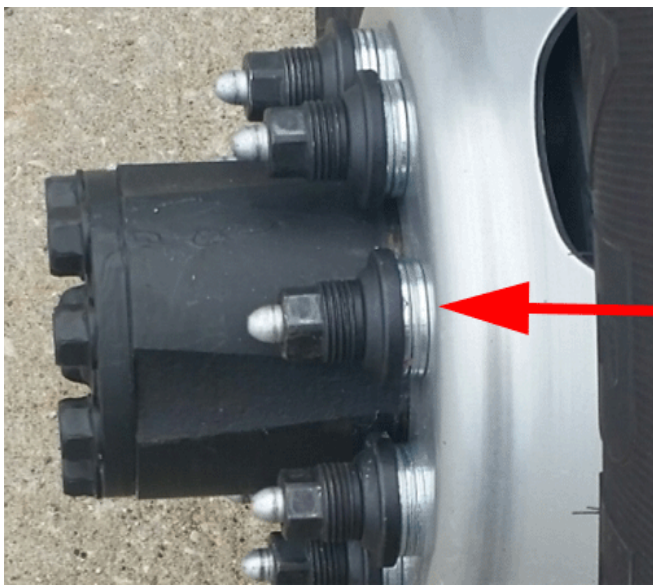
4520743

During transportation preparation, the outer dual rear wheels are removed and 3 washers are installed on each wheel stud for proper lug nut torque. This ensures the nut threads are not damaged by bottoming out on the wheel bolt.
