Service Bulletin

Bulletin No.: 18-NA-068

Subject: Information on Tool Requirement for Transmission Selector Lever Cable Removal

Brand:	Model:	Model Year:		VIN:		Engine:	Transmission:
		from	to	from	to		
Chevrolet	Spark (VIN C)	2016	2018				Manual (MX2, MFM, Y4M)

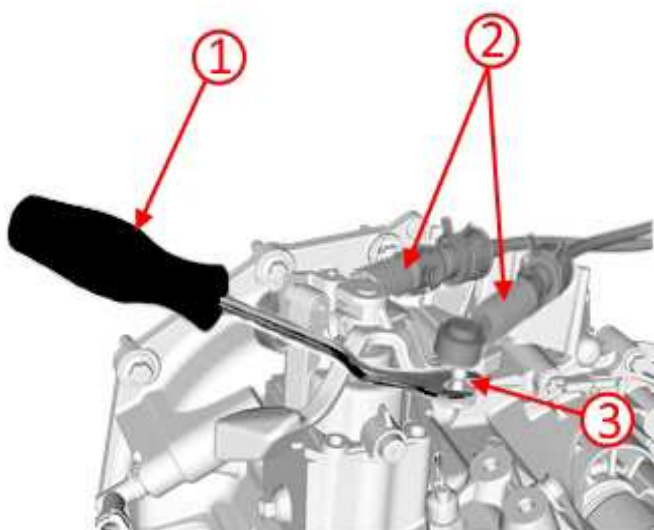
<p style="text-align: right;">4993178</p> <p>When separating the selector lever cable (2) from the ball pin (3), it is recommended that a trim pad removal tool (1) be used to aid in eliminating the possibility of damaging the pin locks.</p>
