Service Bulletin

File in Section: 00 - General Information Bulletin No.: 06-00-89-031E Date: April, 2018

- Subject: OEM and Remanufactured Engine and Automatic Transmission/Transaxle Identification
- Models: 2003-2019 GM Passenger Cars and Trucks
- Attention: This Bulletin also applies to any of the above models that may be Export from North America vehicles.

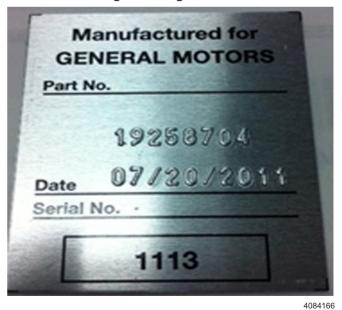
1832842

The tag is made of metal and is approximately 2 in x 1-11/16 in (5.1 cm x 4.3 cm). It is installed on all manufactured for GM service engines and new engines assembled by non-GM suppliers.

This is a list of engines that are made for GM to the original manufacture specifications:

- 7.4L
- 8.0L
- 4.6L
- 2.0L (LNF)

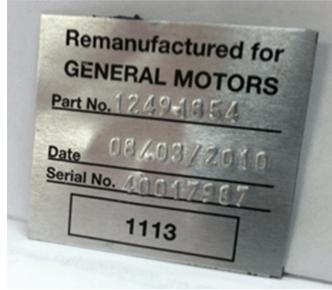
4058686

The tag is made of metal and is approximately 2 in x1-11/16 in (5.1 cm x 4.3 cm). It is installed on all remanufactured for GM service engines and new engines assembled by non-GM suppliers.
