Service Bulletin

Subject: Underbody Component Corrosion

Models: 2019 and Prior GM Passenger Cars and Trucks (including Medium Duty Low Cab Forward)

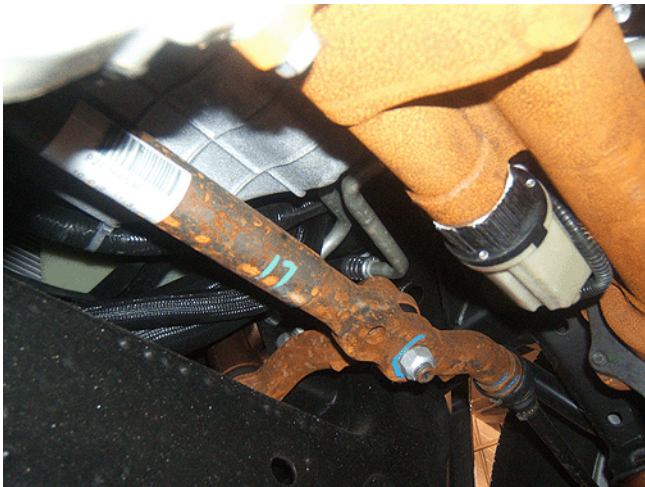
Steering linkage

No repair or consideration should be given for this condition. Surface corrosion on unprotected components will vary with age and exposure. Corrosion on these components has no detrimental impacts, either in short or long term durability.

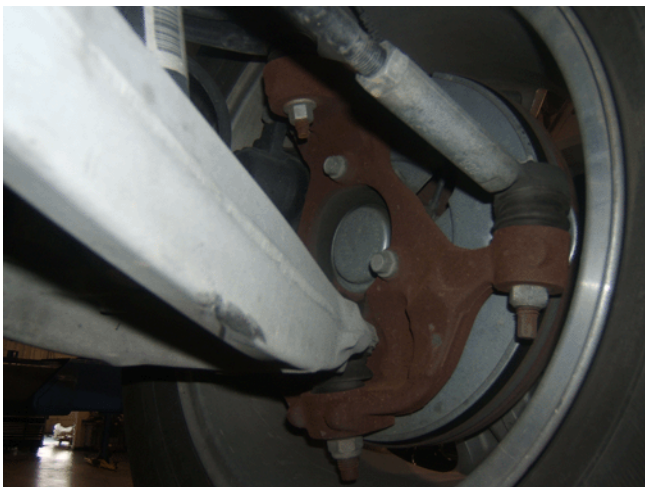
Steering knuckle

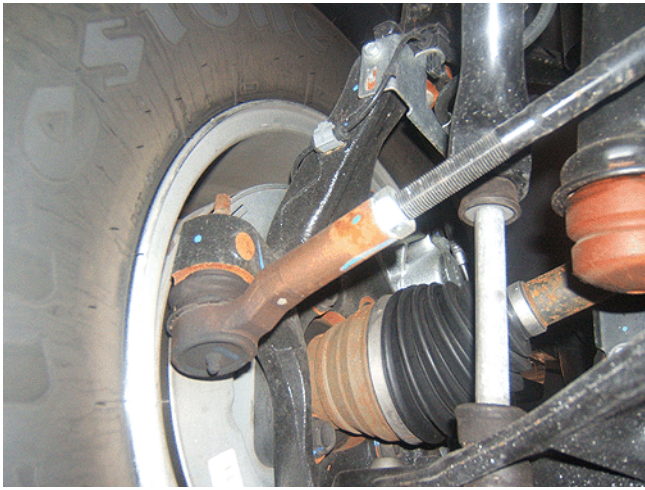
Tie rod end

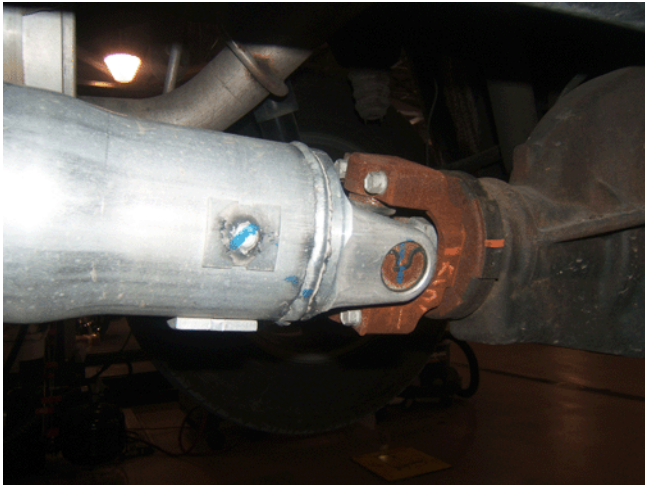
Propshaft yoke

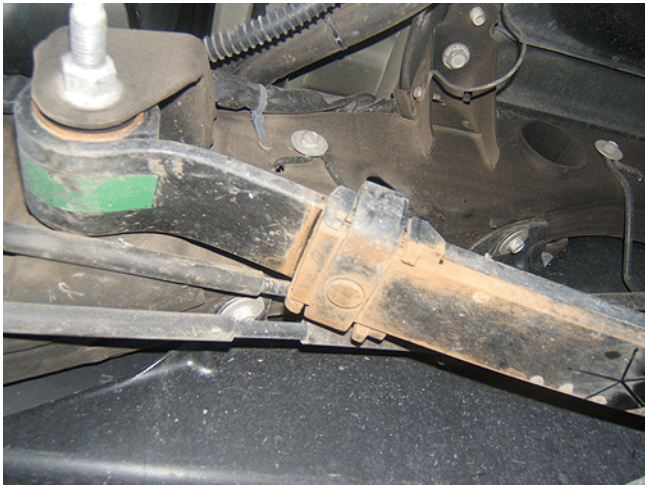
Leaf spring

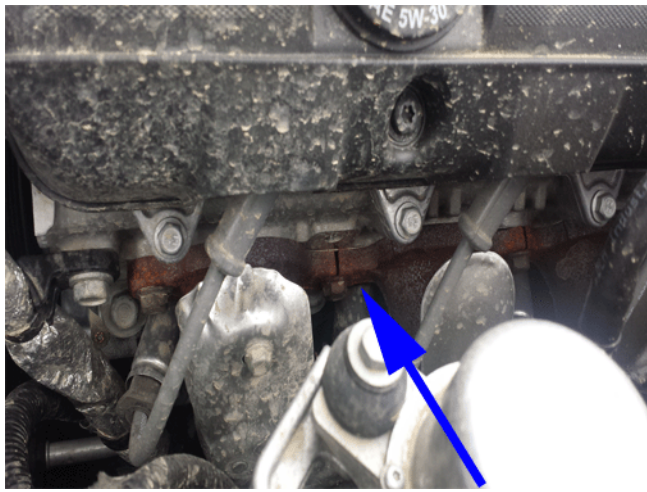
Exhaust system components

Note: During transit between the plant and the dealer, some of the exhaust system components may corrode as a result of salt exposure. These exhaust parts are made of a bare mild-grade stainless steel that will oxidize, or appear rusty. Over time, these components will have a uniform rust-like discoloration, which should be considered a normal condition.
