<b>HYUNDAI</b> <b>Technical Service Bulletin</b>	GROUP	NUMBER
	<b>AUTOMATIC TRANSMISSION</b>	<b>18-AT-006</b>
	DATE	MODEL
	<b>APRIL, 2018</b>	Accent (RB/HC), Azera (TG/HG), Elantra (UD/MD/GD/JK/AD/PD), Kona (OS), Santa Fe (CM/AN/NC), Sonata (YF/YF HEV/LF/LF HEV/PHEV), Tucson (LM/TL), Veloster (FS)
<b>SUBJECT:</b>	<b>AUTOMATIC TRANSAXLE SHIFT LEVER DIAGNOSIS (6-SPEED)</b>

**Description:** The shift lever on some 6-speed vehicles may intermittently not shift out of Park. This bulletin provides the diagnostic procedures to correct this condition.

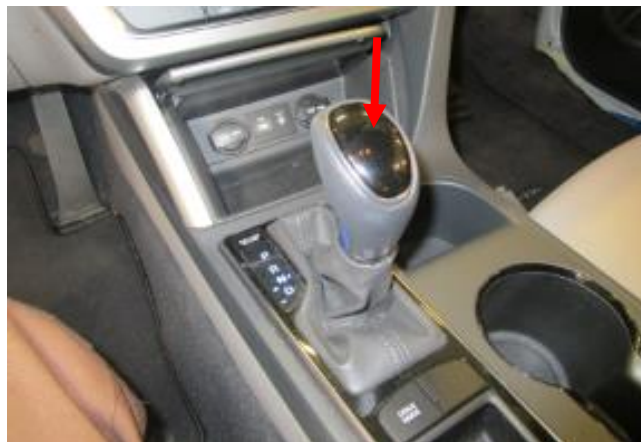
Confirm the shift knob is fully installed on the shift lever by pushing down firmly on the shift knob.

- If not correctly installed, push the shift knob fully on the shift lever. The service is completed.
- If correctly installed, go to Step 2 and continue the diagnosis.

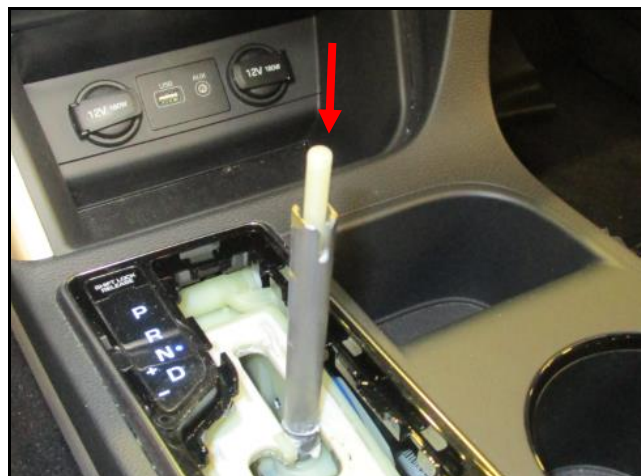
If not, remove the shift knob and press down on the white plastic rod.

- Moves out of Park, replace the shift knob.
- Does not move out of Park, reinstall the shift knob and go to Step 3.

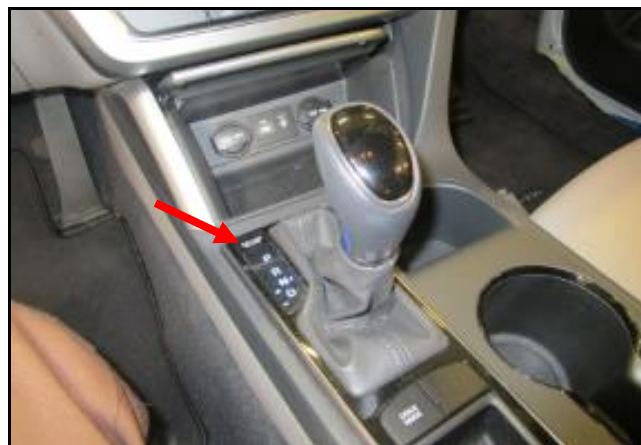
3. Use the ignition key or a screwdriver to engage the shift-lock override. Move the shift lever through all gear positions to confirm that it operates properly.

- If the shift lever does not move out of Park, replace the shift lever.
- If the shift lever moves out of Park, go to Step 4.

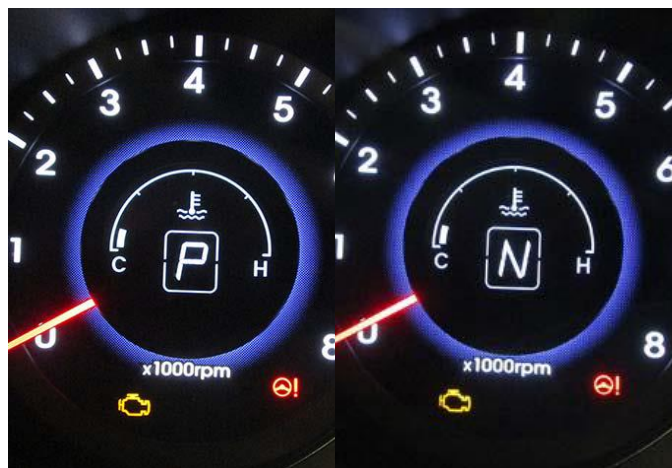
7. Turn the ignition switch to the ON position and place the shift lever in P and N. Confirm the indicator lights in the dash cluster show the correct gear in P and N.
- If P and N are displayed, go to Step 8.
  - If P or N are not displayed, check the alignment of the inhibitor switch according to TSB 17-AT-005. Replace the inhibitor switch if the adjustment is correct.
  - If P and N are not displayed after inhibitor switch adjustment, go to Step 8.

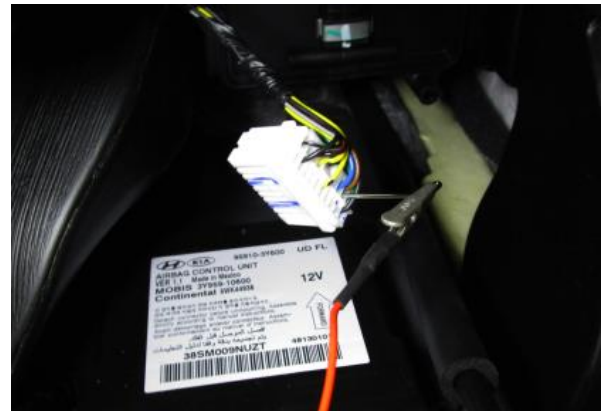
12. Use a DVOM to test the circuit:
  - a. Check for 12V at the shift lock solenoid (A) – (See Step 14 diagram).
    - If not 12V, check the fuse and the harness from the fuse to the shift lock solenoid (A) for an open/short circuit. Repair as necessary.
    - If 12V, go to Step 12b.
  - b. Depress the brake pedal and check for 0V at the shift lock solenoid (B).
    - If 0V, the BCM is functioning correctly. Replace the shift lever (includes ATM solenoid).
    - If not 0V, go to Step 13.

13.
  - Refer to the shop manual and locate the BCM or IPM. Disconnect the connector to the BCM/IPM that provides ground for the shift lock solenoid (C).
  - Use a small pin to probe the harness side of the connector and connect to ground. If the shift lever:
    - Releases from Park, the solenoid and shift lever are functioning properly.
    - Does not release from Park: Inspect the harness between the shift lock solenoid (B) and BCM/IPM (C) for an open/short circuit. If OK, go to Step 14.
