Service Bulletin

File in Section: 08 - Body and Accessories

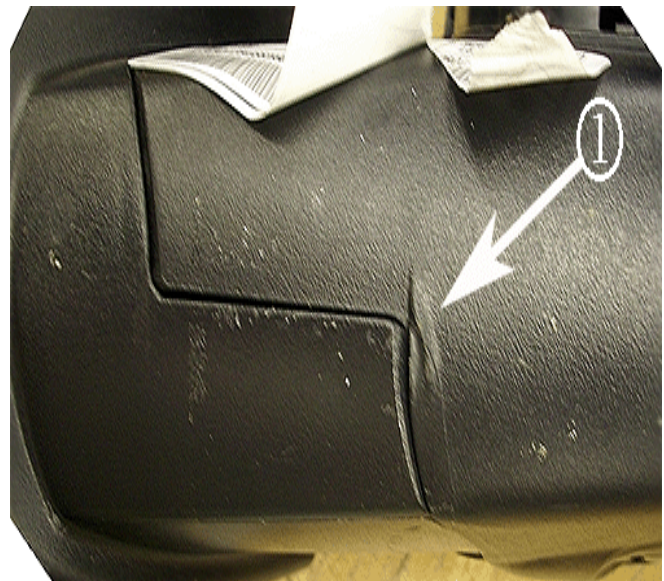
Distortion of the Mirror Arm

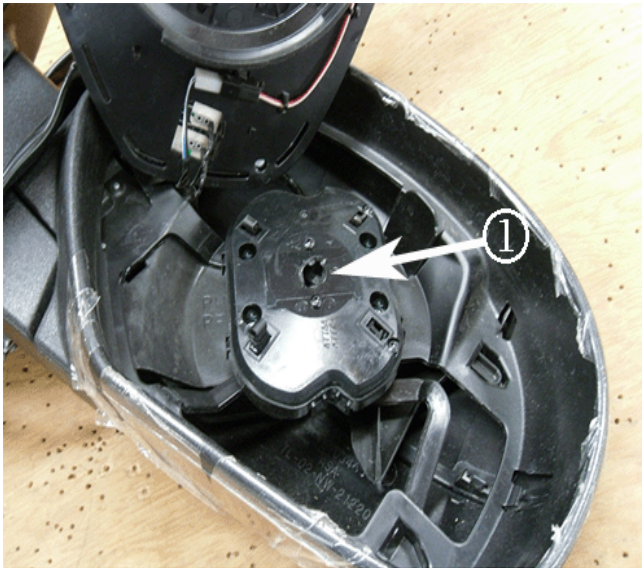
Glass Sheared Off the Actuator
