ST18-003
 NTB18-030
 April 3, 2018

2013 – 2016 SENTRA; OIL RESIDUE FOUND ON STEERING COLUMN

APPLIED 2013 – 2016 Sentra (B17)

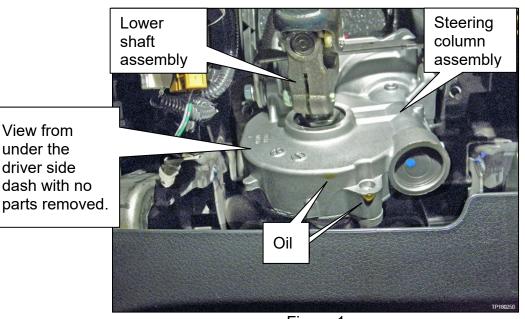
Figure 1

Oil residue is found on the steering column assembly near the lower shaft assembly connection.

Clean oil drip and residue from the steering column assembly per the **SERVICE PROCEDURE** on page 2.

NOTE: Do NOT replace the Steering Column Assembly for this incident, if it should occur.

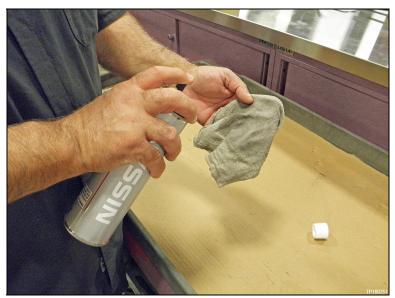
Figure 2

- 1. Spray brake parts cleaner onto a clean shop cloth as shown in Figure 2.
 - Use only Low VOC brake cleaner that complies with local regulations.
 - DO NOT use carburetor cleaner for this action.
 - Nissan Low VOC brake cleaners are listed in the PARTS INFORMATION section of this bulletin.

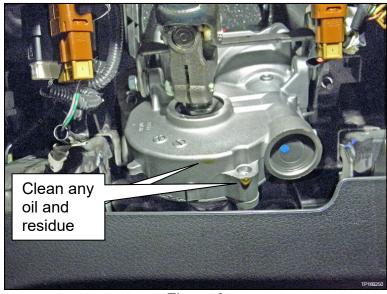
Figure 3

2. Wipe any oil drips and residue from the steering column assembly as shown in Figure 3.
