May 25, 2018

Version 1

Warranty Extension: Customer Support Program For Front Passenger's Airbag Inflator for 2001-05 Civic and Other Listed Years and Models (Expires October 31, 2022)

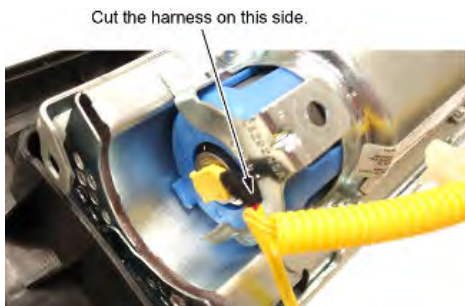
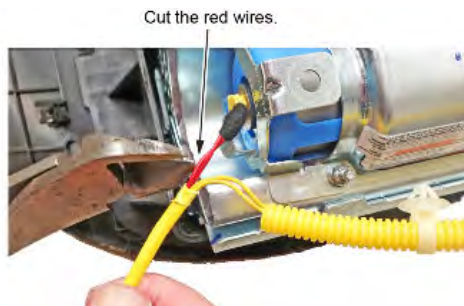
- 3.1. Cut the red wires about 2 inches from the inflator.

There may be some protective tube covering the wires that needs to be cut away to access the wires.

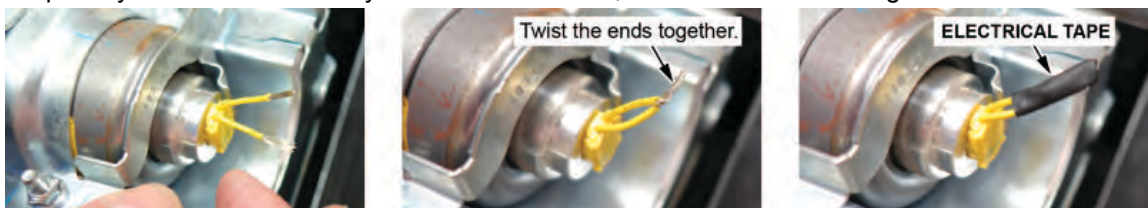
3.5. Strip away about 1 inch of the yellow wire insulation, then twist the wires together.

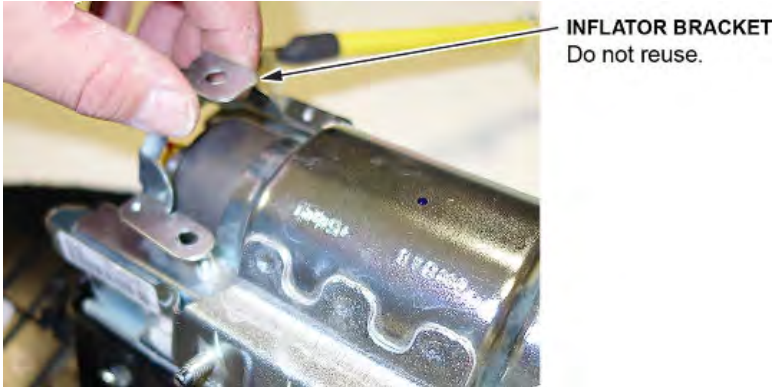
4. Remove the inflator bracket.

You can only remove one of the brackets, as the other is welded to the airbag housing.

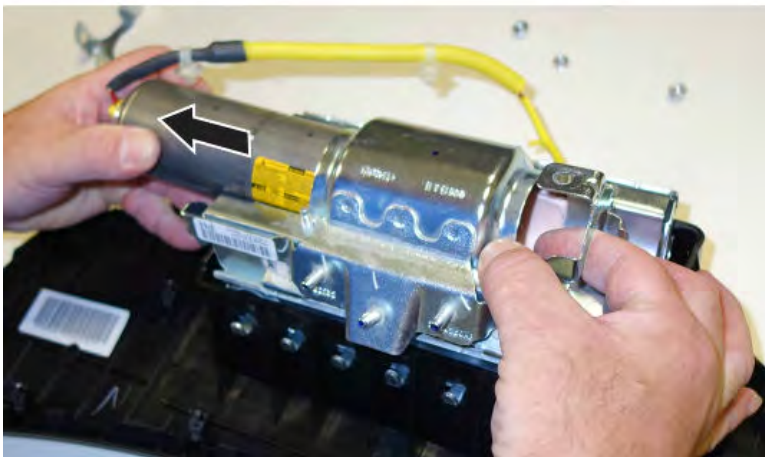
5. Remove the inflator by pulling it out.
