May 24, 2018

Warranty Extension: Customer Support Program For Driver's Airbag Inflator for 2003-06 MDX (Expires June 30, 2022)

AFFECTED VEHICLES

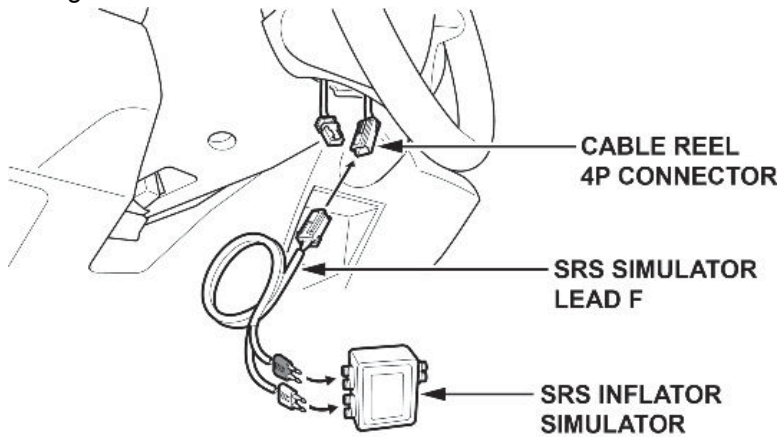
11. Remove the access panel from the steering wheel, and disconnect the cable reel 4P connector from the driver's airbag 4P connector.

12. Connect the terminals of SRS simulator lead F to the SRS inflator simulator (2 Ω connectors), then connect SRS simulator lead F to the cable reel 4P connector as shown.
13. Reconnect the negative battery cable.
14. Turn the ignition to ON, not ACC, and wait 10 seconds.
15. Check if the SRS DTC listed in step 8 return.
 - If the same SRS DTC returned, the inflator is OK. The Customer Support Program does not apply. Continue with normal troubleshooting.
 - If the same SRS DTC **did not** return, go to the REPAIR PROCEDURE.

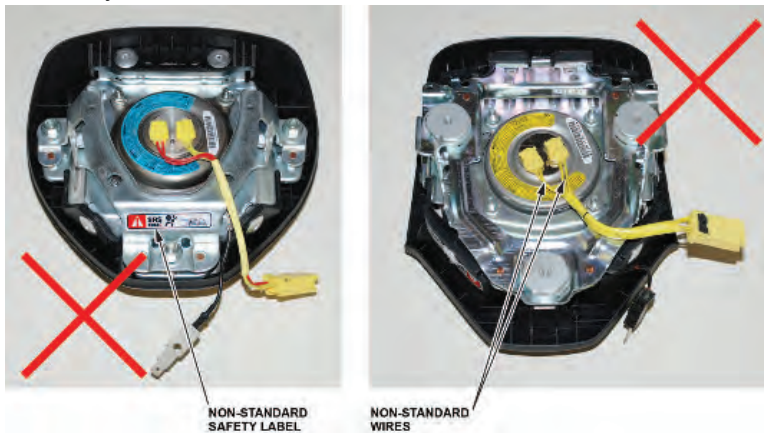
- If there are any unusual markings, like an incorrect label or a model year written in marker, the airbag module and inflator may not be the correct airbag module and/or inflator for the vehicle or it may be a counterfeit part. For more information about counterfeit airbags, you can refer to safercar.gov, enter keywords **MANAGING COUNTERFEIT**, and select **Recommended Dealer Guidance for Managing Counterfeit Air Bags** from the list. **If you suspect that the airbag module or inflator is counterfeit, do not continue this procedure.** Contact your DPSM for assistance.

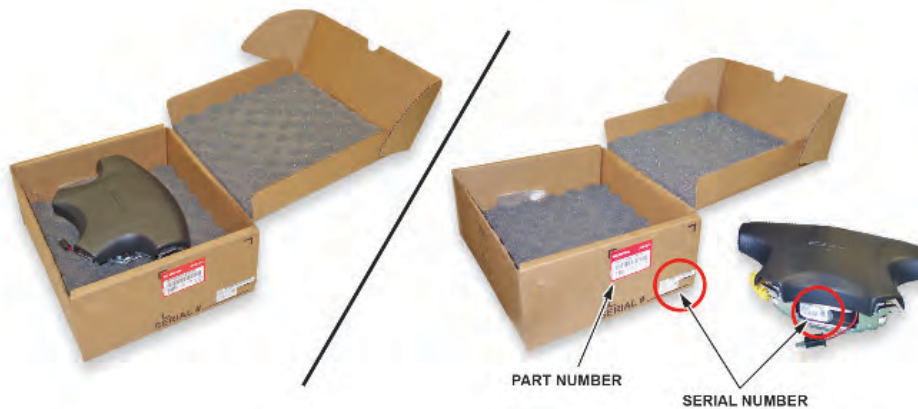
6. Write the serial number and part number from the outside of the airbag module box on the RO.

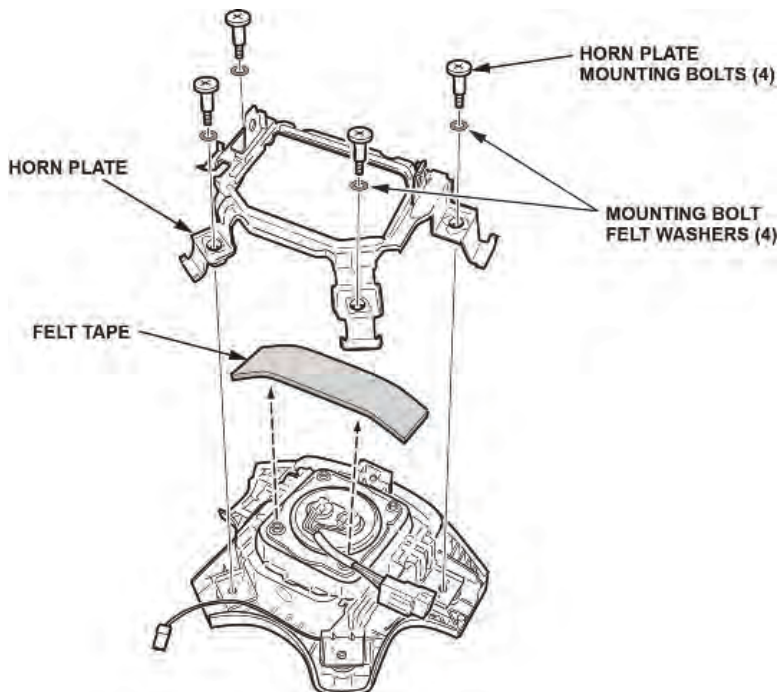
1. Order a new inflator box from XPO to return the original airbag module inflator. Use the contact information below:
Primary Contact: Tel#: 1-210-250-5079
Email: SCFieldAction.14305@xpo.com
2. **If the driver's airbag module has a bracket preventing you from accessing the locknuts and removing the inflator**, remove the bracket and any felt tape covering the locknuts.

The airbag module shown below is an example, other modules are similar.

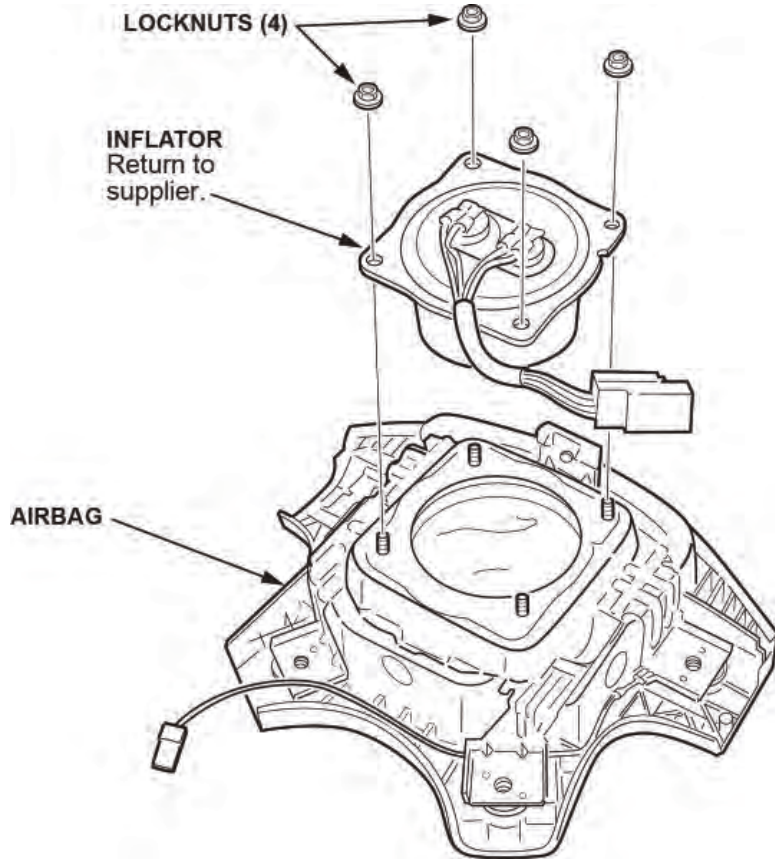
- Using needle-nose vise grips or a 3/8 in. 6-point socket, remove the four locknuts from the inflator, then remove it.

- Put the original inflator into the new inflator box acquired from XPO. Make sure there is no other hardware in the box because if the package rattles, it will not be accepted by the courier.
- Follow the shipping instructions outlined in PIB B15-0006 to return the undeployed inflator.
- Place the original airbag module (without the inflator) in the airbag module box that the replacement came in. Properly fill out and attach a warranty claim tag to it. The original airbag module may be called in by AHM.
