## CR152 Replacement of number plate holder subframe vibration dampers

Models: Panigale V4 2018 (all model versions)

Technical Service Bulletin SRV-TSB-18-007

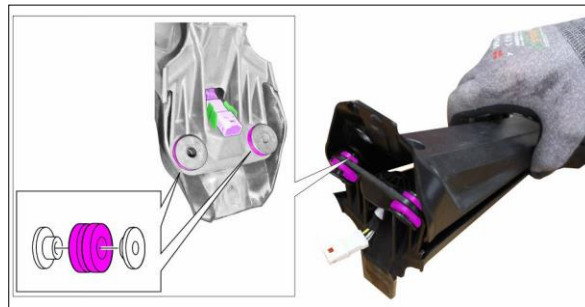
On the above listed models, ongoing product quality tests and feedback from the field have identified an opportunity for vehicle improvement. We have decided to introduce 2 new vibration dampers, part no. 76412501A to prevent excessive oscillation. These updates will bring the vehicles listed to the current production configuration.

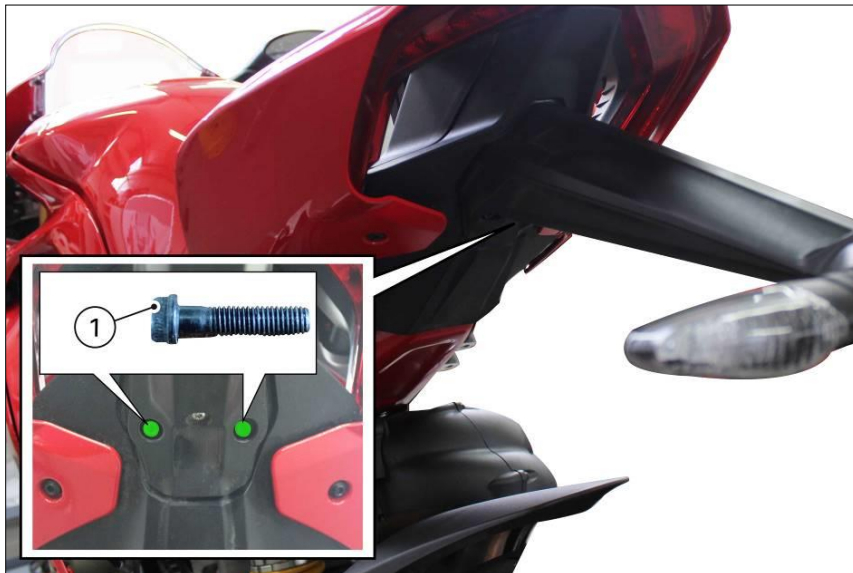
- 1) Remove the **2 M5x22 screws (1)** securing the number plate holder assembly to the rear subframe.

- 12) Tighten the **2 M5x22 screws (1)** securing the number plate holder assembly to the rear subframe to **6 Nm  $\pm$ 10%**.

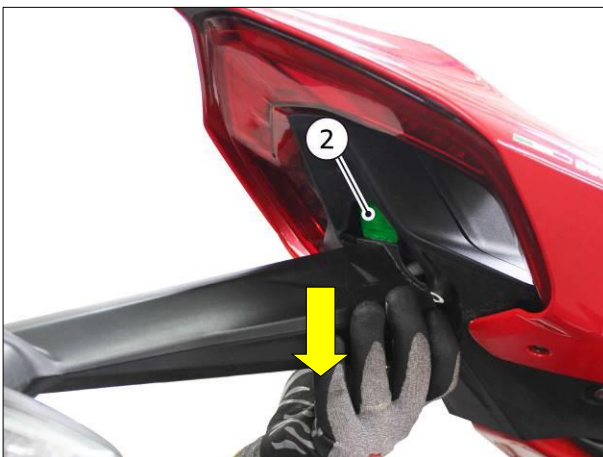
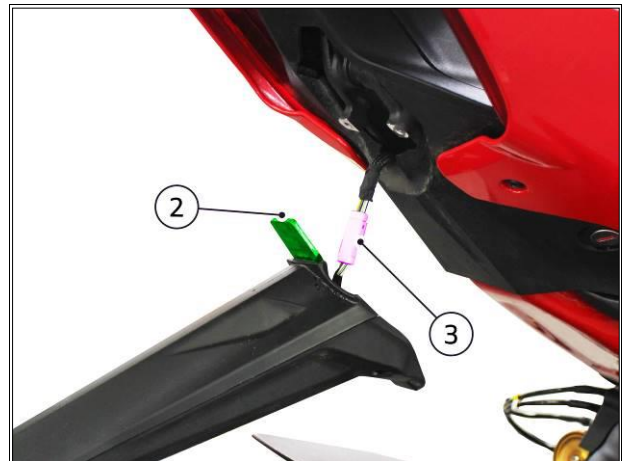
- 2) Remove the number plate holder assembly by sliding it down to disengage **tooth (2)** from the relevant rubber support on tail guard.
- 3) Disconnect number plate/rear turn indicator light **connector (3)**.

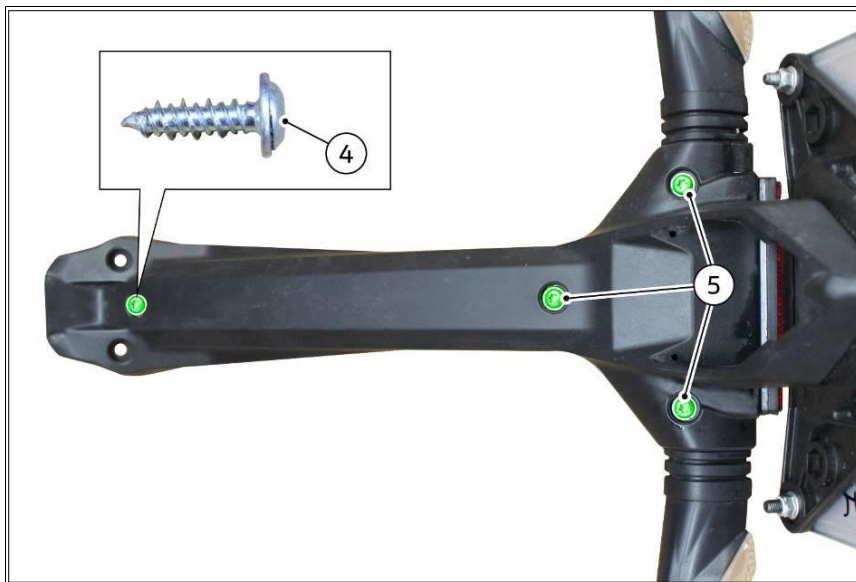
- 4) Place the number plate holder assembly on a clean surface and remove the **M5X16 self-tapping screw (4)** and loosen, without removing, the **3 M5x16 self-tapping screws (5)**.

- 9) Tighten the **M5X16 self-tapping screw (4)** and the **3 M5x16 self-tapping screws (5)** to **5 Nm  $\pm$  10%**.

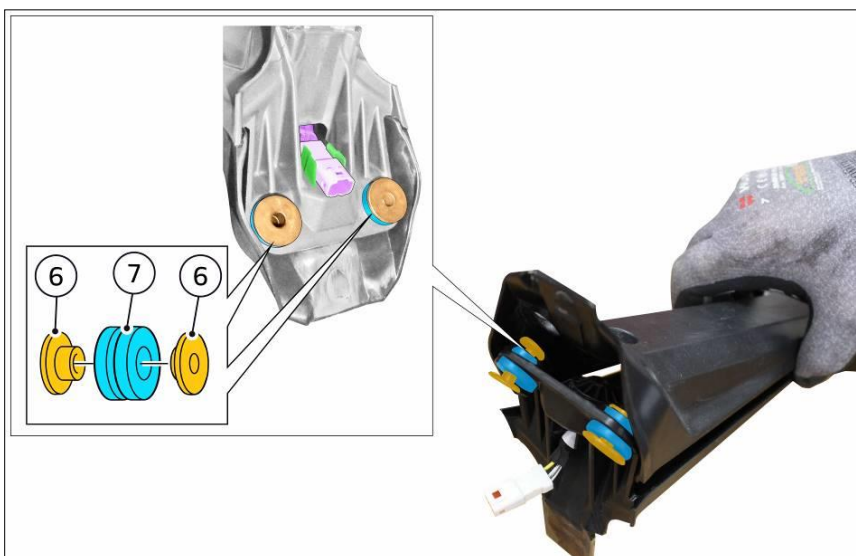
- 5) Remove the **4 upper and lower spacers (6)** with collar, then remove the **2 vibration dampers (7)**.

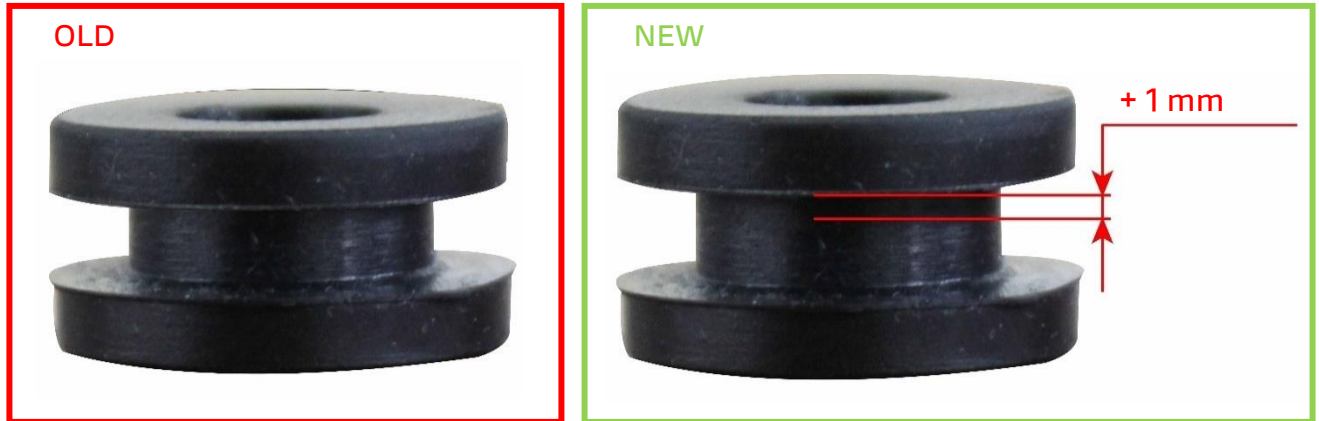
6) Take the 2 new vibration dampers Part no.76412501A.

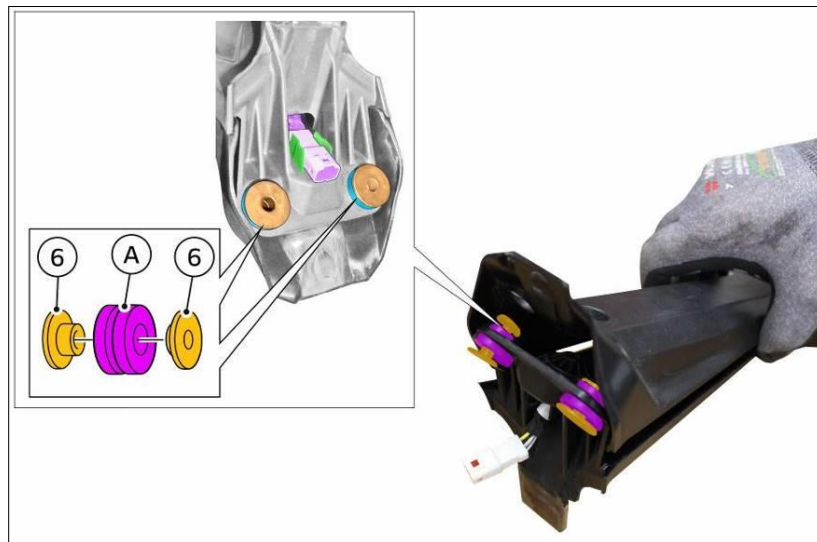
7) Install the 2 new **vibration dampers (A)** inside the holes of the upper number plate support and insert the **4 upper and lower spacers (6)** with collar as shown in the figure.

8) Match the upper number plate support with the lower number plate support and start the **M5X16 self-tapping screw (4)**.

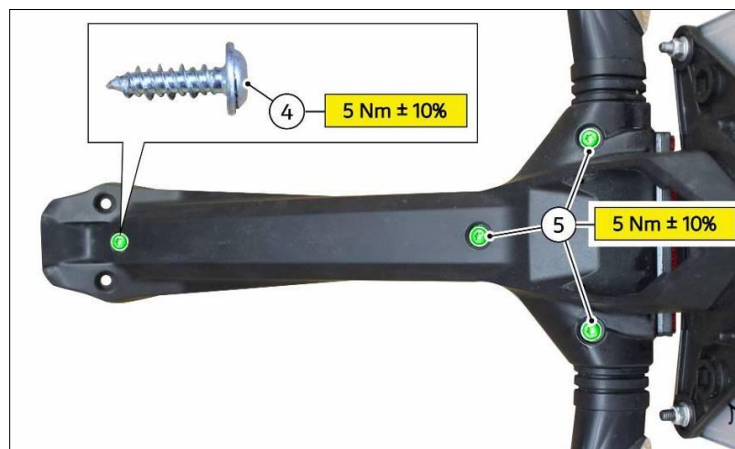
When matching the upper and lower number plate supports, make sure that the 4 spacers with collar remain seated.

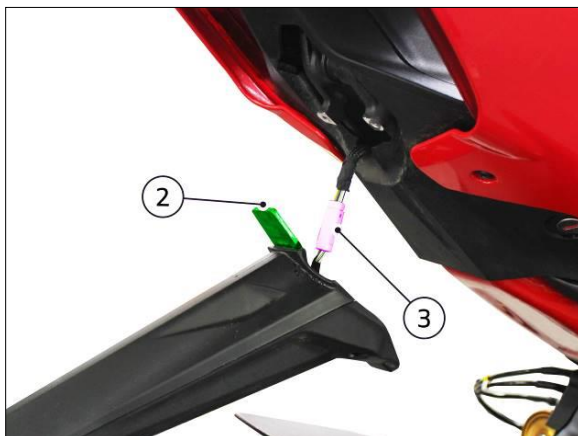
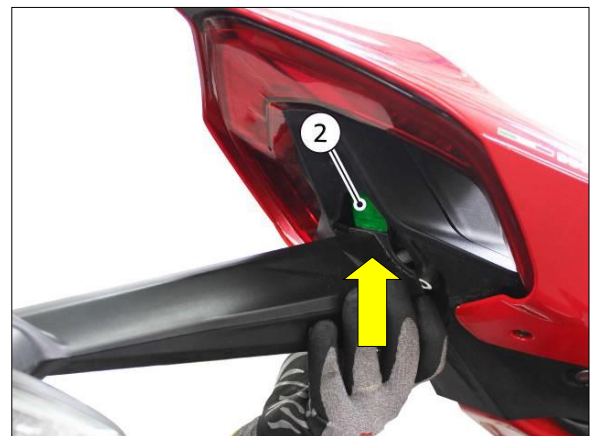
- 10) Connect the number plate/rear turn indicator light **connector (3)**.
- 11) Lubricate the rubber support with KLÜBERPLUS S 06/100 rubber lubricant or equivalent and install the number plate holder assembly by inserting **tooth (2)** inside the rubber support on tail guard.

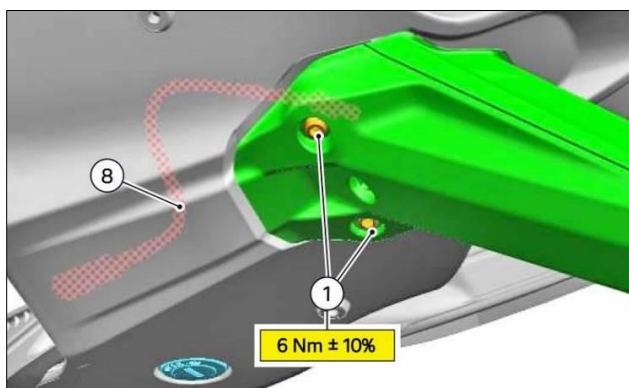
Make sure that number plate/rear turn indicator light **wiring (8)** is positioned on tail guard lower cover side opposite to the one showing the seat lock, as shown in the figure.
