Service Bulletin

18-050

Warranty Extension: Customer Support Program For Front Passenger's Airbag Inflator for 2005-06 CR-V and Other Listed Vehicles (Expires June 30, 2026)

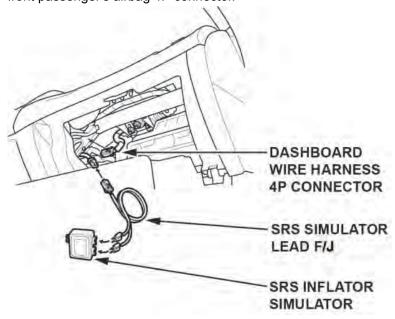
- 12. Connect the terminals of SRS simulator lead (F or J) to the SRS inflator simulator (2 Ω connectors), then connect SRS simulator lead (F or J) to the 4P connector as shown.
- 13. Reconnect the negative battery cable.
- 14. Turn the ignition to ON, not ACC, and wait 10 seconds.

- 11. Access the front passenger's airbag, and disconnect the dashboard wire harness connector 4P connector from the front passenger's airbag 4P connector.

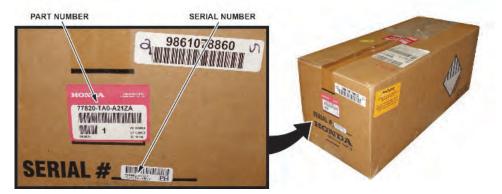
6. Write the serial number and part number from the outside of the airbag module box on the RO.

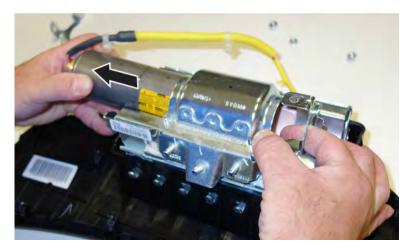
5. Remove the inflator by pulling it out.
