June 1, 2018

Version 1

Warranty Extension: Customer Support Program For Front Passenger's Airbag Inflator for 2009-11 TSX and 2010-11 ZDX (Expires June 30, 2026)

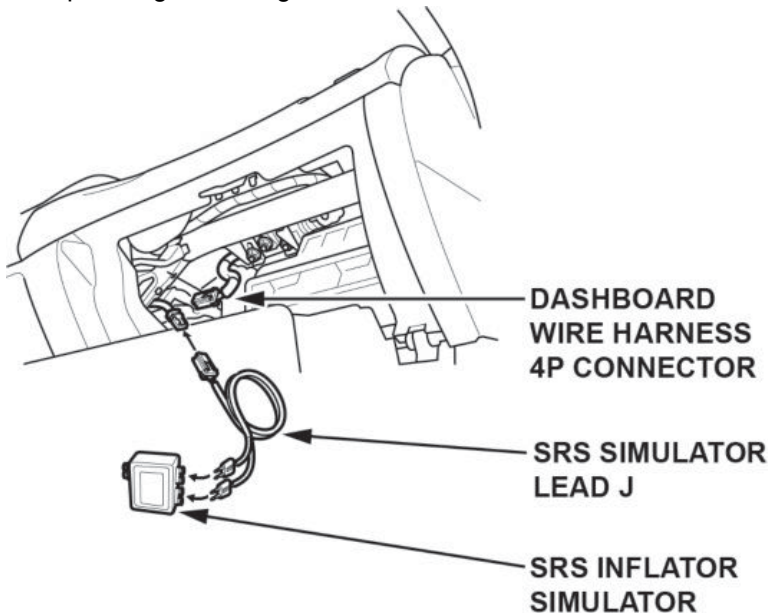
11. Access the front passenger's airbag, and disconnect the dashboard wire harness connector 4P connector from the front passenger's airbag 4P connector.

12. Connect the terminals of SRS simulator lead J to the SRS inflator simulator (2 Ω connectors), then connect SRS simulator lead J to the 4P connector as shown.
13. Reconnect the negative battery cable.
14. Turn the ignition to ON, not ACC, and wait 10 seconds.
15. Check if the SRS DTC listed in step 8 returns.
 - If the same SRS DTC returned, the inflator is OK. The Customer Support Program does not apply. Continue with normal troubleshooting.
 - If the same SRS DTC **did not** return, go to the REPAIR PROCEDURE.

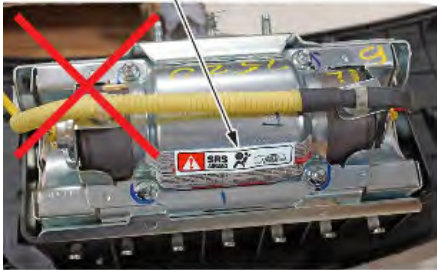
NON-STANDARD SAFETY LABEL

- If there are any unusual markings, like an incorrect label or a model year written in marker, the airbag module and inflator may not be the correct airbag module and/or inflator for the vehicle or it may be a counterfeit part. For more information about counterfeit airbags, you can refer to safercar.gov, enter keywords **MANAGING COUNTERFEIT**, and select **Recommended Dealer Guidance for Managing Counterfeit Air Bags** from the list. **If you suspect that the airbag module or inflator is counterfeit, do not continue this procedure.** Contact your DPSM for assistance.

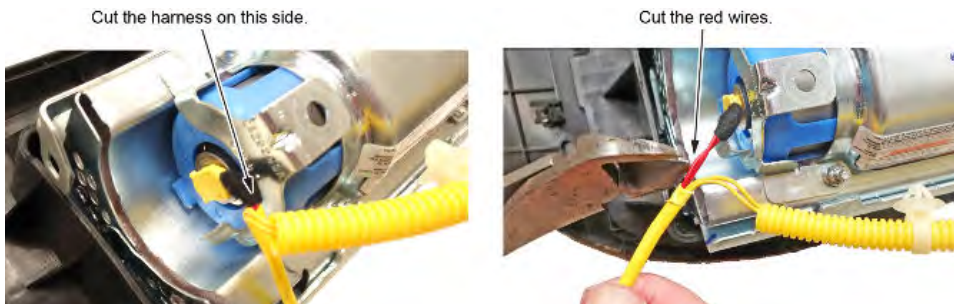
- 3.1. Cut the red wires about 2 inches from the inflator.

There may be some protective tube covering the wires that needs to be cut away to access the wires.

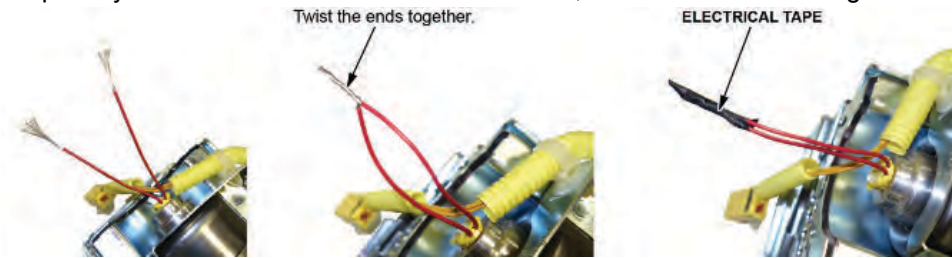
3.2. Strip away about 1 inch of the red wire insulation, then twist the wires together.

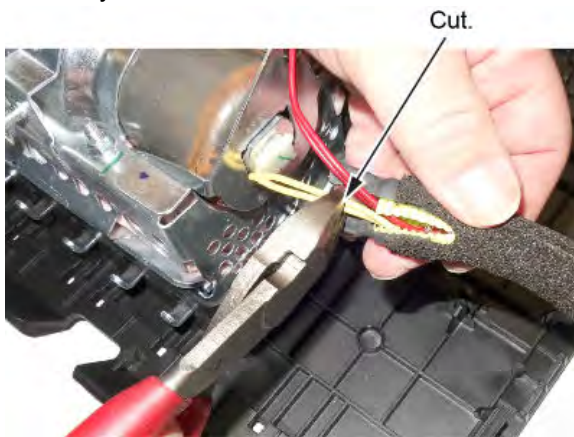
3.4. Cut the yellow wires about 2 inches from the inflator.

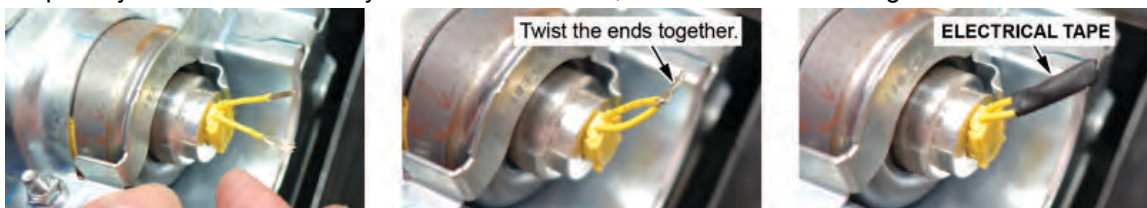
3.5. Strip away about 1 inch of the yellow wire insulation, then twist the wires together.

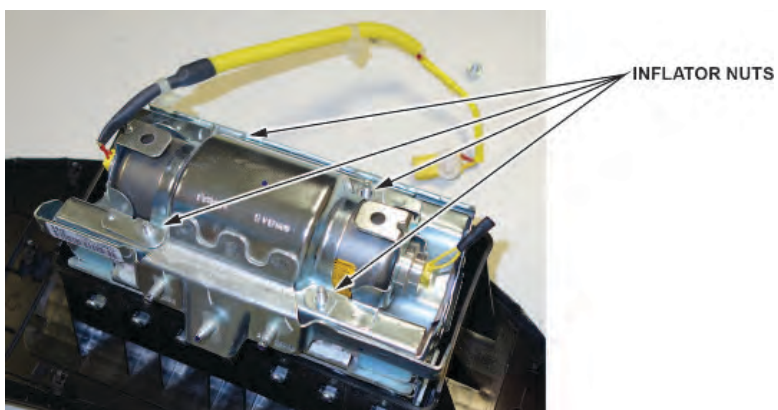
3.7. Remove the four inflator nuts.

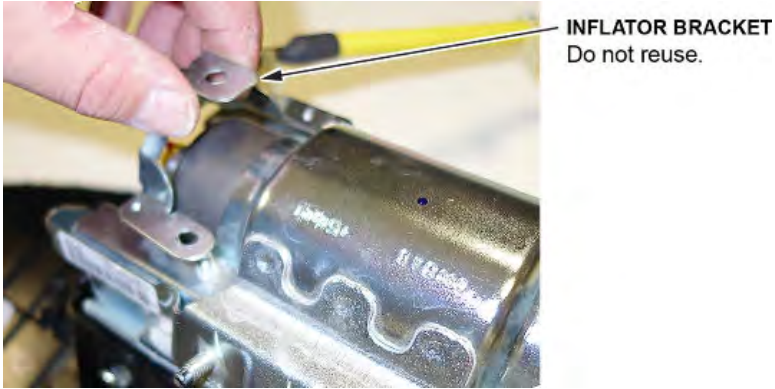
4. Remove the inflator bracket.

You can only remove one of the brackets, as the other is welded to the airbag housing.

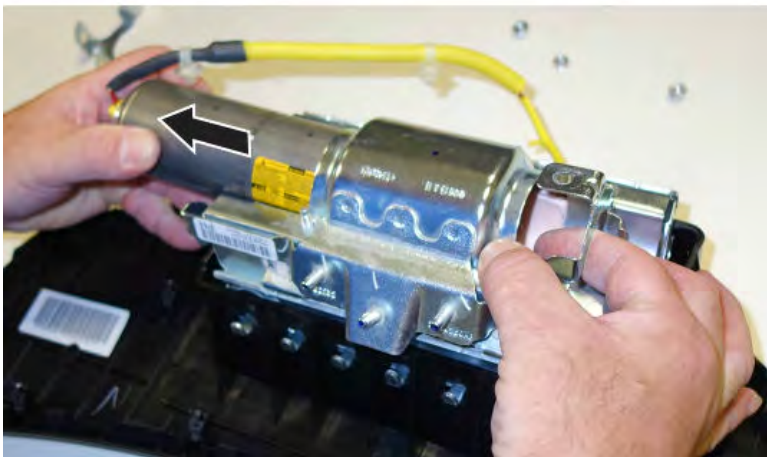
5. Remove the inflator by pulling it out.
