June 8, 2018

Version 1

## Warranty Extension: Customer Support Program For Front Passenger's Airbag Inflator for 2009-13 TSX and 2010-13 ZDX (Expires January 31, 2028)

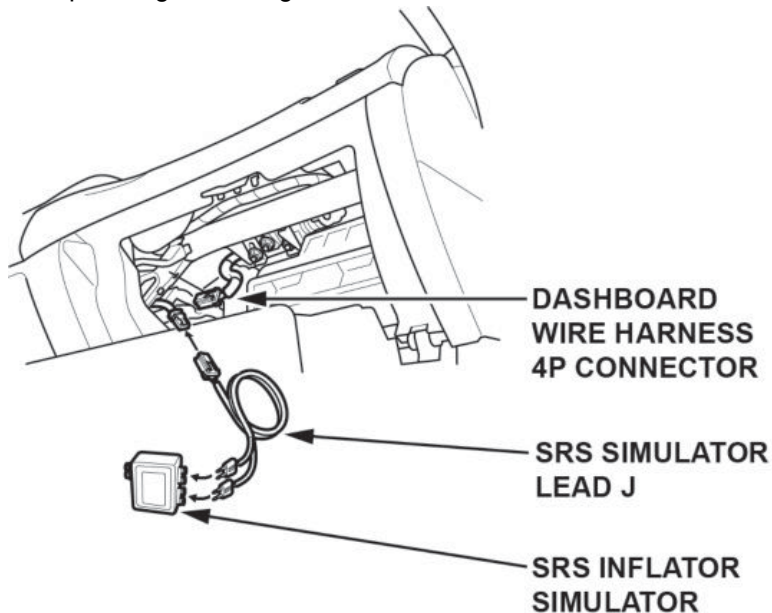
12. Connect the terminals of SRS simulator lead J to the SRS inflator simulator (2  $\Omega$  connectors), then connect SRS simulator lead J to the 4P connector as shown.
13. Reconnect the negative battery cable.
14. Turn the ignition to ON, not ACC, and wait 10 seconds.
15. Check if the SRS DTC listed in step 8 returns.
  - If the same SRS DTC returned, the inflator is OK. The Customer Support Program does not apply. Continue with normal troubleshooting.
  - If the same SRS DTC **did not** return, go to the REPAIR PROCEDURE.

11. Access the front passenger's airbag, and disconnect the dashboard wire harness connector 4P connector from the front passenger's airbag 4P connector.

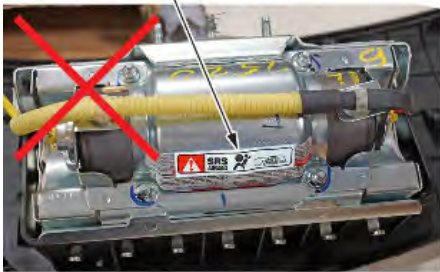
NON-STANDARD SAFETY LABEL

- If there are any unusual markings, like an incorrect label or a model year written in marker, the airbag module and inflator may not be the correct airbag module and/or inflator for the vehicle or it may be a counterfeit part. For more information about counterfeit airbags, you can refer to [safercar.gov](http://safercar.gov), enter keywords **MANAGING COUNTERFEIT**, and select **Recommended Dealer Guidance for Managing Counterfeit Air Bags** from the list. **If you suspect that the airbag module or inflator is counterfeit, do not continue this procedure.** Contact your DPSM for assistance.

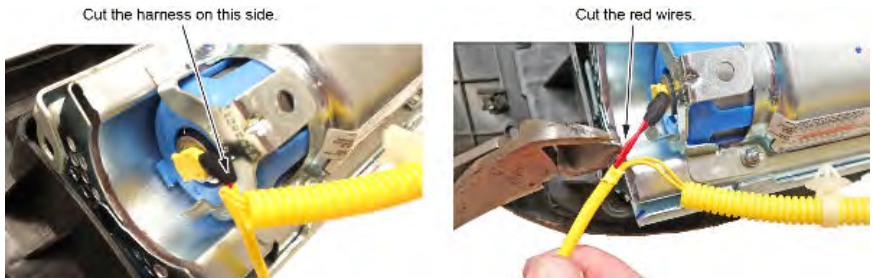
- 3.1. Cut the red wires about 2 inches from the inflator.

There may be some protective tube covering the wires that needs to be cut away to access the wires.

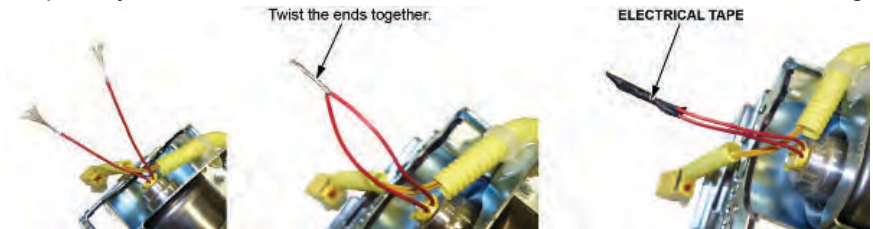
- 3.2. Strip away about 1 inch of the red wire insulation, then twist the wires together.

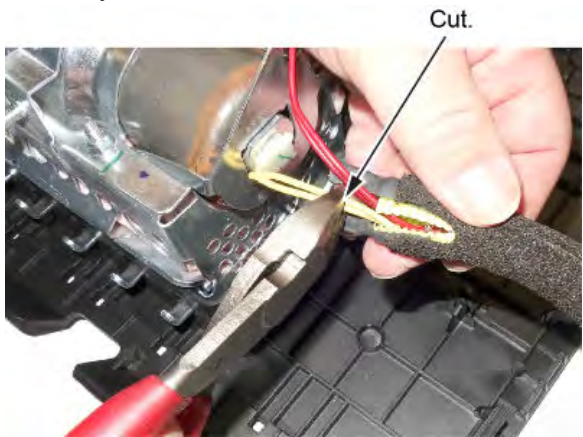
- 3.3. Tape the twisted ends with electrical tape.
- 3.4. Cut the yellow wires about 2 inches from the inflator.

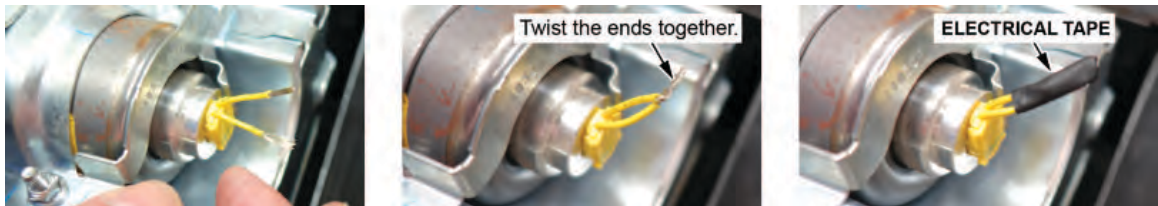
- 3.5. Strip away about 1 inch of the yellow wire insulation, then twist the wires together.

- 3.6. Tape the twisted ends with electrical tape.

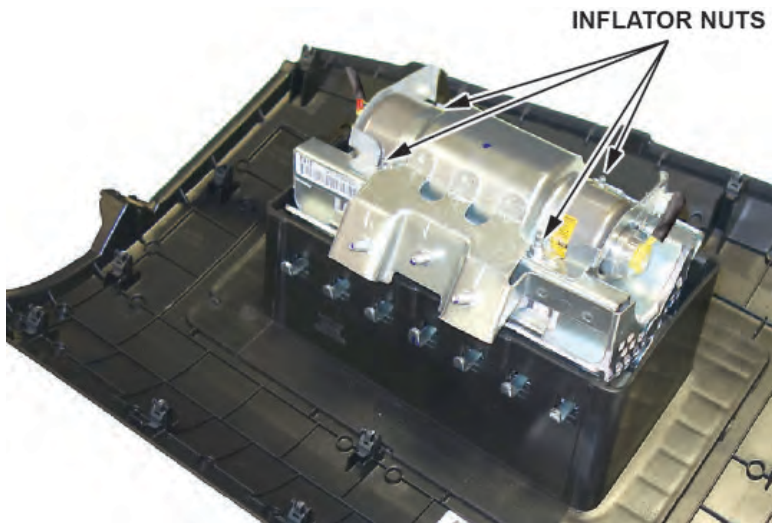
3.7. Remove the four inflator nuts.
