# Technical Service Bulletin

| <b>Technical Service Bulletin:</b><br>TSB180048 | <b>Released Date:</b> 15-May-2018 |

## - Campaign #3296 - HGJBB Wiring Issue Between Oil Level Sensor and Ignition Coil

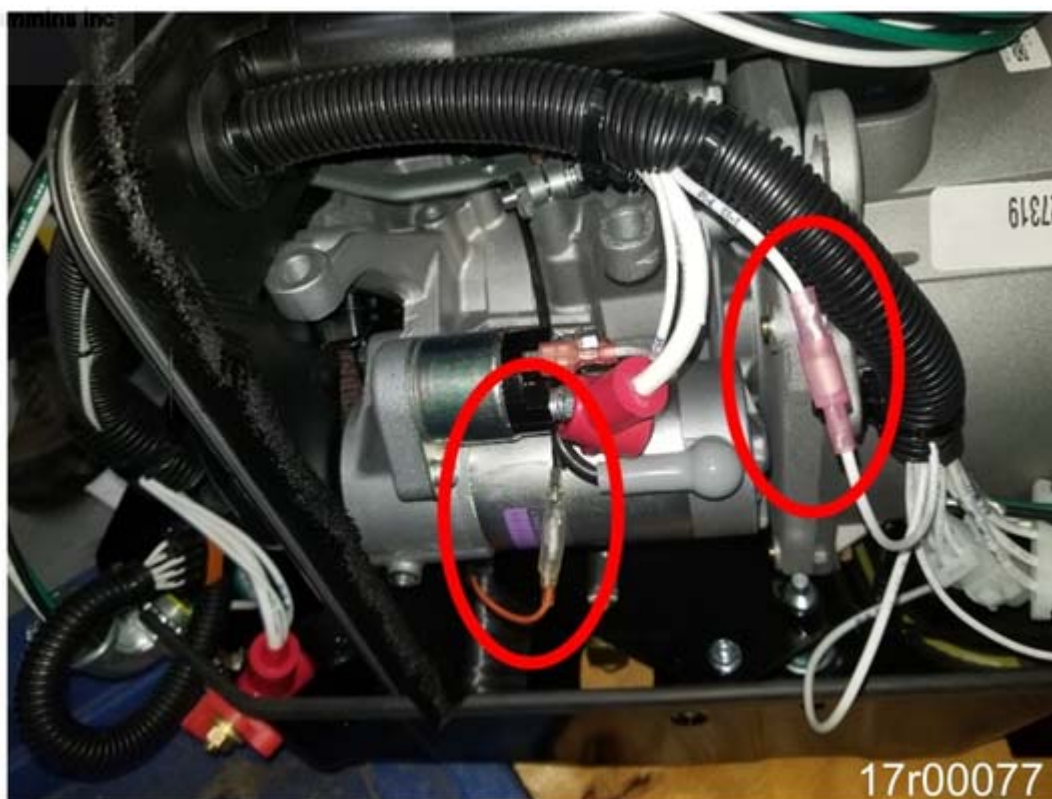
Figure 1, Incorrect Wiring

- During production, the ignition coil and low engine oil level sensor leads were wired together instead of being wired to the correct leads on the control harness. Pictures of the incorrect and correct wiring can be seen below.
- On LP units: Pressing the STOP button will engage the fuel shutoff solenoid valve and shut the generator down on command.
- On gasoline units: Pressing the STOP button will turn the fuel pump off, but the generator will continue to run until the fuel in the carburetor bowl is depleted. Therefore, the generator may take up to three minutes to shut down after the STOP button has been pressed.

Inspection Method 2: Visually inspect the wires to ensure they are properly connected. The black ignition coil wire should be connected to the white wire marked P1-4 (the white wire will also be marked S1-1). The orange oil level sensor wire should be connected to the white wire marked P1-6 (the white wire will also be marked S2-1). The black ignition

coil wire and the orange oil level sensor wire **should not** be connected to each other. If the black and orange wires are found to be connected to each other, follow the steps given in the resolution section of this document to correct the issue.

For both LP and gasoline units: Connect the black ignition coil wire to the white wire marked P1-4 (the white wire will also be marked S1-1). Additionally, connect the orange oil level sensor wire to the white wire marked P1-6 (the white wire will also be marked S2-1). After both wire connections have been made, start the generator set, allow it to run for a short period of time, and then ensure the generator shuts down when the STOP button is pressed.
