NA_VOLVO_Vehicle_Range
nge VNR , VNX , VNL , VNM , VHD , VAH

Engine family 11L Engine , 13L Engine , 16L Engine , Mack , MP7 , MP8 , MP10

Title (customer effect) Selective Catalytic Reduction (SCR) Efficiency And NOx Sensor Codes P225C, P225E, P221A, P2201, P103C, P20EE, And P207F : **NOx Sensor Diagnostic Information TO BE USED BEFORE SENSOR REPLACEMENT - OBD13 And Newer Emissions (Commonly Model Year 2014 And Newer)**

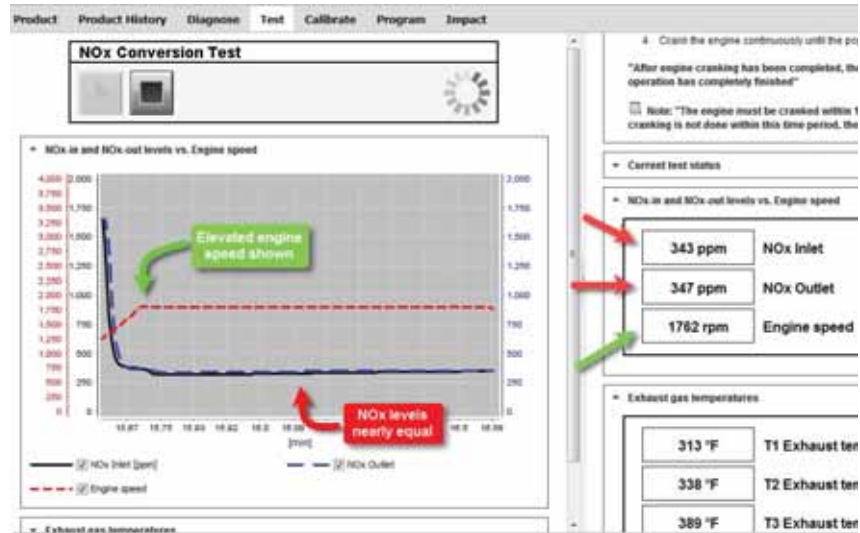
- Inlet and Outlet NOx values should be within 40 parts per million (ppm) of one another just before the engine shuts down. Shown below is an example of how a graph

with two properly functioning sensors will look:

5. If diagnostic steps do not locate a root cause for the code(s), open an eService case with Dealer Technical Support
 - The screenshot(s) taken of the NOx conversion screen prior to engine shutdown (as shown in the screenshot above) should be attached to the case.
