| <b>Topic</b> | Trim Strip For Rear Panel Brake Light – Blackware - Paint Adhesion (SC18/05) |
| <b>Brand</b> | Bentley |
| <b>Campaign number</b> | EB02 |

### Bentley Continental GTC / Supersports GTC

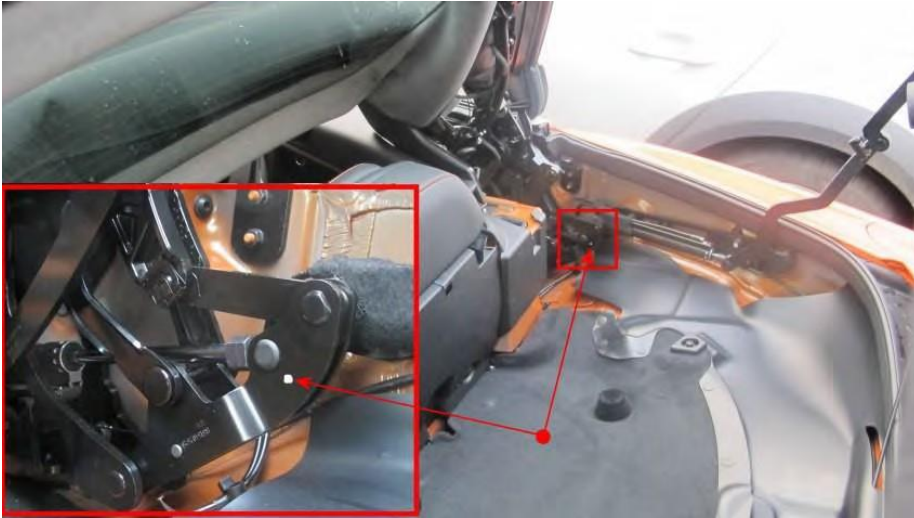
If the vehicle is not already listed as repaired in the "Repair history" (in Elsapro), check for the presence of a white campaign identification mark on the convertible roof mechanism- see Figure 1 - should neither be evident carry out the required work in accordance with these instructions.

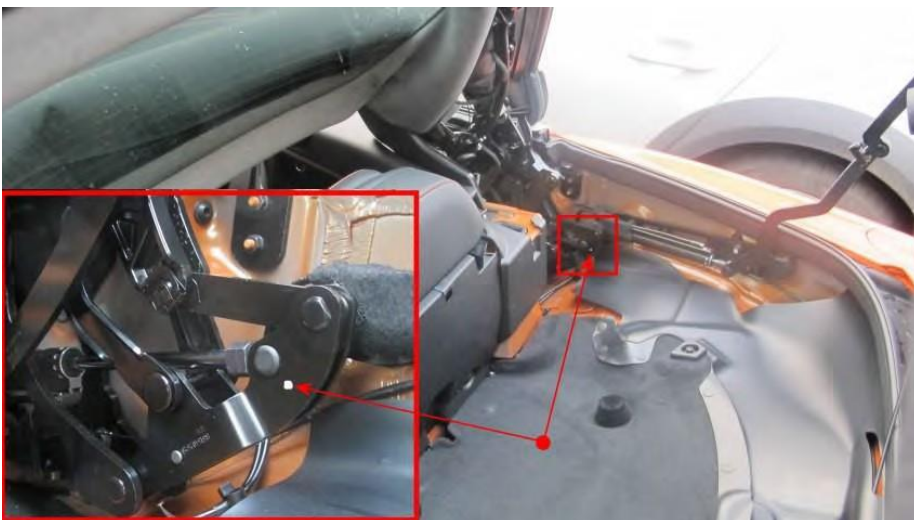
Figure 1

Upon completion apply a white campaign identification mark on the convertible roof mechanism- see Figure 1.
