**Freightliner
 Service Bulletin**

Preheater Replacement

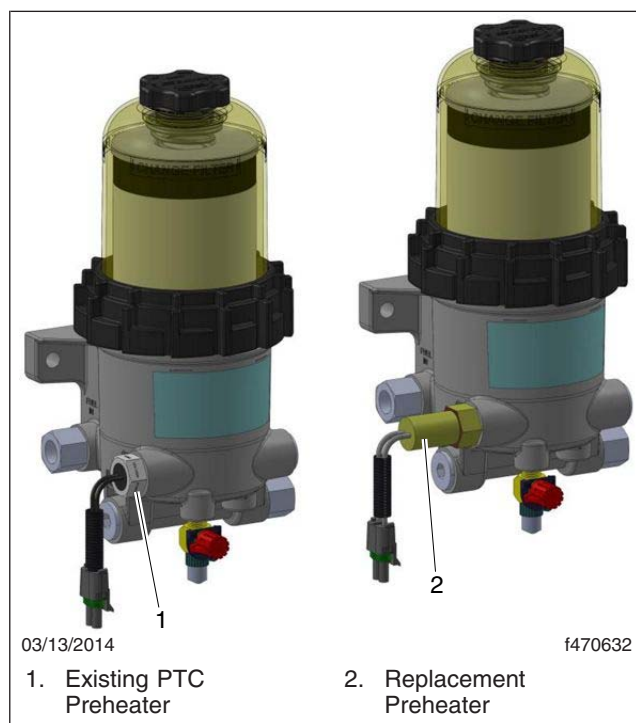
Fig. 1, DAVCO Preheater Installation

Effective December 3, 2013 DAVCO Fuel Pro and Diesel Pro preheaters were upgraded to positive temperature coefficient (PTC) 195w heater technology. This technology uses less amperage during operation, however there is an "in rush" current spike that exceeds 20amps for up to 5 seconds at initial start-up. Due to this "in rush" current spike the M2, 108SD, and 114SD chassis electrical control module (ECM) may activate fault code SA 33 SPN 6897 FMI 6 when the engine is first started.

Refer to [Fig. 1](#) for this procedure.

1. Park the vehicle on a level surface, shut down the engine and set the parking brake. Chock the tires.
2. Drain the fuel from the fuel filter into an appropriate container.
3. Clip the zip-ties holding the wire harness in place.
4. Disconnect the wire harness.
5. Remove the PTC style preheater.
6. Install the replacement preheater.
7. Connect the wire harness.
8. Secure the wire harness in place with zip-ties.

9. Prime the fuel filter.
10. Start the engine and check for leaks. Repair as needed.
