# SS - 1033273: WST 5700XE Sun Visor Cracks - Mounting Screws Loose

## **WST 5700 Sun Visor Cracks - Mounting Screws Loose**

WST 5700XE

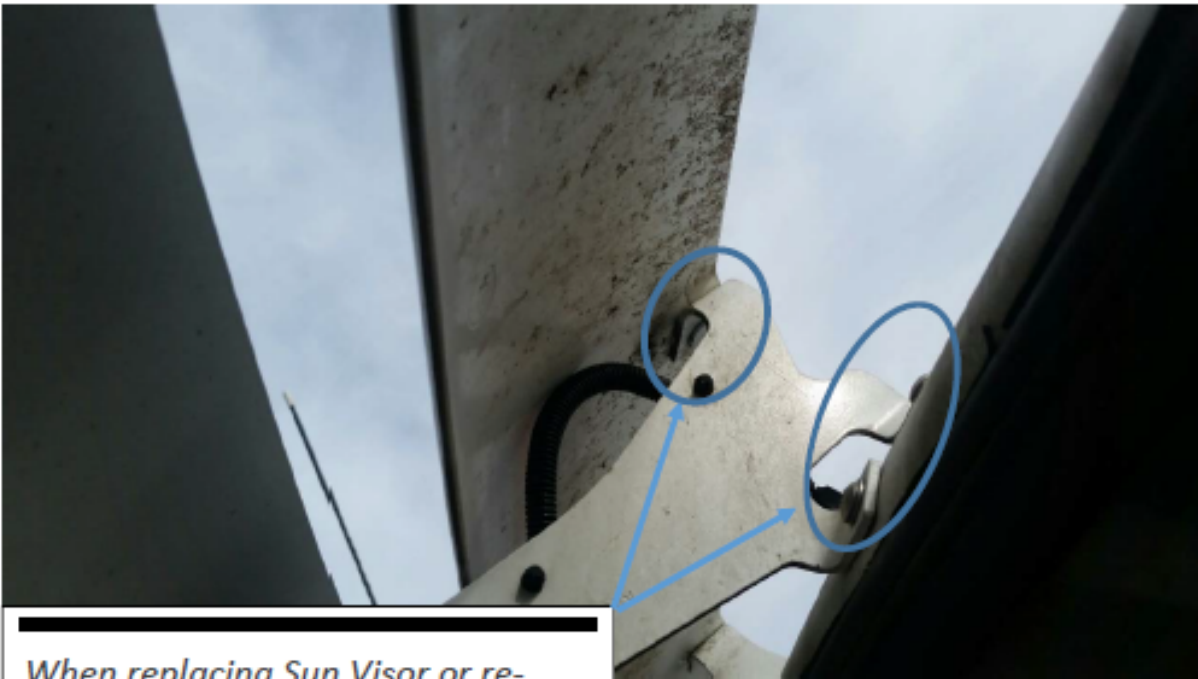
Sun Visors cracking and Sun Visor mounting screws loose.

Reports of sun visors cracking and/or mounting screws loose have been received from some areas with windy conditions.

When replacing the Sun Visors, installing/torqueing the mounting screws (or removing and retorquing loose mounting screws) it is recommended to use Loctite 272:
