Title: LT Starter power connection cleaning

Applies To: LT

Red paint found on Starter power cable eyelet removal.

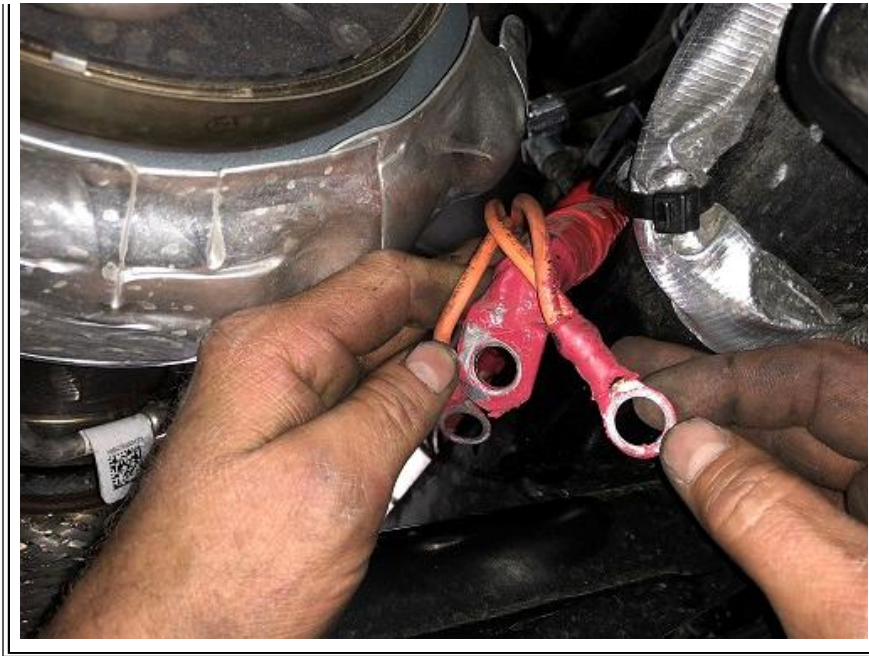
Example:

This iKNOW is primarily a reminder to ensure removal of all RED paint found on any Starter eyelet when replacing a starter on an LT vehicle.

1. Step 1. Remove power cable from the positive stud on the starter, using wire brush (tool example) clean all eyelets that show RED paint covering the connection area. Once reassembled make sure to apply corrosion protection IE Graffo, Tribbotuff
