09345 Version 10

**Warranty Extension: MIL Comes On with DTCs P0301 thru P0304**Supersedes 13-078, dated May 4, 2018, to revise the information highlighted in **yellow**.**AFFECTED VEHICLES**

Year	Model	Trim	VIN Range
2008–12	Accord	All V6 A/T	Check the iN VIN Status for Eligibility.

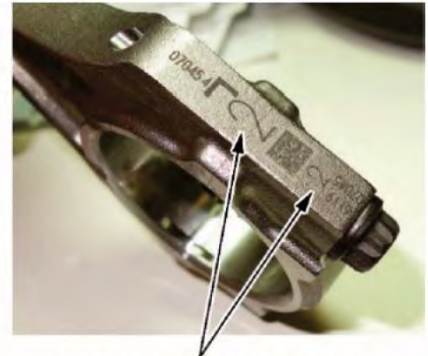
These are manufacturing marks, and do not indicate the cylinder number.

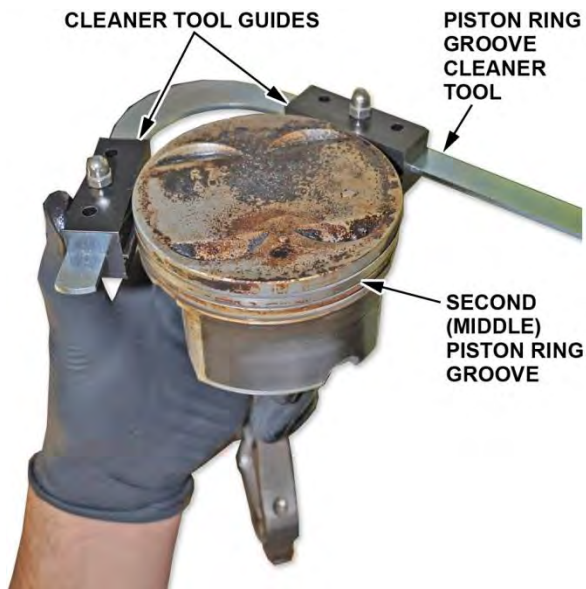
3. While holding the piston upright in your left hand, take the piston ring groove cleaner tool in your right hand and line up the cleaner tool guides with the second (middle) piston ring groove.

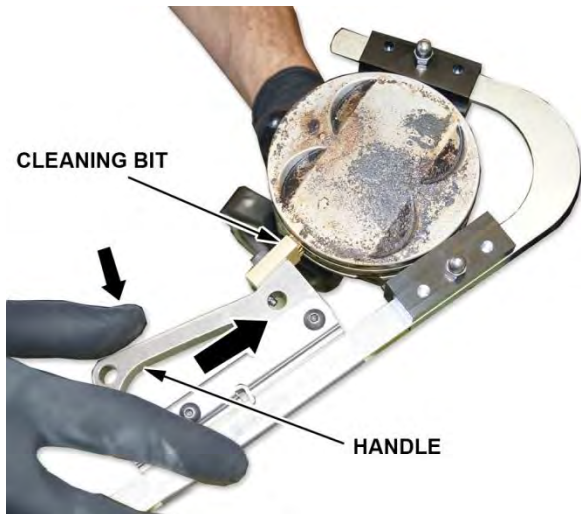
4. Press the handle on the piston ring groove cleaner tool and slide the cleaning bit onto the appropriate piston ring grooves.

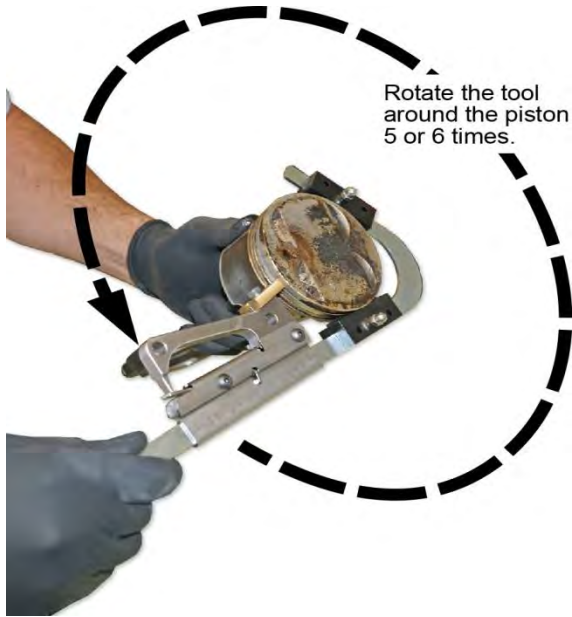
6. Hold the piston steady and rotate the tool counterclockwise five to six times to remove any carbon deposits in the piston ring grooves. **Do not** rotate the tool clockwise.

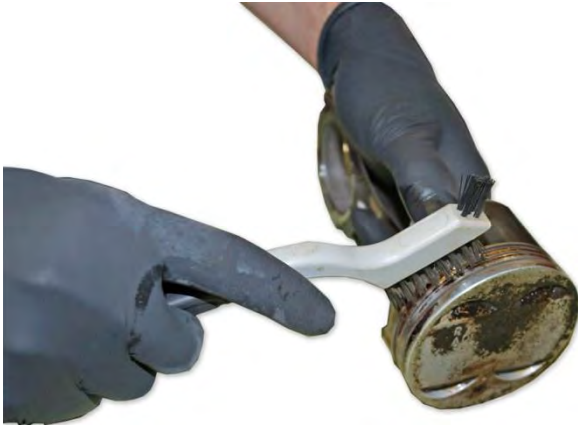
7. Remove the piston groove cleaning tool and clean off the carbon from the tool bit.
8. Finish cleaning the piston with throttle plate cleaner and the nylon brush. **Do not** use a steel wire brush.

NOTE: Below are some examples of before and after pictures. Depending on mileage and running conditions, the pistons will achieve different levels of cleanliness.
