09351 Version 15

Warranty Extension: MIL Comes On With DTCs P0301 thru P0304

Supersedes 13-081, dated May 4, 2018, to revise the information highlighted in **yellow**.

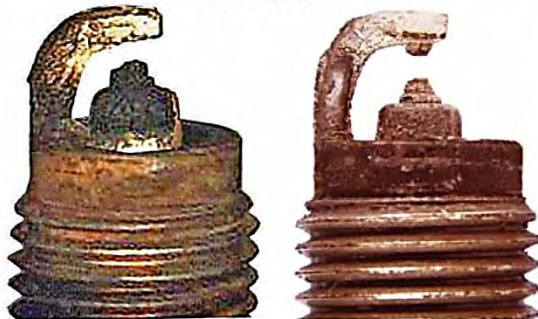
2. Remove and check the spark plug(s) on the affected cylinders (example: if P0301 is stored, check the spark plug on cylinder No. 1).

Are the spark plug(s) fouled?

GOOD

NO GOOD

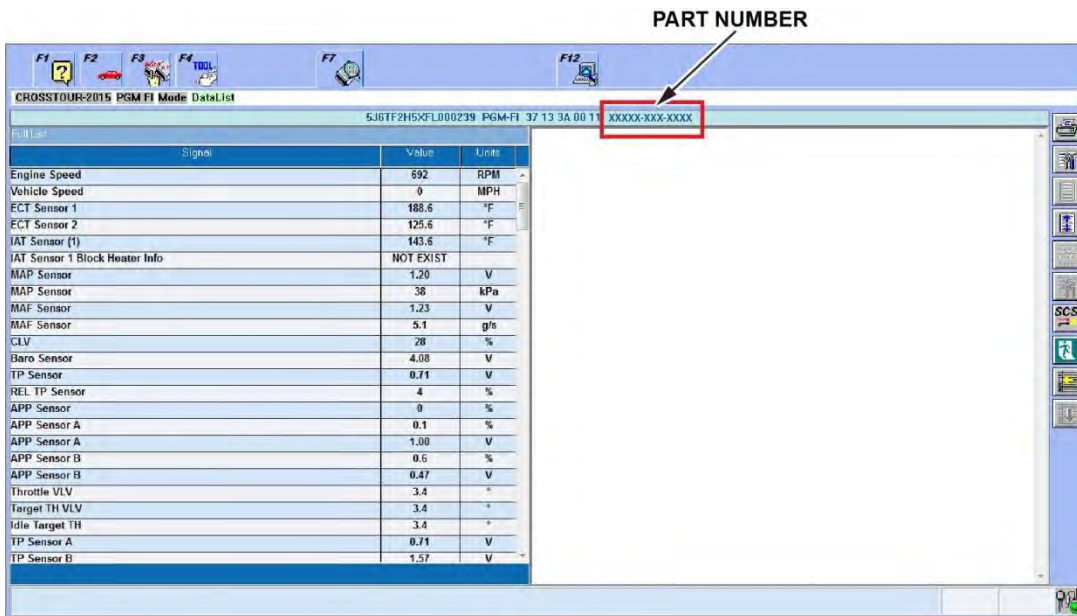
3. For 2011 Odyssey only: Check the PCM software version P/N located above the **PGM FI Data List**.

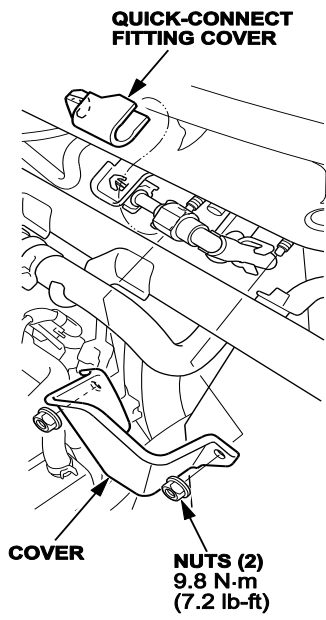
4. Disconnect the fuel feed hose line at the bulkhead.

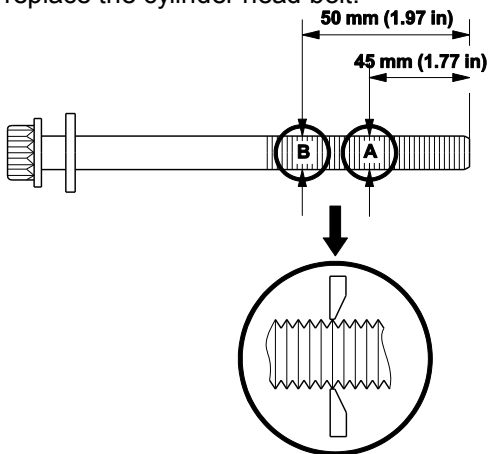
41. Measure the head bolts to determine if they need replacement. If either diameter is less than **11.3 mm (0.445 in)**, replace the cylinder head bolt.

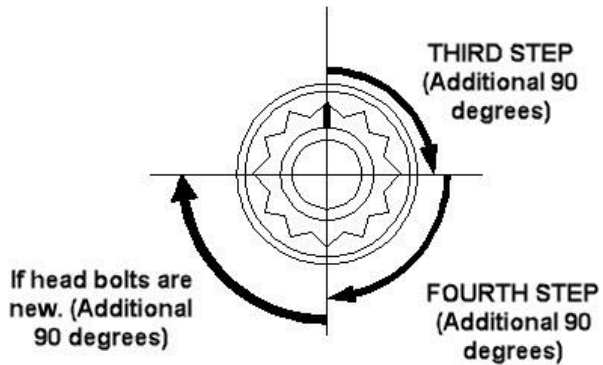
NOTE: Below are the head bolt torque specifications for reinstallation.

- **First step: Apply new engine oil to the threads and under the bolt heads.**
- Second step: torque the cylinder bolts in sequence to **29 N•m (22 lb-ft)**.
- Third step: tighten in sequence an additional **90 degrees**.
- Fourth step: tighten in sequence an additional **90 degrees**.
- If the bolts are new, tighten an additional **90 degrees**.

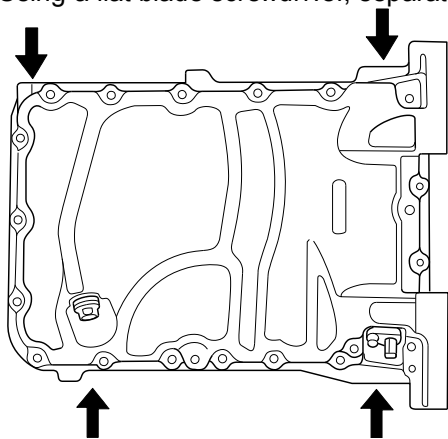
46. Using a flat blade screwdriver, separate the oil pan from the engine block in the areas shown.

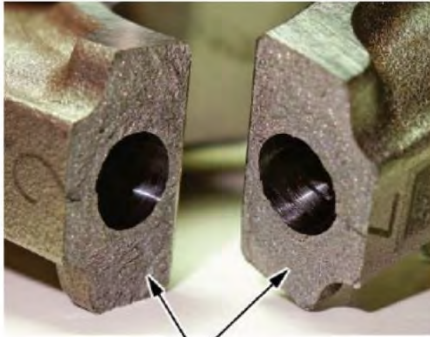
The uneven mating surfaces are uniquely matched and not interchangeable.

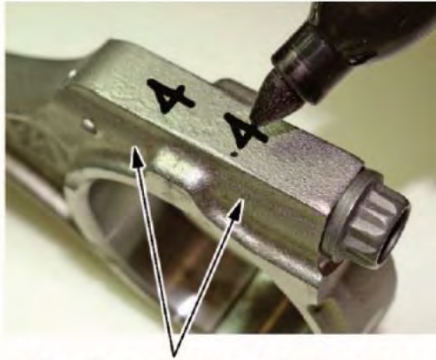
Mark the connecting rod and rod cap with the cylinder number.

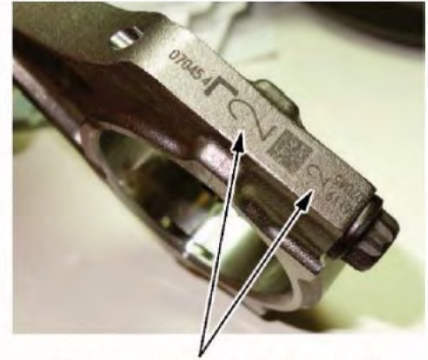
These are manufacturing marks, and do not indicate the cylinder number.

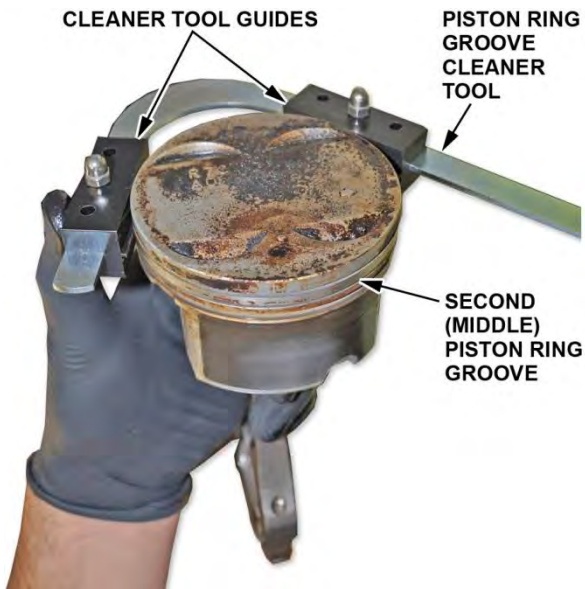
3. While holding the piston upright in your left hand, take the piston ring groove cleaner tool in your right hand and line up the cleaner tool guides with the second (middle) piston ring groove.

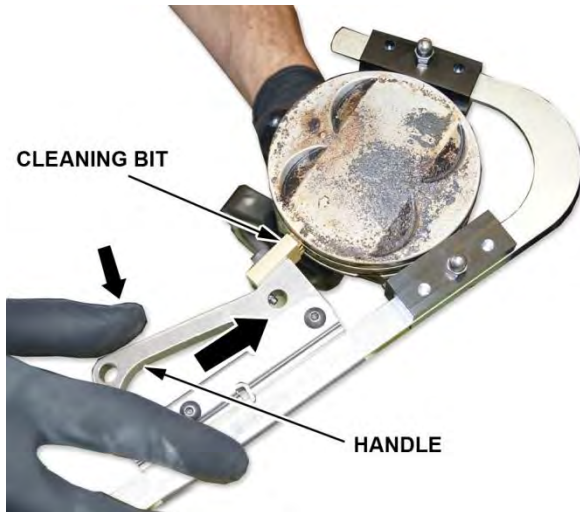
4. Press the handle on the piston ring groove cleaner tool and slide the cleaning bit onto the appropriate piston ring grooves.

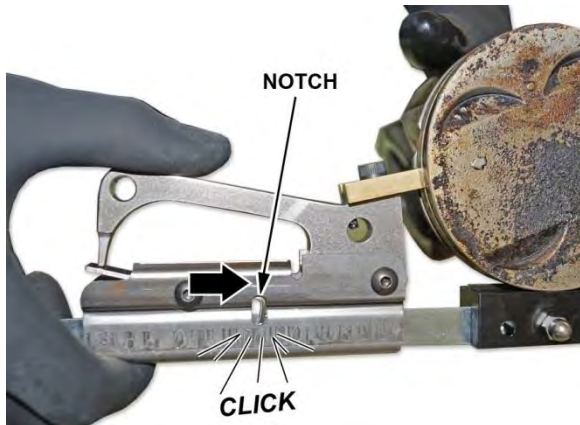
5. Once the cleaning bit is in the appropriate ring grooves of the piston, make sure the tool handle clicks in to place.
NOTE: There is only one notch on the tool for the handle to engage.

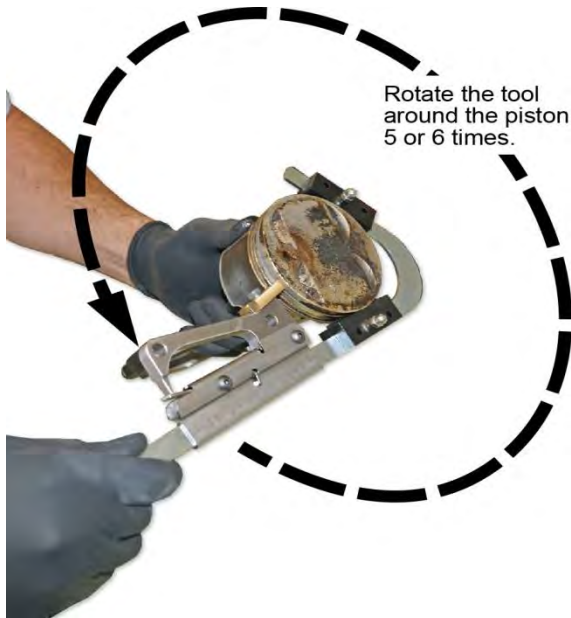
6. Hold the piston steady and rotate the tool counter-clockwise five to six times to remove any carbon deposits in the piston ring grooves. **Do not** rotate the tool clockwise.

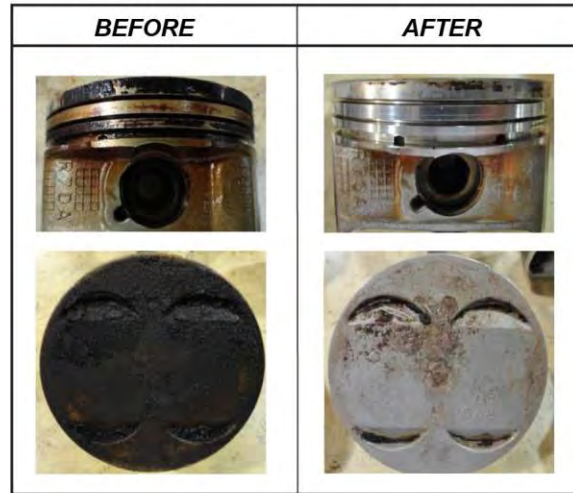
54K PISTON

NOTE: Below are some examples of before and after pictures. Depending on mileage and running conditions, the pistons will achieve different levels of cleanliness.

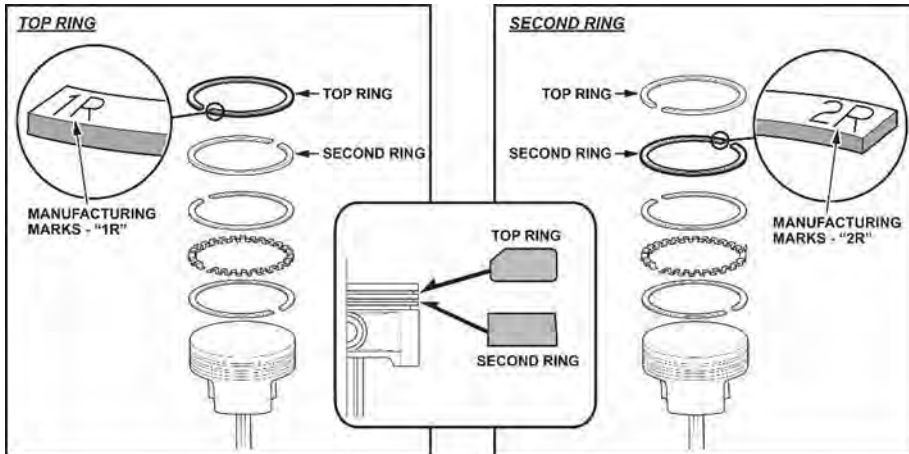
9. Install the piston rings as shown.

NOTE: The first (top) ring has a **1R** manufacturing mark and the second (middle) ring has an **2R** manufacturing mark. The manufacturing marks must be facing upward.

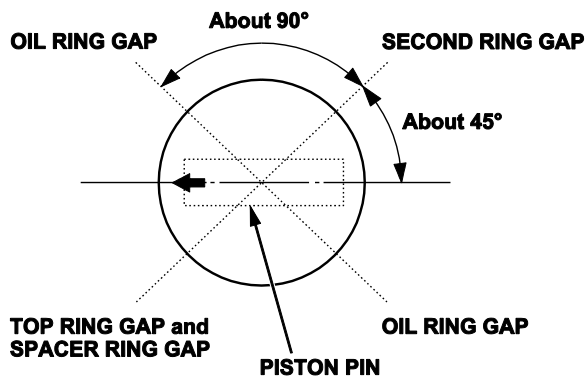
10. Position the ring end gaps as shown.

NOTE: If the ring gaps are not positioned correctly, excessive blowby may occur.

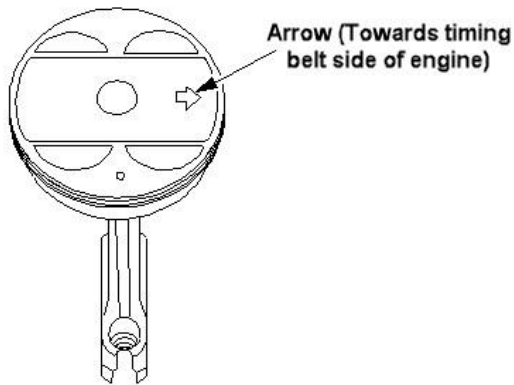
12. Install the piston/connecting rod assembly into the cylinder bore with the arrow on top of the piston facing the timing belt side of the engine.

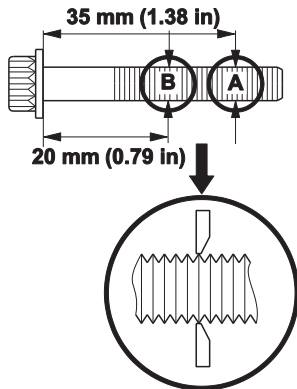
13. Measure the diameter of the connecting rod bolts to determine if they need replacement. Calculate the difference in diameter between point A and point B. It should not be more than **0–0.1 mm (0–0.004 in)**.

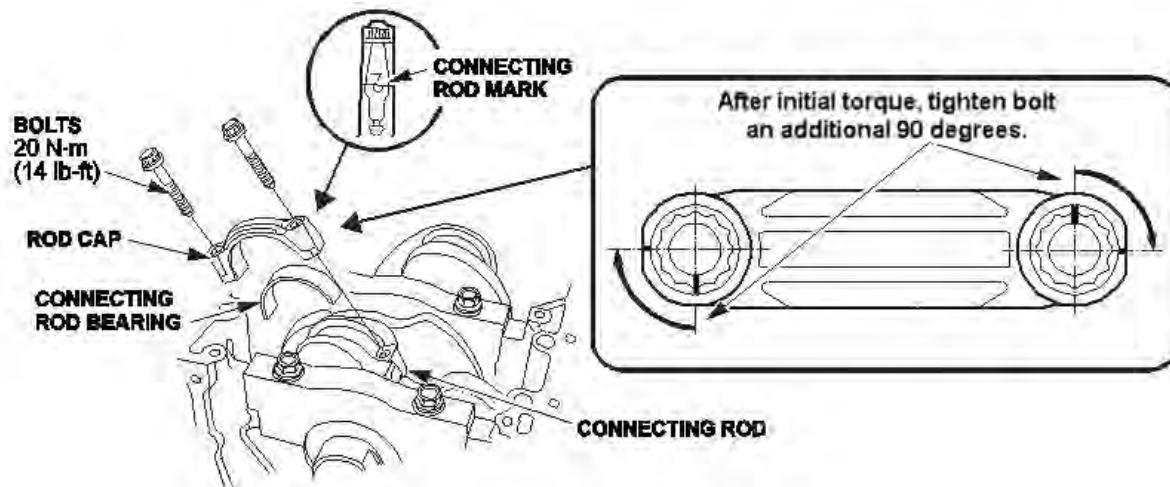
14. Apply new oil to the connecting rod bolt threads and flanges. Torque the bolts to **20 N•m (14 lb-ft)** then tighten the connecting rod bolts an additional **90 degrees**.
