June 15, 2018

Warranty Extension: Customer Support Program For Front Passenger's Airbag Inflator for 2013-14 Accord and 2013-15 Civic (Expires June 30, 2030)

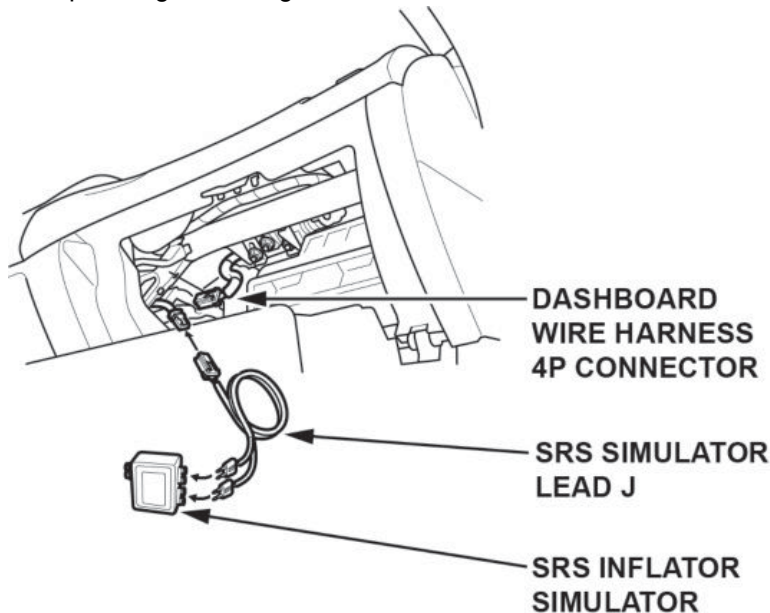
11. Access the front passenger's airbag, and disconnect the dashboard wire harness connector 4P connector from the front passenger's airbag 4P connector.

12. Connect the terminals of SRS simulator lead J to the SRS inflator simulator (2 Ω connectors), then connect SRS simulator lead J to the 4P connector as shown.
13. Reconnect the negative battery cable.
14. Turn the ignition to ON, not ACC, and wait 10 seconds.
15. Check if the SRS DTC listed in step 8 returns.
 - If the same SRS DTC returned, the inflator is OK. The Customer Support Program does not apply. Continue with normal troubleshooting.
 - If the same SRS DTC **did not** return, go to the REPAIR PROCEDURE.

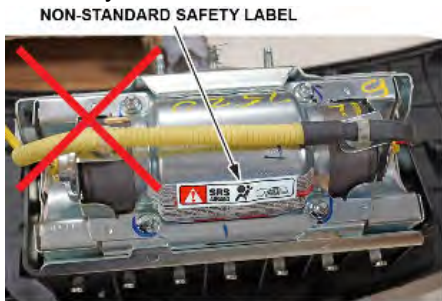
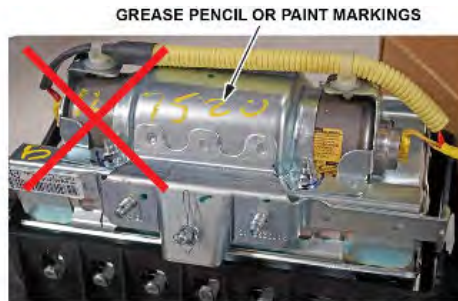
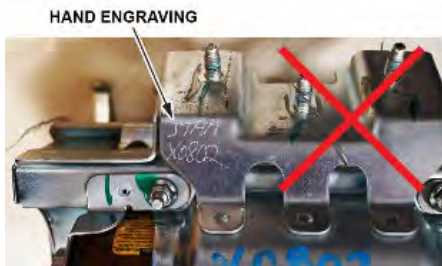
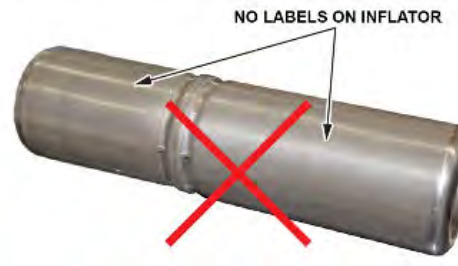
4. Place the airbag module, face down, on a clean shop towel.
 5. Visually inspect the airbag module and the inflator for any unusual writing or markings. Click [HERE](#) to watch a video to help identify counterfeit airbags.

- If there are any unusual markings, like an incorrect label or a model year written in marker, the airbag module and inflator may not be the correct airbag module and/or inflator for the vehicle or it may be a counterfeit part. For more information about counterfeit airbags, you can refer to safercar.gov, enter keywords **MANAGING COUNTERFEIT**, and select **Recommended Dealer Guidance for Managing Counterfeit Air Bags** from the list. **If you suspect that the airbag module or inflator is counterfeit, do not continue this procedure.** Contact your DPSM for assistance.

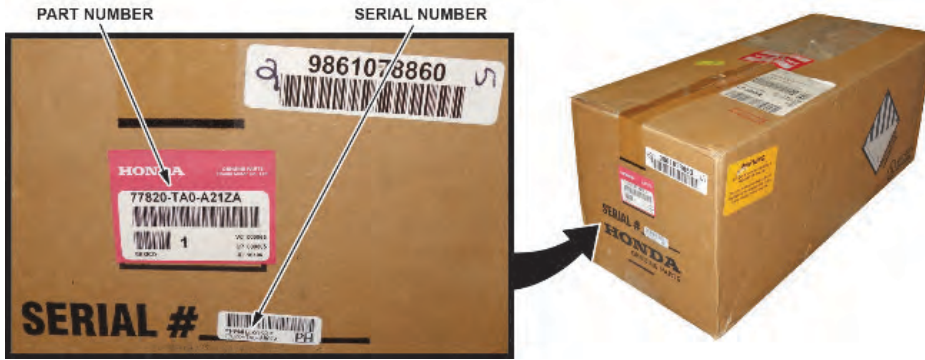
6. Write the serial number and part number from the outside of the airbag module box on the RO.
