June 15, 2018

## Warranty Extension: Customer Support Program For Front Passenger's Airbag Inflator for 2013-15 ILX and 2013-15 RDX (Expires June 30, 2030)

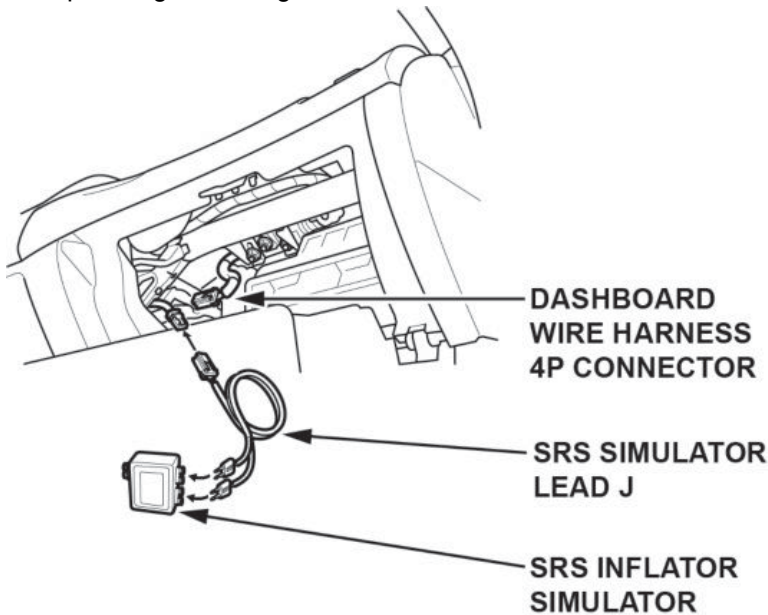
11. Access the front passenger's airbag, and disconnect the dashboard wire harness connector 4P connector from the front passenger's airbag 4P connector.

12. Connect the terminals of SRS simulator lead J to the SRS inflator simulator (2  $\Omega$  connectors), then connect SRS simulator lead J to the 4P connector as shown.
13. Reconnect the negative battery cable.
14. Turn the ignition to ON, not ACC, and wait 10 seconds.
15. Check if the SRS DTC listed in step 8 return.
  - If the same SRS DTC returned, the inflator is OK. The Customer Support Program does not apply. Continue with normal troubleshooting.
  - If the same SRS DTC **did not** return, go to the REPAIR PROCEDURE.

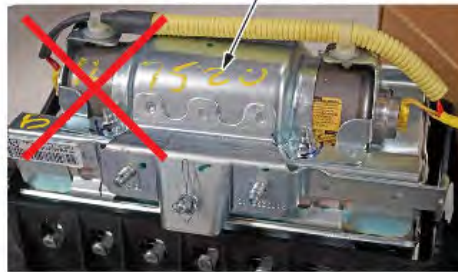
GREASE PENCIL OR PAINT MARKINGS

- If there are any unusual markings, like an incorrect label or a model year written in marker, the airbag module and inflator may not be the correct airbag module and/or inflator for the vehicle or it may be a counterfeit part. For more information about counterfeit airbags, you can refer to *safercar.gov*, enter keywords **MANAGING COUNTERFEIT**, and select **Recommended Dealer Guidance for Managing Counterfeit Air Bags** from the list. **If you suspect that the airbag module or inflator is counterfeit, do not continue this procedure.** Contact your DPSM for assistance.

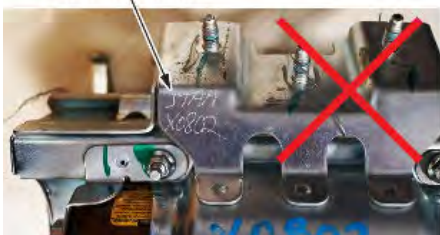
HAND ENGRAVING

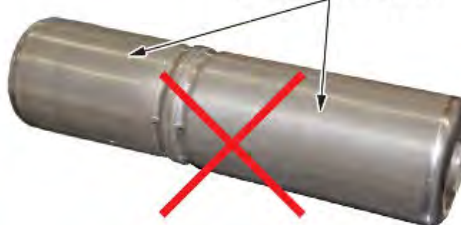
NO LABELS ON INFLATOR

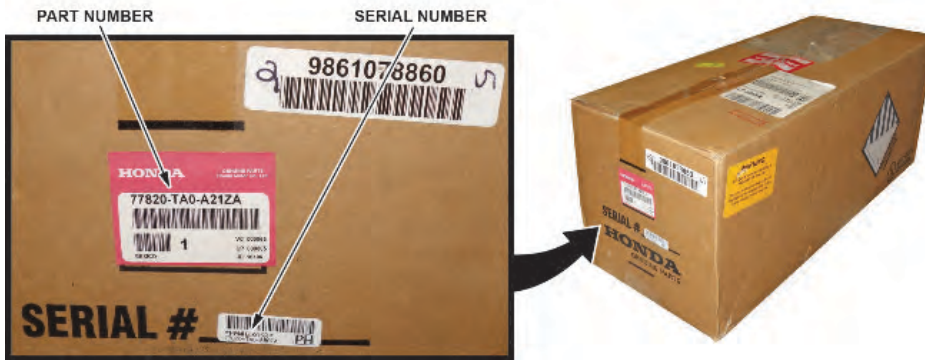
6. Write the serial number and part number from the outside of the airbag module box on the RO.

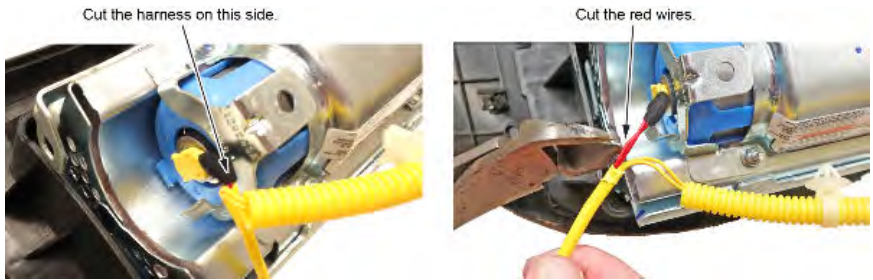
- 3.1. Cut the red wires about 2 inches from the inflator.

There may be some protective tube covering the wires that needs to be cut away to access the wires.

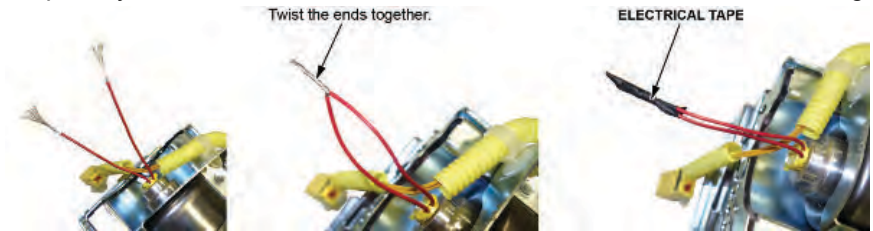
- 3.2. Strip away about 1 inch of the red wire insulation, then twist the wires together.

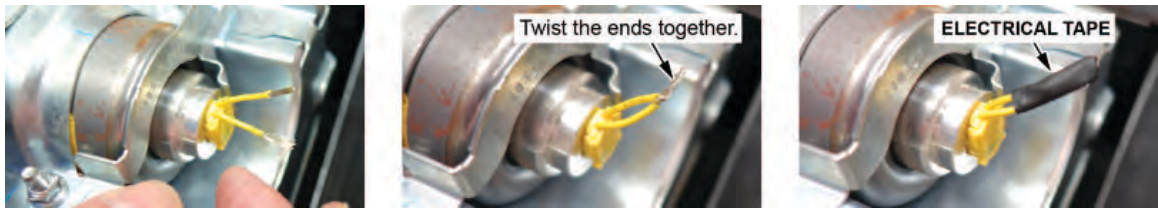
- 3.5. Strip away about 1 inch of the yellow wire insulation, then twist the wires together.

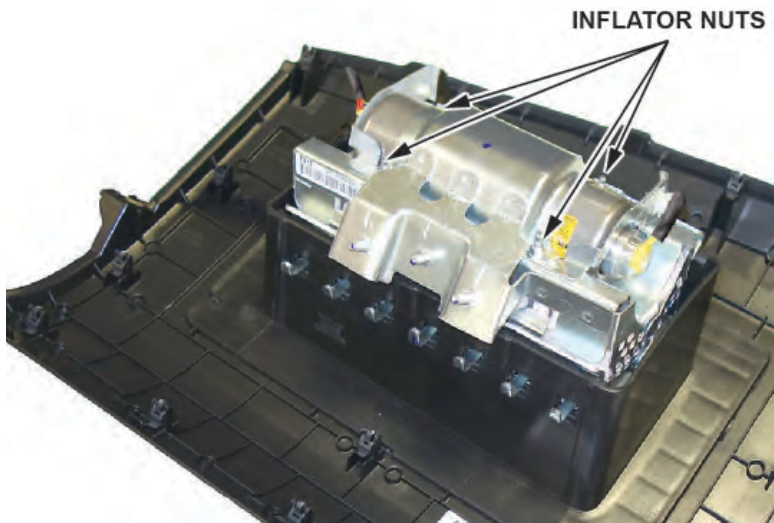
3.7. Remove the four inflator nuts.

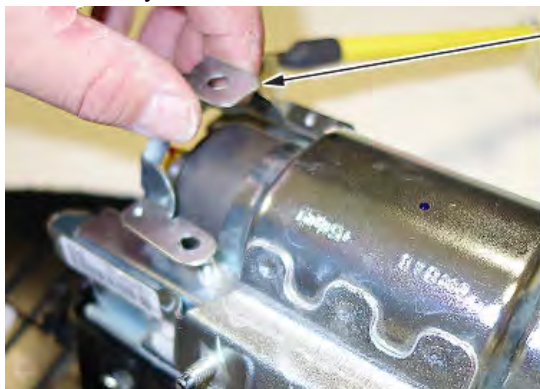
4. Remove the inflator bracket.

You can only remove one of the brackets, as the other is welded to the airbag housing.

INFLATOR BRACKET  
Do not reuse.

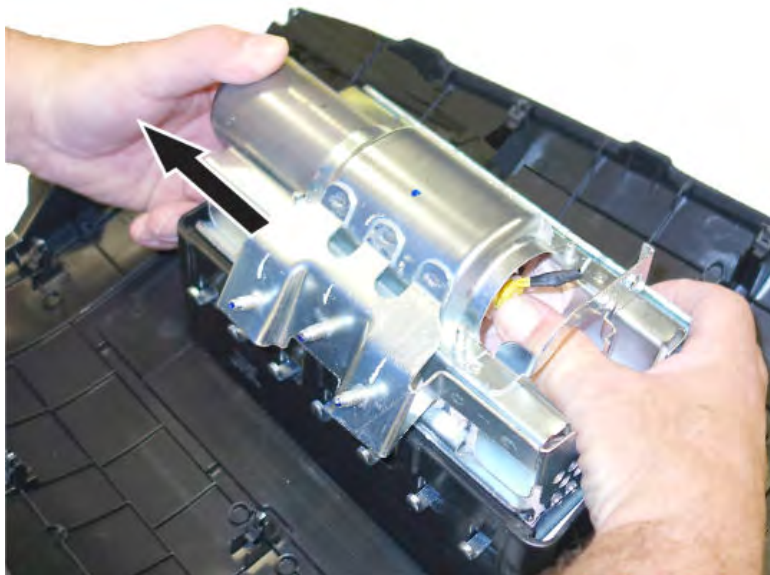
5. Remove the inflator by pulling it out.
