MODEL  
2018MY~  
Stinger (CK)  
Niro (DE PHEV)

NUMBER  
PS549 (Rev 1, 06/26/2018)

### BATTERY TESTING PROCEDURE

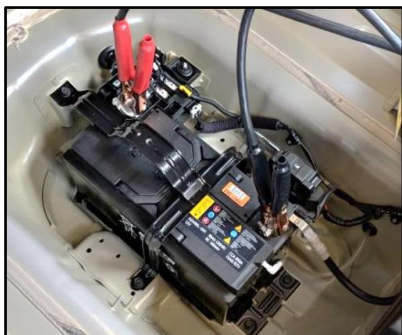
Stinger (CK)

When required to test the battery in a Stinger or Niro Plug-in Hybrid, whether during PDI or at other times, ensure to always conduct the battery test directly at the battery posts, as shown below, and not at clamp(s) located under the hood. Testing the battery using clamps under the hood can result in a false “measured Cold Cranking Amps” (CCA) and voltage readings, resulting in unnecessary battery replacement. When prompted to charge the battery, connect probes directly to the battery posts to ensure proper charging.

NOTE: In the Stinger, removal of rear floor cargo cover and spare tire is necessary to access the battery located in the rear cargo area. In the Niro Plug-in, removal of the right side cargo cover is necessary.
