Preliminary Information

PIT5565A Squeak/Squawk Noise When Turning Steering Wheel

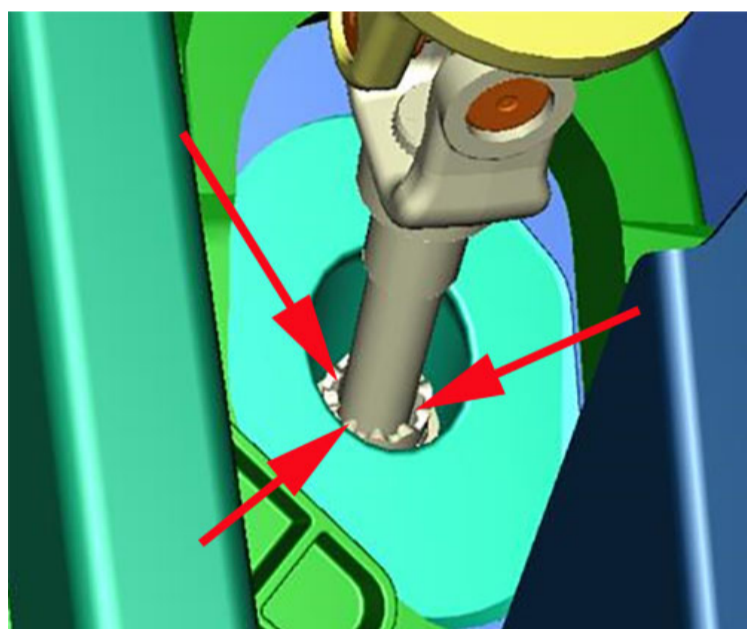
Involved Region or Country	North America
Condition	Some owners may comment that when turning the steering wheel they may hear a squeak/squawk noise from the driver's foot well area.
Cause	Lack of lubrication where the intermediate shaft passes through the engine bulkhead I-shaft boot.

From inside of the vehicle, locate where the steering column I-shaft passes through the engine bulkhead I-shaft boot. Apply a liberal amount of lithium based grease where the I-shaft contacts the rubber boot as shown in picture below.
