SERVICE BULLETIN

Reference number:	SB-06-1117	Issued: 15 June, 2018
Subject:	DB11 Brake Squeal	
Model(s):	DB11	
VIN Range:	All	
Applicable to:	All Dealers	
Distribute to:	After Sales Manager Executive Manager Service Manager Sales Manager	Warranty Staff Technician(s) Parts Staff

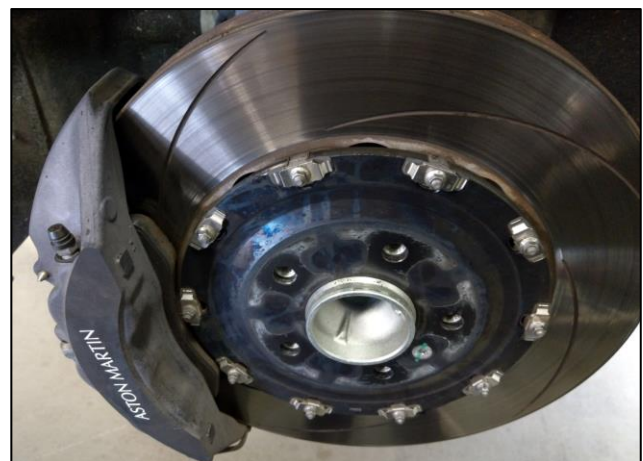
Do a visual inspection of the brake discs, pads and wheel mounting face for signs of external contamination. If there are signs of external contamination because the incorrect wheel cleaner was used, this damage will not be covered by the vehicle warranty. The brake pads must be replaced.

Figure 1 gives an example of contamination on the wheel mounting face and caliper.

1. Remove the brake pads (refer to Workshop Manual procedure 06.03.AD – front pad kit or 06.04.AD – rear pad kit). Keep the brake pads if inspection is necessary.
2. Use an abrasive paper to fully clean the braking surface of all four brake discs.
3. Clean all brake dust and remaining contaminants with an aerosol brake cleaner.
4. Apply Tunap paste to the replacement brake pads (refer to Service Bulletin SB-06-0344V2).
5. Do Service Bulletin: SB-06-1005 - Low-Speed Brake Modulation if applicable.
6. Do the brake pad bedding-in procedure (refer to Workshop Manual procedure 06.03.BC)
