# Preliminary Information

## PIC6095C Diagnostic Aid: Part Identification For Next Generation Infotainment Components And Correct Labor Codes

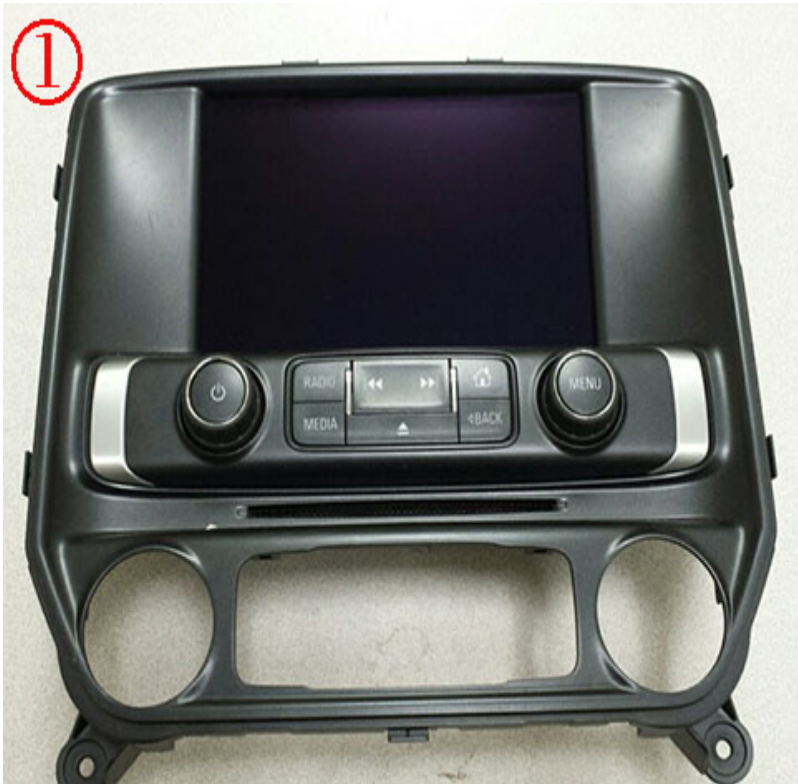
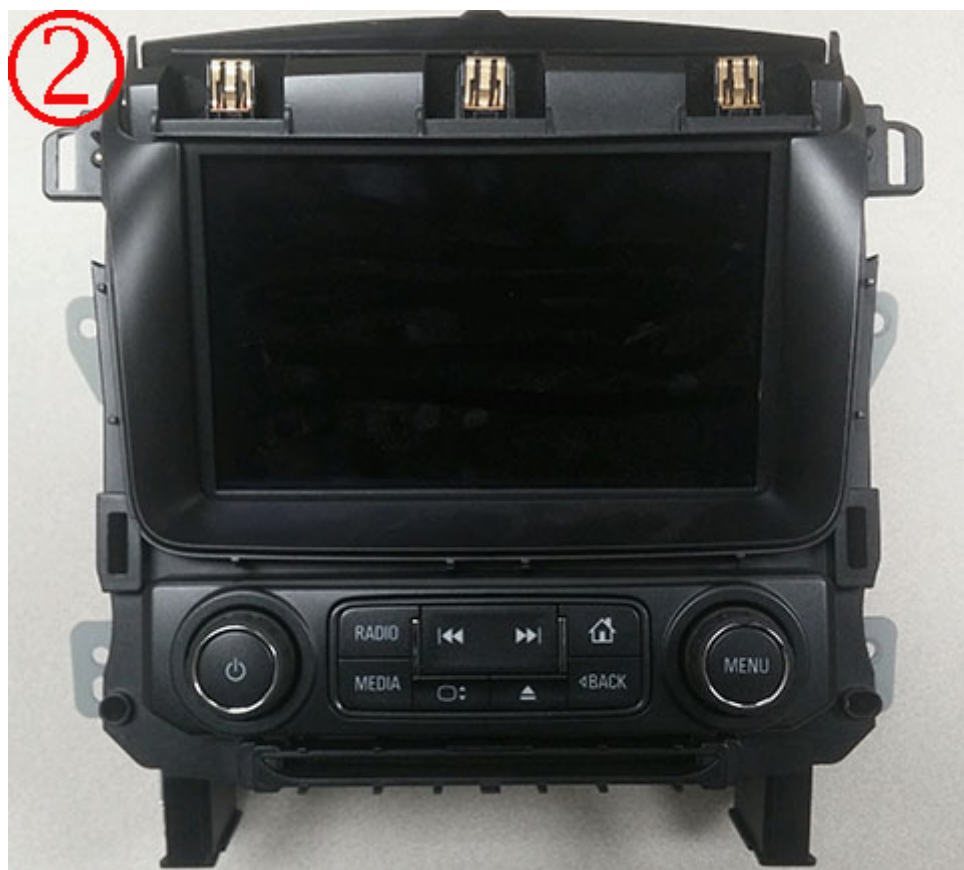
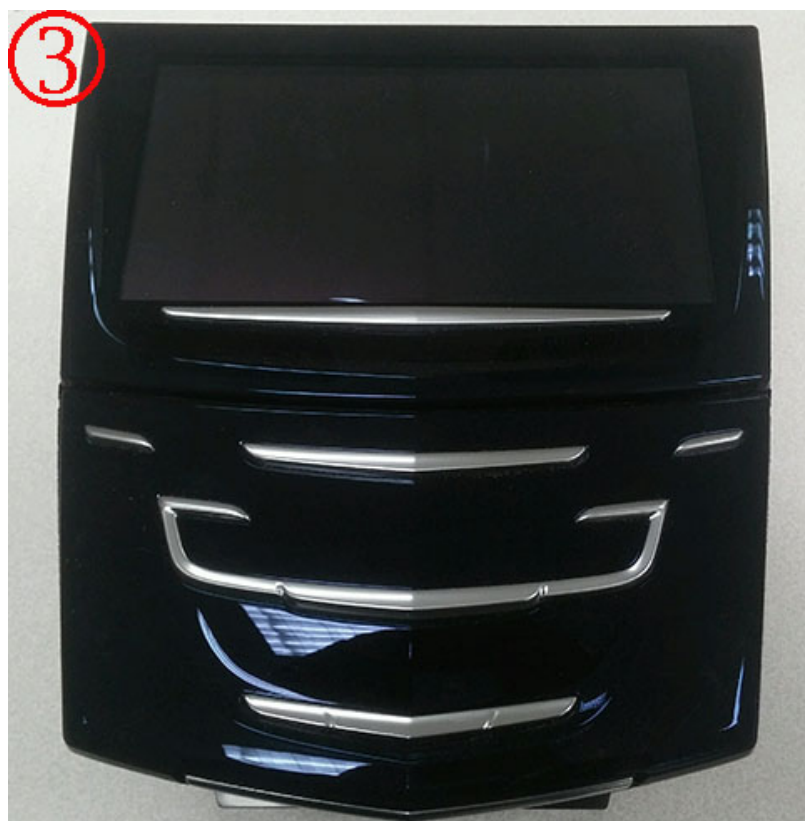
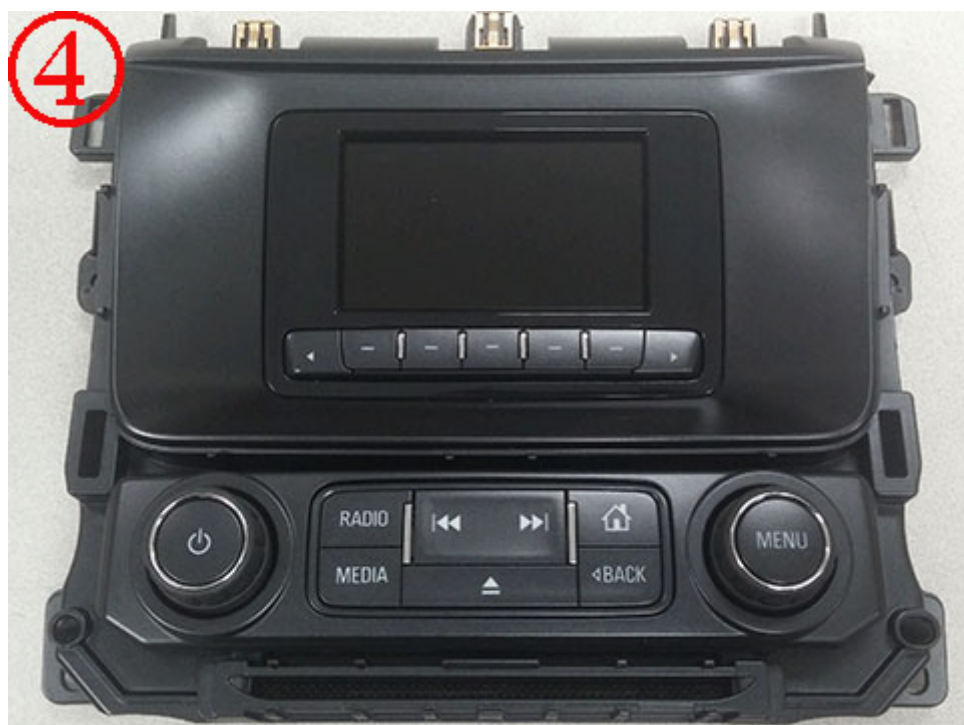
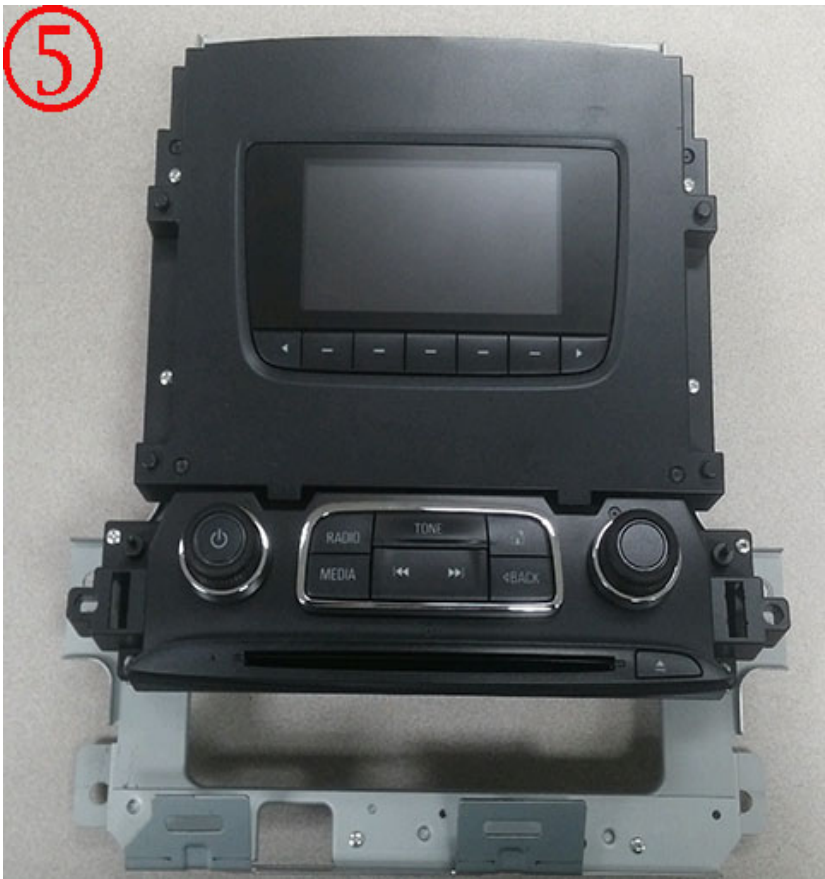
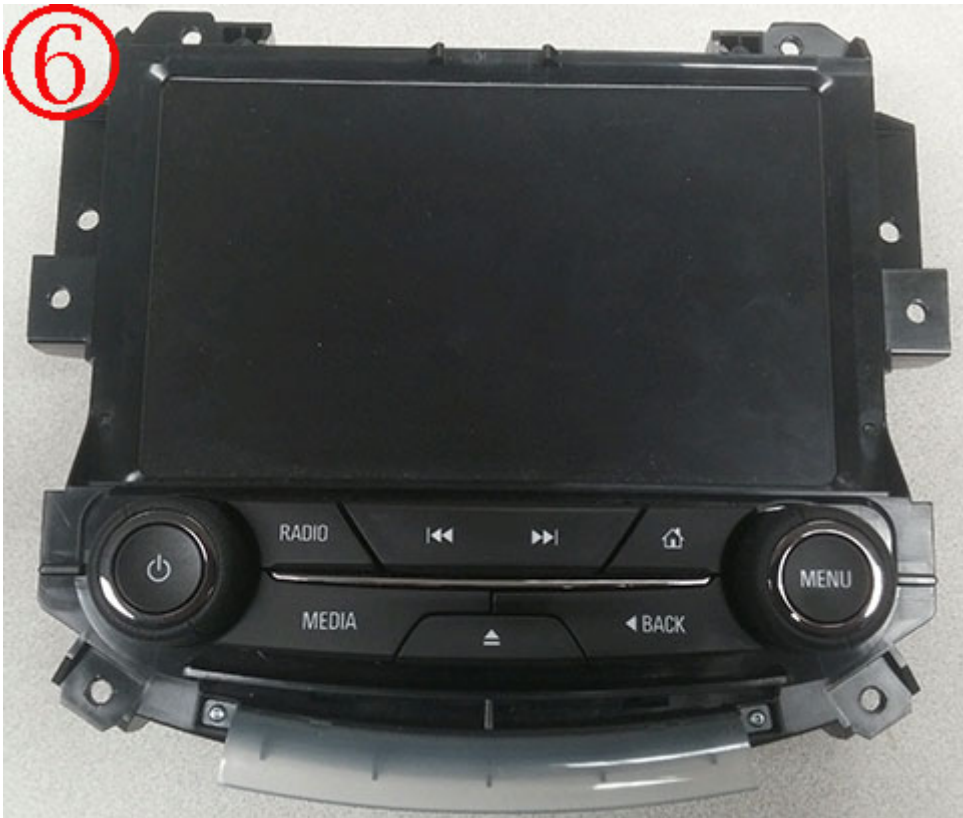
## ICS (Integrated Center Stack) -Display/Radio Control Assembly

ICS examples (See figure 1-6)

**Note: Some technicians have replaced the ICS thinking they were replacing the radio. See figure 11 for radio example**

Replacement Labor Code: 3420700 - Use Published Labor Operation Time

Reprogram Labor Code: 2810325 - Use Published Labor Operation Time

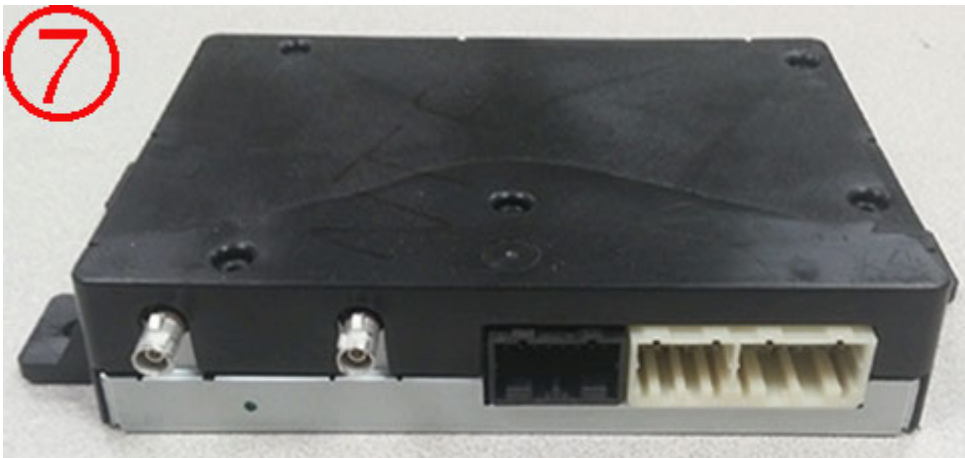
**OnStar (Telematics Control Module/VCIM)**

**Examples (See figures 7- 8)**

**Note: Technicians have replaced VCIM's thinking they were replacing the HMI. Please see figures 9-10 for HMI examples**

**Replacement Labor Code: 3422790 - Use published Labor Operation time**

**Reprogram Labor Code: 2810145 - Use published Labor Operation time**

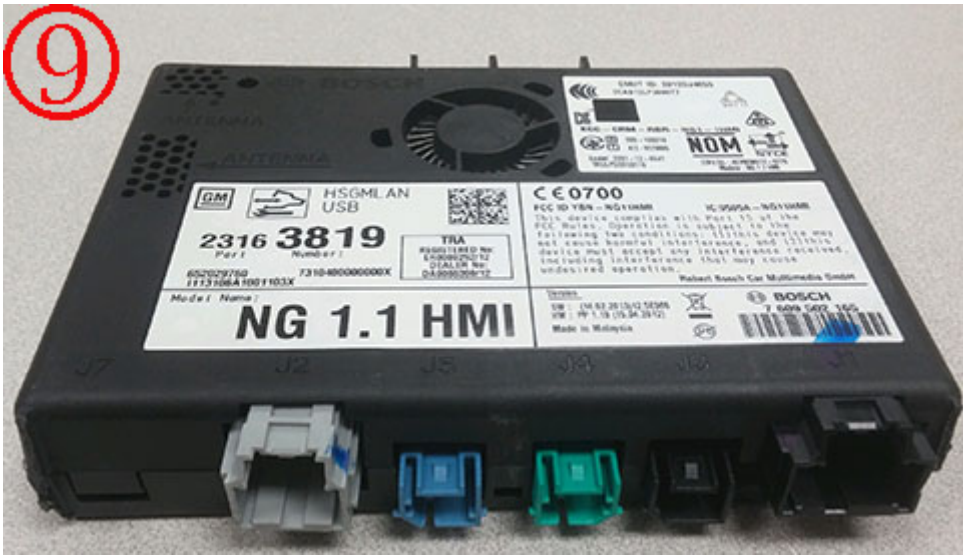
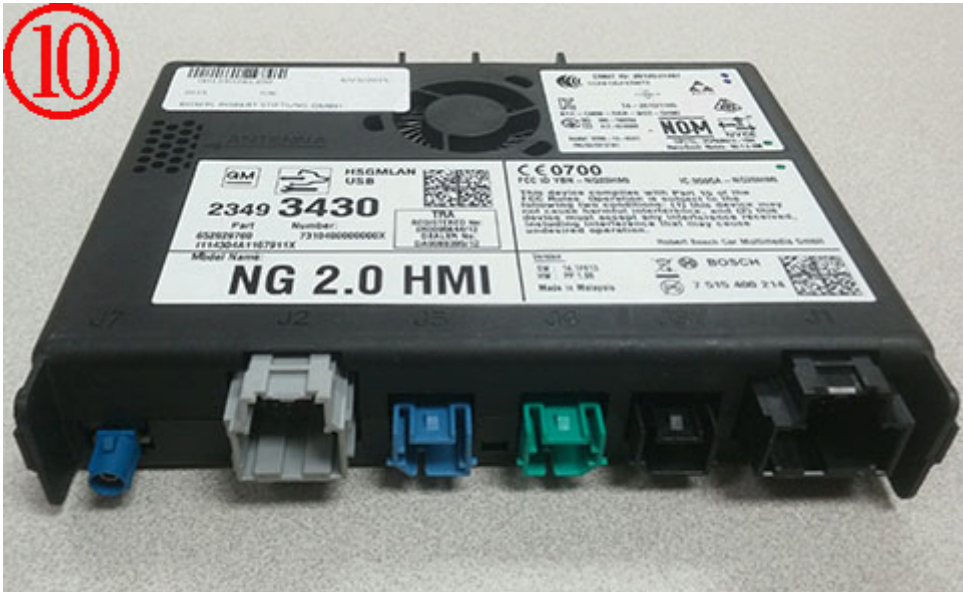
### HMI (Human Machine Interface)

Examples (See figures 9- Non Navigation HMI, 10- Navigation HMI)

Replacement Labor Code: 3421060 - Use published Labor Operation time

Reprogram Labor Code: 2810345 - Use published Labor Operation time

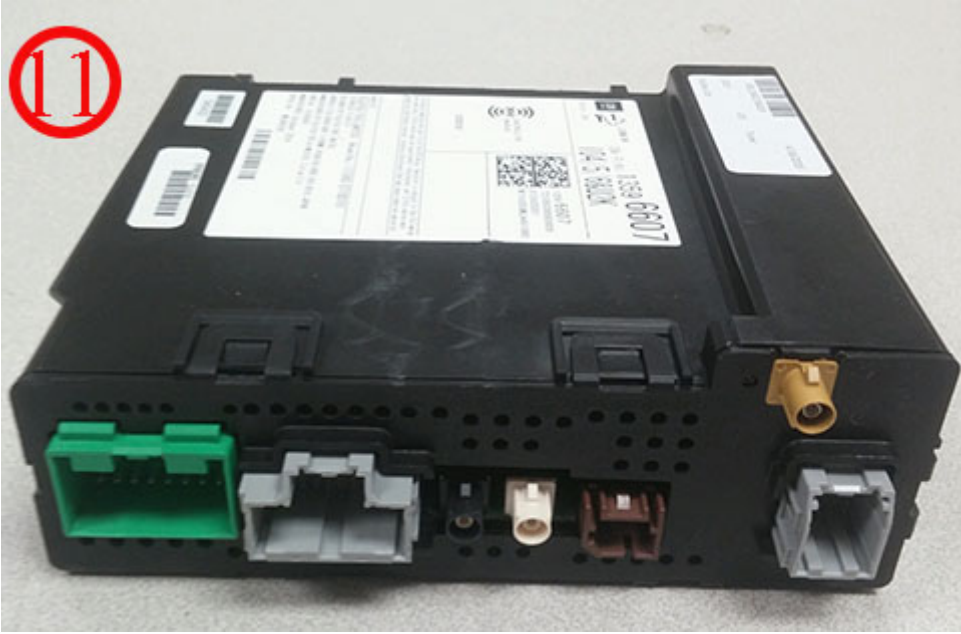
**Radio/Tuner**

**Example (See figure 11, 14 and 15)**

**Replacement Labor Code: 3420840 - Use published Labor Operation time**

**Reprogram Labor Code: 2810335 - Use published Labor Operation time**
