Service Alert

Subject: DO NOT SWAP RADAR UNITS BETWEEN VEHICLES	Service Alert No.: SA-031/18
	Last Issued: 06/27/2018

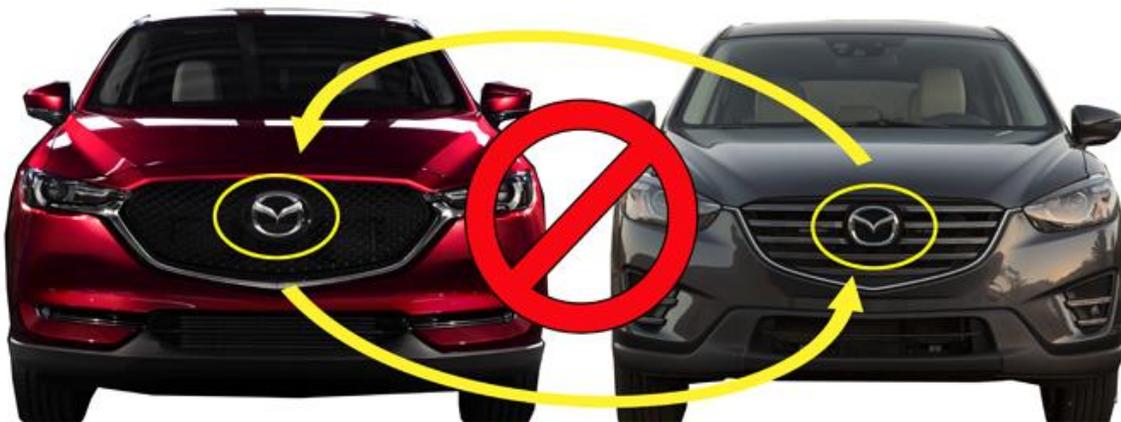
When troubleshooting a radar unit, DO NOT swap it with another vehicle. Radar units are configured to the original vehicle, and if installed in another vehicle, a configuration error will occur. Refer to MGSS (RADAR UNIT INSPECTION) for proper diagnosing.
