Cargo Area Not Lit?

AFFECTED VEHICLES

Year	Model	Trim
2017	CR-V	ALL
2018	CR-V	ALL

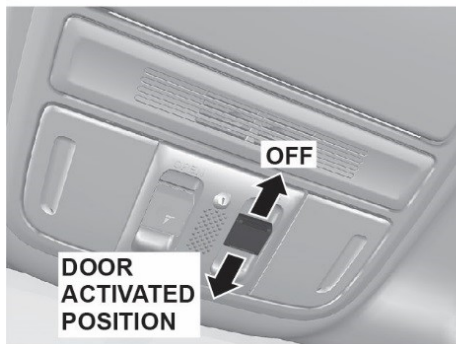
OVERHEAD CONSOLE
(Models with moonroof)

If the cargo area is looking on the dim to dark side, chances are the interior lights switch in the overhead console and the cargo area light switches in the cargo area just need to be set.

Make sure the interior lights switch is set to the **door activated** position and the cargo area light switches are set to **ON**.

With the interior lights switch set to the **door activated** position, the interior lights will come on when any of the doors are opened. With the cargo area light switches set to **ON**, the cargo area lights will come on when the tailgate is opened and will go off when it's closed.
