## Charging socket/charging cable: Charging cable lock jams (P12E900, P13E800)

Topic number	LI54.10-P-067824
Version	1
Function group	54.10 Battery, power supply, voltage converter
Date	03-07-2018
Validity	451ev3 (smart electric drive 3rd generation)
Reason for change	Remedy adjusted
Reason for block

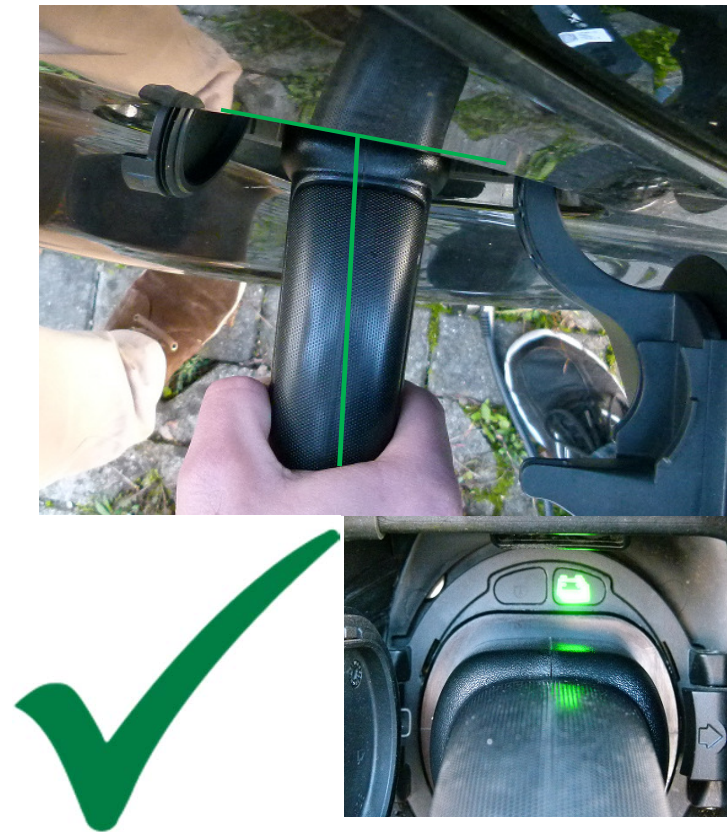
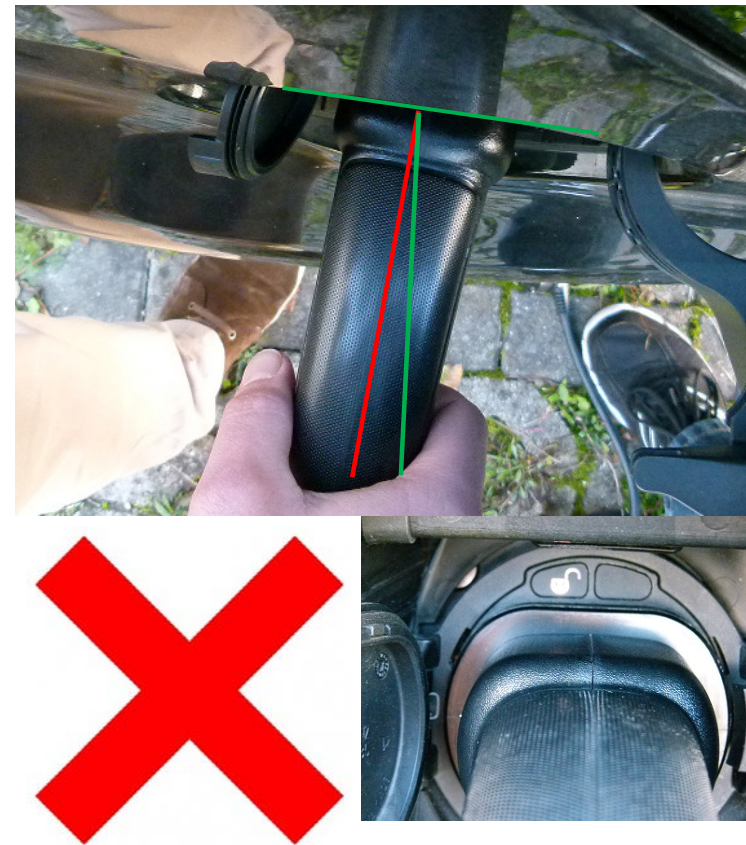
# 451ev3 (smart electric drive 3. Generation) Plug-in process

- Make sure that the cable is plugged into the socket completely with the connector neither tilted nor misaligned; if necessary, hold on to the connector until you hear the locking pin move.
- Also, make sure that the cable does not exert any tension or torque on the connecting in the vehicle. This can cause the locking pin to jam. The cable must be routed freely without load between the infrastructure and the vehicle.
