Service Campaign Bulletin

Campaign No. 2018020006, March 2018

SUBJECT: **Model 166 and 292 Model Year 2017**
Check right front air suspension strut, replace if necessary

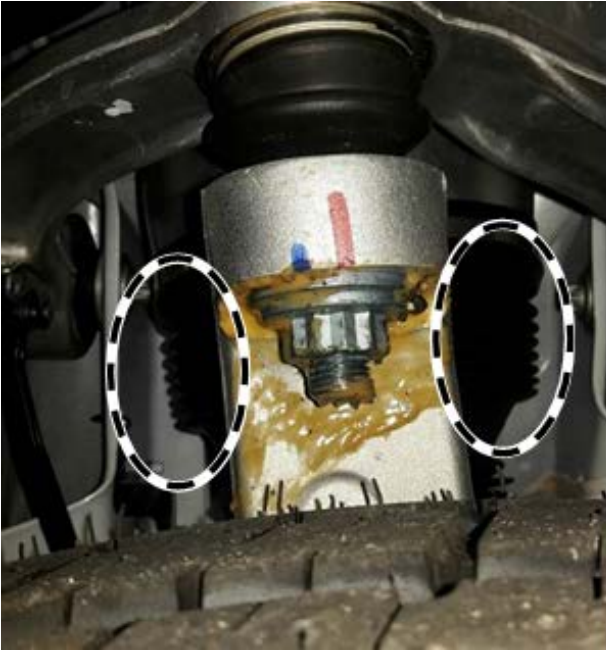
Figure 1 (OK Pictured)

Results as seen in (Figure 1) Air suspension strut **OK**: end measure.

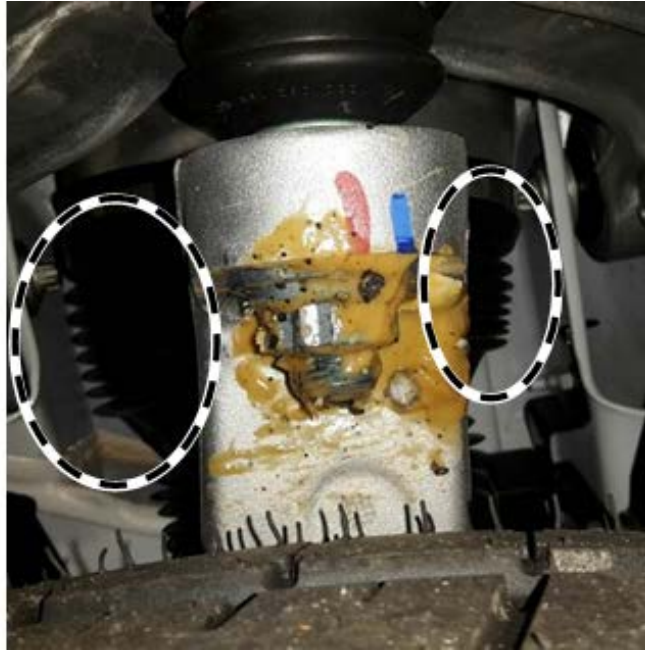
i Check whether boot of air suspension strut is deformed or has moved or has significantly different heights on both sides.

Figure 2 (Not OK, air suspension bellows significantly compressed on one side)

Results as seen in (Figure 2) Air suspension strut **NOT OK**: perform repair procedure.

1. Replace right front air suspension strut. (AR32.25-P-1017GQ.)
2. Perform wheel alignment check. (AR40.20-P-0200GQ)
