## Capless Fuel Filler (Mis-Fuel Inhibit Device) Leaks When Refueling Vehicle

Supersedes 18-014, dated April 21, 2018, to revise the sections highlighted in **yellow**.

Year	Model	Trim	VIN Range
2016-17	Civic	4-door	ALL
2016-18	Civic	2-door	ALL
2017-18	Civic	5-door	ALL

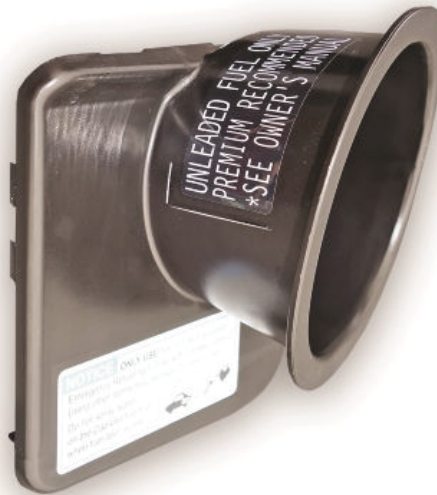
1. **On Si models only:** Apply the fuel lid label to the new fuel lid cover as shown.

Make sure the new fuel lid cover is clean and grease-free, especially on the surface where the label will be applied.

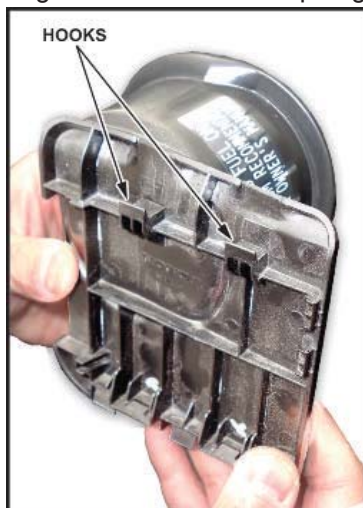
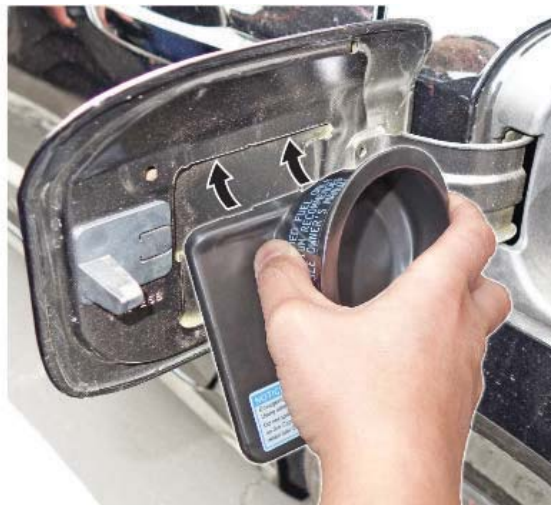
2. Align the hooks on the top edge of the fuel lid cover to slots on the fuel door as shown.

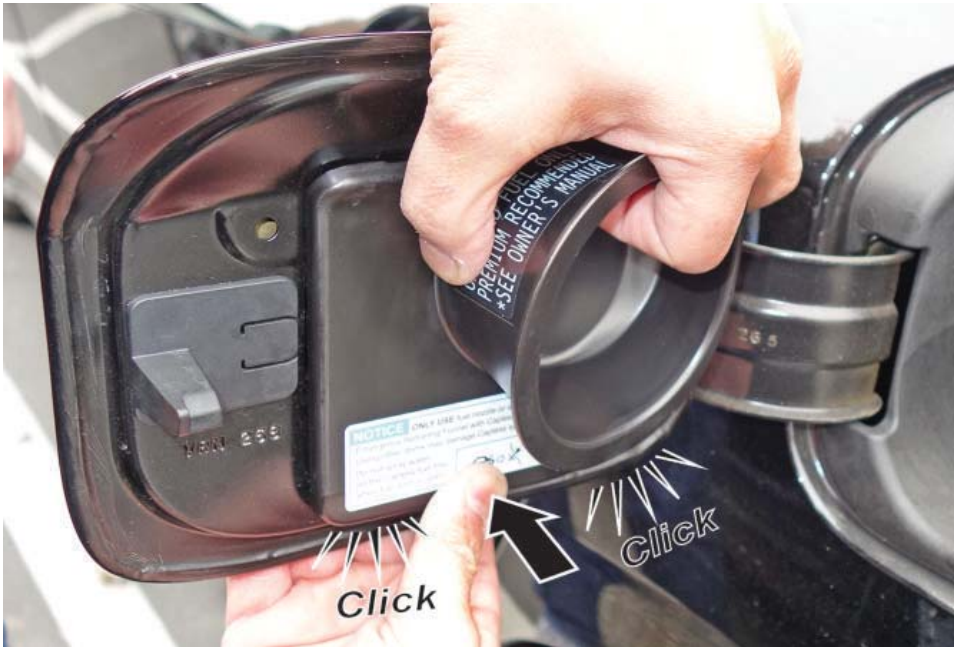
3. Press the bottom of the fuel lid cover against the fuel door until both locking tabs click. This indicates the fuel lid cover is securely and correctly installed.

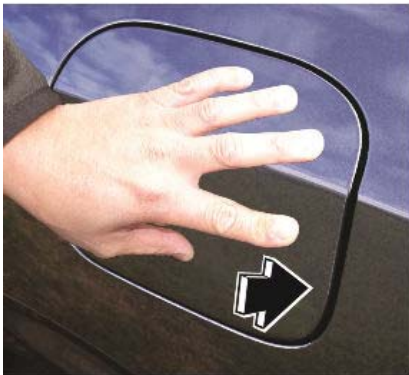
4. Make sure the fuel door closes and latches without contact or interference from the mis-fuel inhibit device and surrounding area. The gap between the door and the surrounding quarter panel should remain consistent.

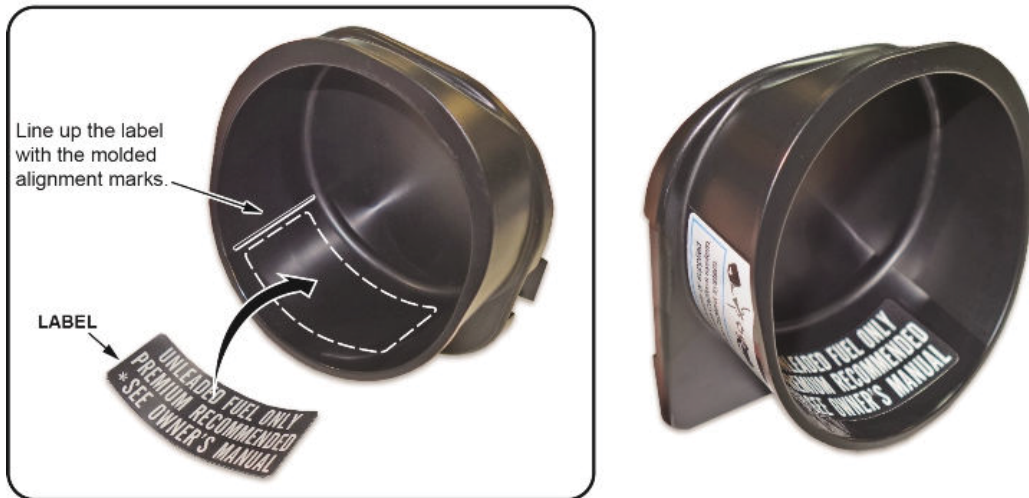
1. **On Si models only:** Apply the fuel lid label to the new fuel lid cover as shown.

Make sure the new fuel lid cover is clean and grease-free, especially on the surface where the label will be applied.

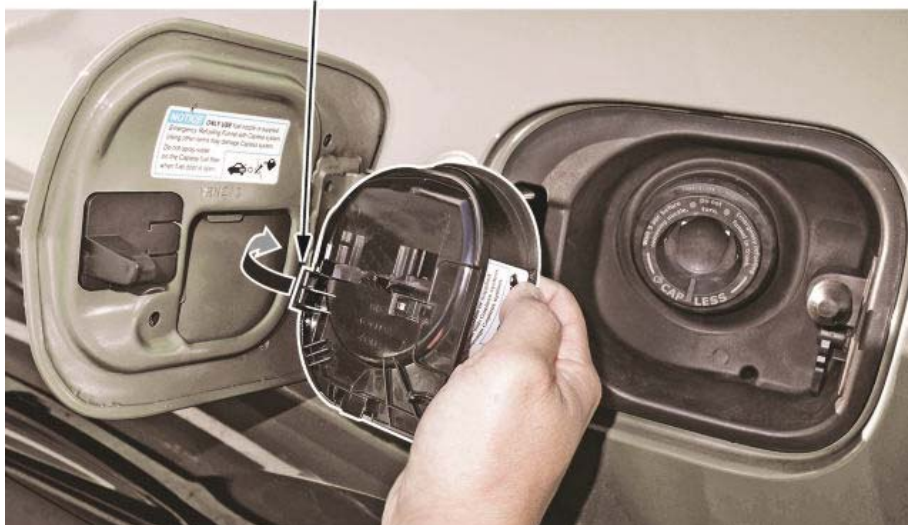
**HOOK**

2. Align the hook on the right side edge of the fuel lid cover to the fuel door as shown.

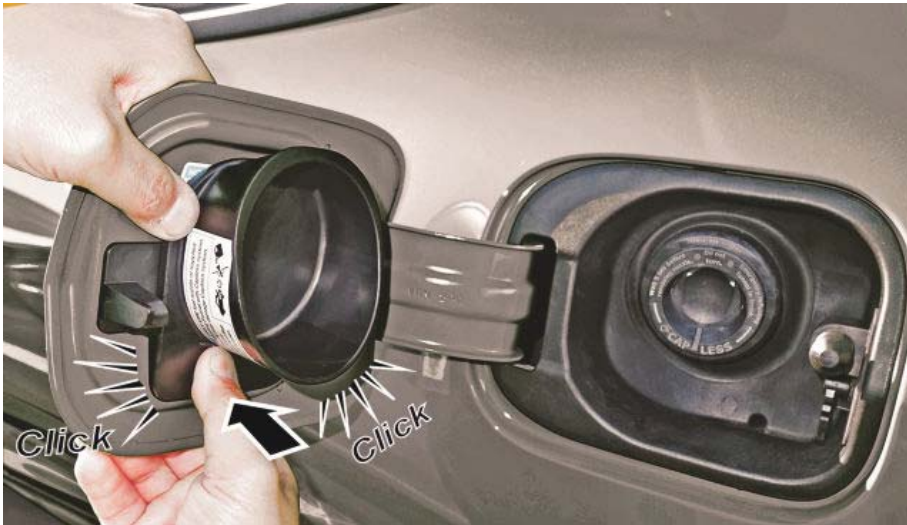
3. Press the left of the fuel lid cover against the fuel door until both locking tabs click. This indicates the fuel lid cover is securely and correctly installed.

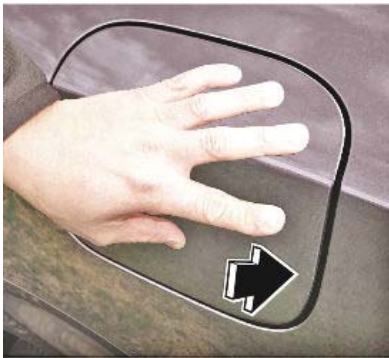
4. Make sure the fuel door closes and latches without contact or interference from the mis-fuel inhibit device and surrounding area. The gap between the door and the surrounding quarter panel should remain consistent.

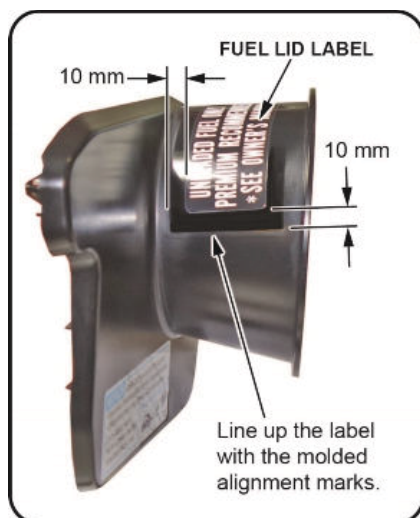
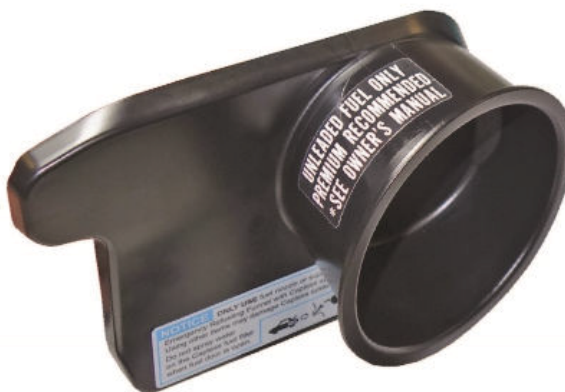
1. On Sport, Sport Touring, or Type R models only: Apply the fuel lid label to the new fuel lid cover as shown.

Make sure the new fuel lid cover is clean and grease-free, especially on the surface where the label will be applied.

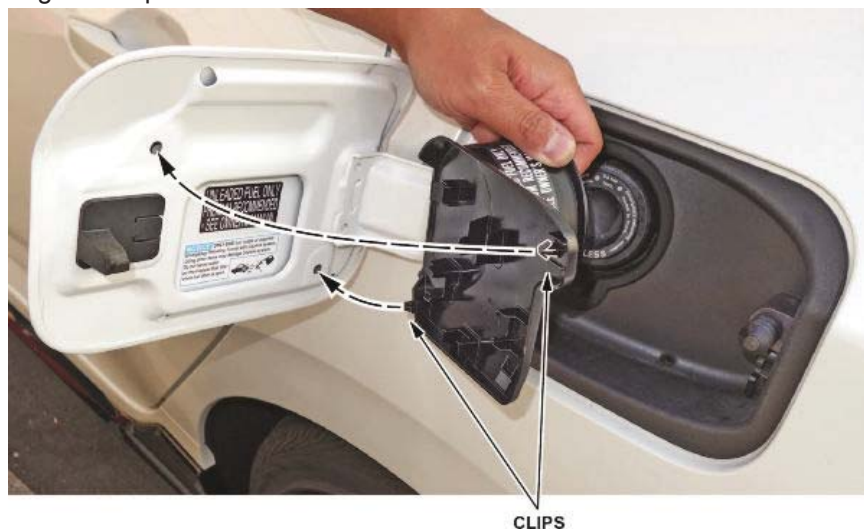
CLIPS

2. Align the clips on the back of the fuel lid cover to the holes in the fuel door.

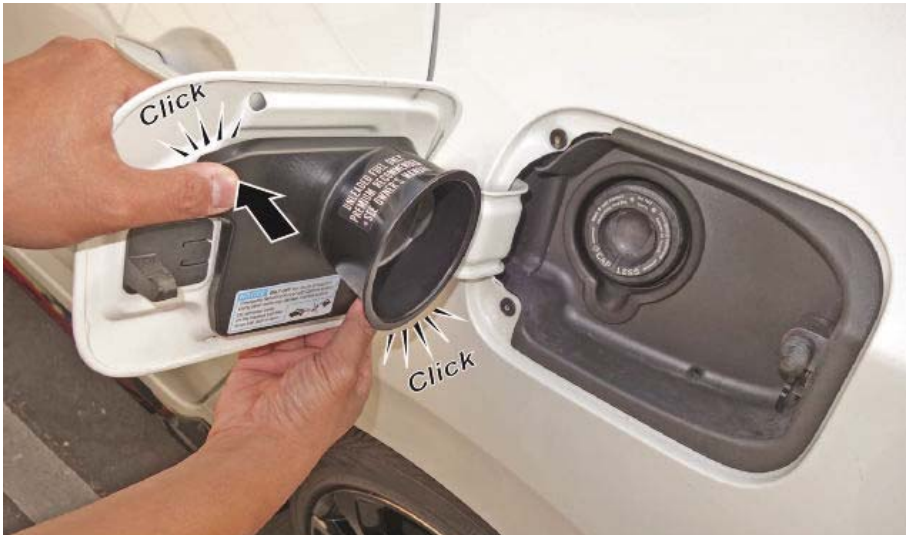
3. Press the left of the fuel lid cover against the fuel door until both clips click. This indicates the fuel lid cover is securely and correctly installed.

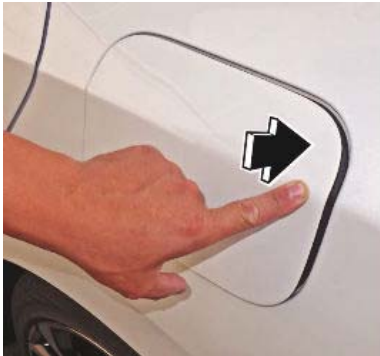
4. Make sure the fuel door closes and latches without contact or interference from the mis-fuel inhibit device and surrounding area. The gap between the door and the surrounding quarter panel should remain consistent.
