BT18-012

VOLUNTARY SERVICE CAMPAIGN 2017 – 2018 QX30; CERTIFICATION LABEL AND SUPPLEMENTAL LABEL

CAMPAIGN ID #: PG8B2**APPLIED VEHICLES:** 2017 – 2018 QX30 (H15)

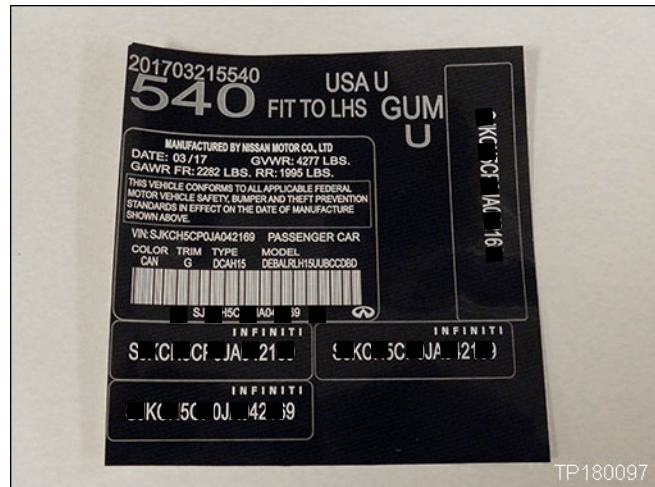
Figure A

One Certification Label

- The new/additional certification label is vehicle specific (VIN specific).
- **DO NOT REMOVE THE EXISTING CERTIFICATION LABEL.** Affix the new label as an additional label.

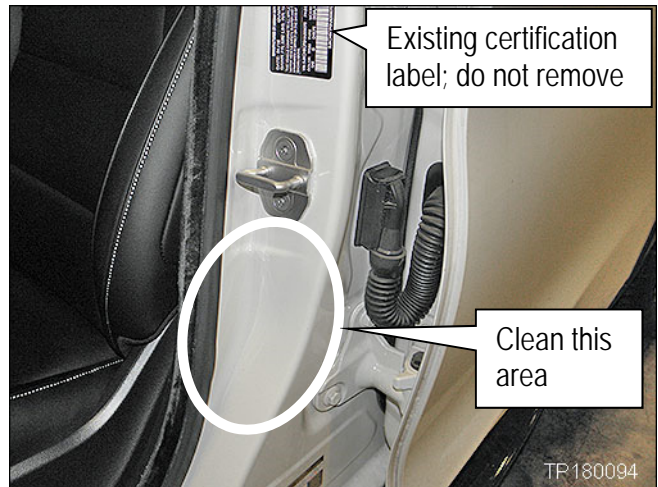
Figure 4

6. Clean the area on the driver side B-pillar, shown in Figure 4, with isopropyl alcohol.

NOTE: It is important the surface be free of dirt and oil to ensure proper adhesion of the new label.

7. Completely dry the area you just cleaned.

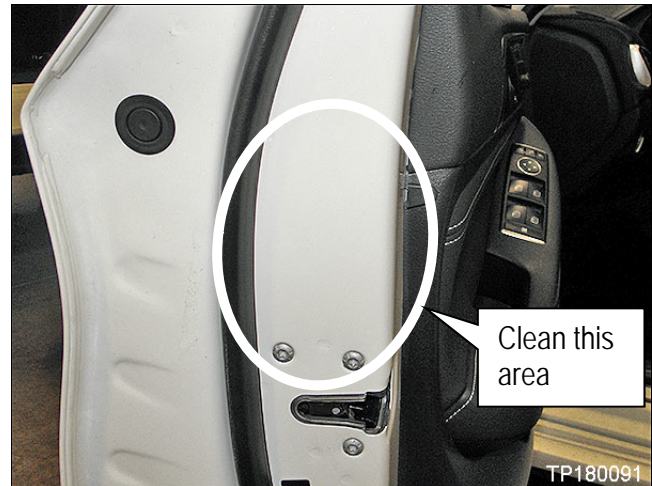
9. Open the driver door.
10. Clean the area shown in Figure 6 with isopropyl alcohol.

NOTE: It is important the surface be free of dirt and oil to ensure proper adhesion of the label.

11. Completely dry the area you just cleaned.

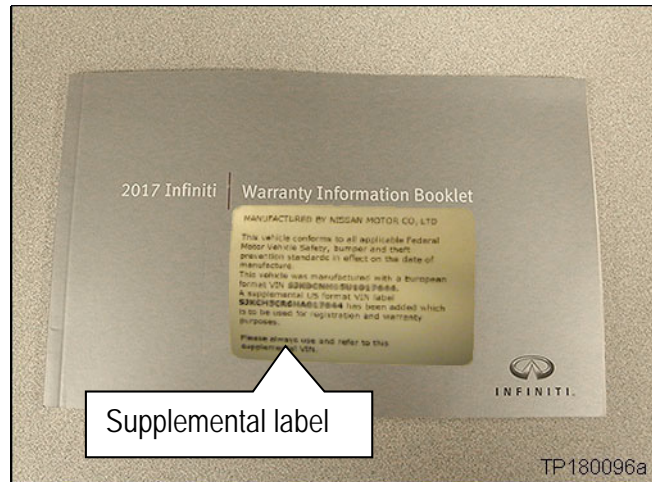
Figure 9

14. Obtain the customer's Warranty Information Booklet.
15. Make sure the cover is free of dirt, dust, or oil.
16. Peel the new label from the backing sheet and affix it to front of the booklet as shown in Figure 9.

NOTE: The adhesive on the label is permanent. Extra care should be taken when applying the new label since it cannot be moved once it is attached.
