Technical Service Bulletin

46 Q7 MY17 Squeal from front brakes

46 18 86 2050735/1 May 4, 2018.

Model(s)	Year	VIN Range	Vehicle-Specific Equipment
Q7	2017	All	With disc brakes in front

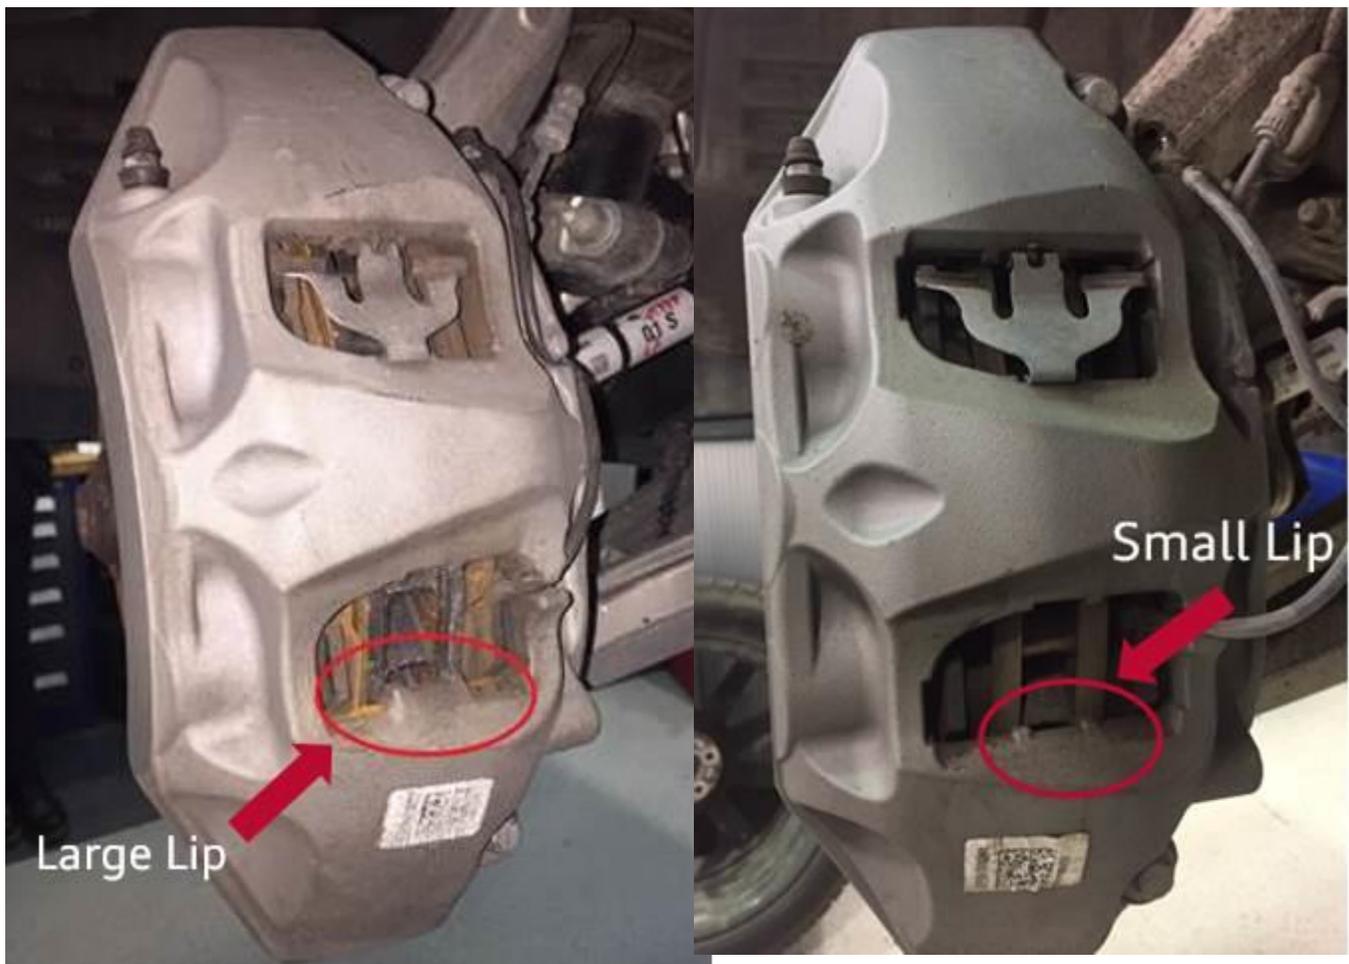
Figure 1. Caliper casting lip configurations.

1. Identify the caliper casting lip installed in the vehicle. There are 2 possibilities of lip; large and small. (Figure 1).

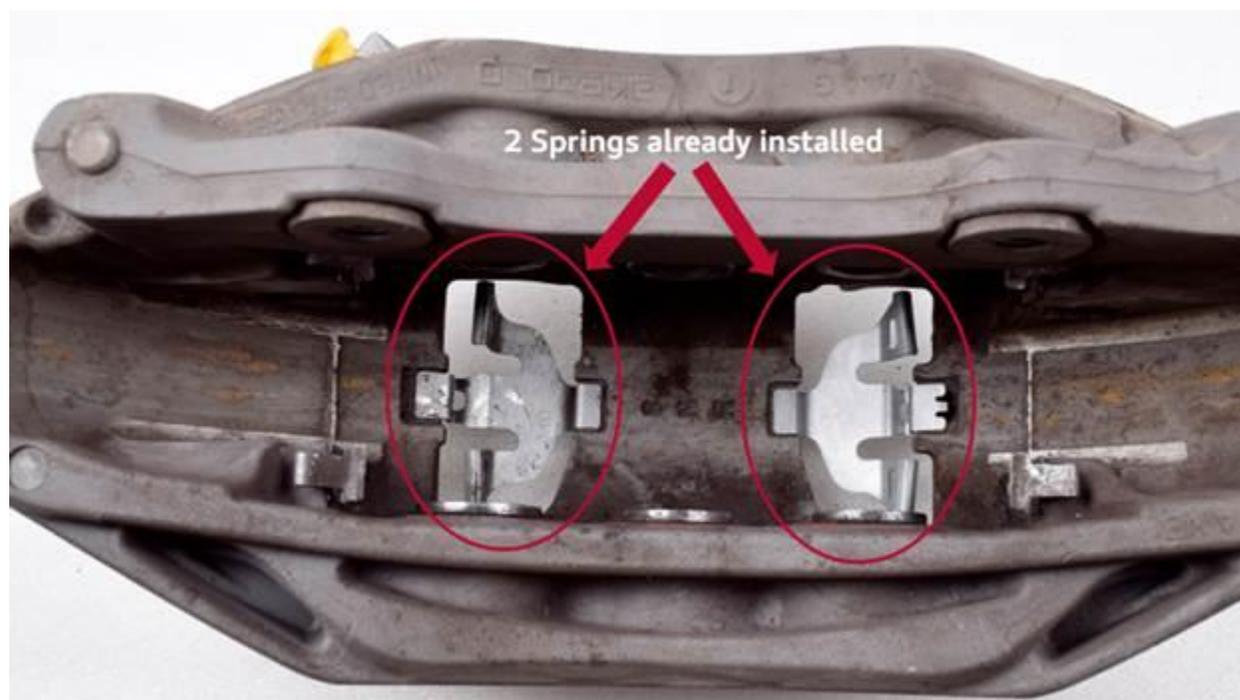
Figure 2. Spring configuration, after installation.

2. Install spring in the caliper. It is mandatory to install 2 springs per caliper as a final configuration (Figure 2). See available spring designs (Figure 3).

3. According to caliper casting, a specific type of spring must be assembled, as follows:

LARGE CASTING LIP >>> INSTALL SPRING 4M0 615 269 C

SMALL CASTING LIP >>> INSTALL SPRING 4M0 615 269

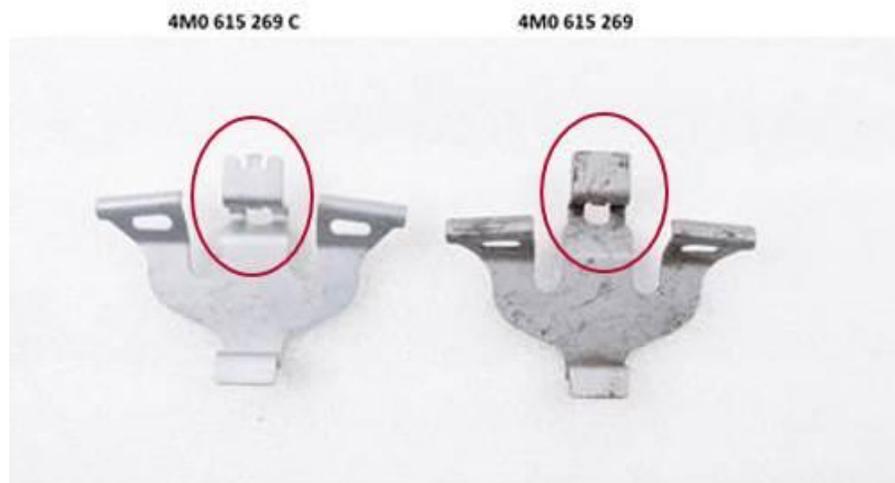
Figure 3. Spring designs.

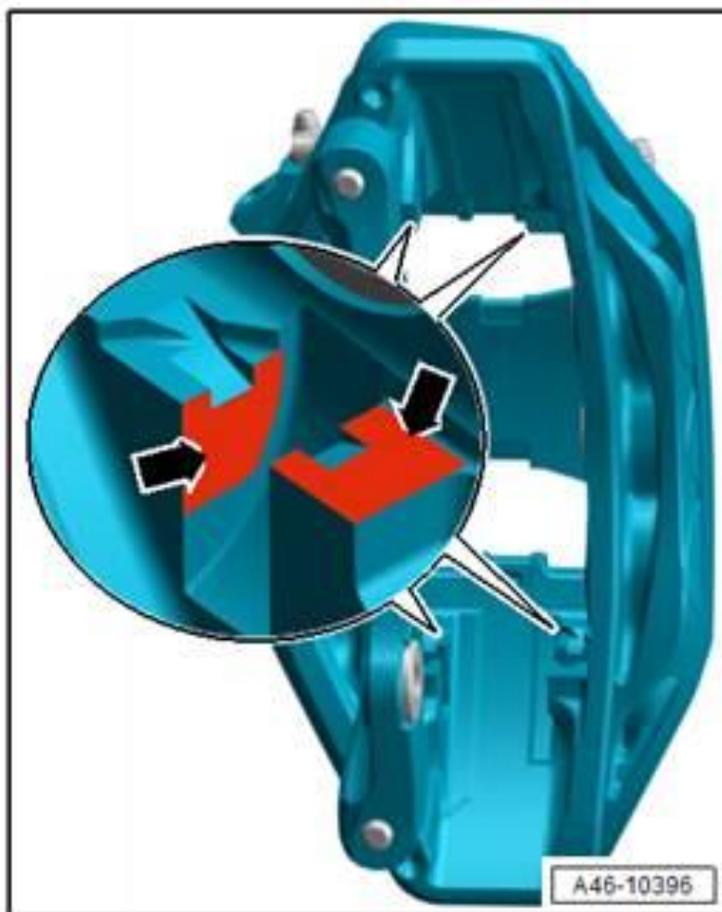
Figure 4. Clean contact surfaces and then coat with lithium grease.

4. It is mandatory to clean the contact surfaces (red marked with arrows) and coat with lithium grease (Figure 4). Also, coat the brake pad plate/guide pins and pad contact surfaces with lithium grease.

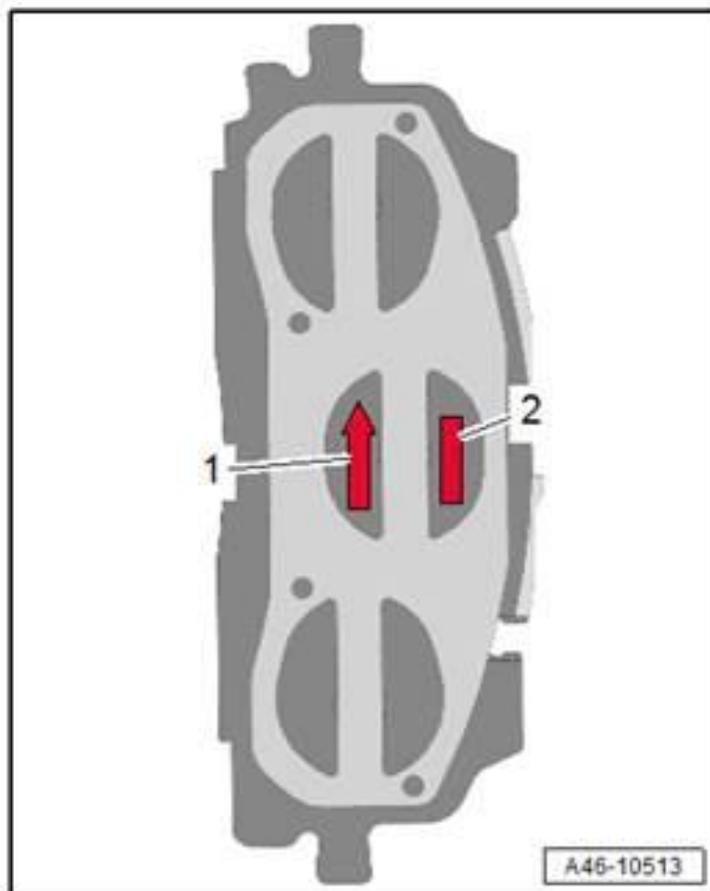
Figure 5. Correct installation positioning for the brake pad.

5. It is mandatory to pay attention to the labeling on the brake pad (Figure 5). When installed the arrow (1) position on the backing plate must point upward (the pads should be installed with the arrows following the forward rotation of the wheel). Labeling (2) indicate correct assembly position (left outer/inner, right outer/inner).
