Technical Service Bulletin

46 Q7 MY18 Squeal from front brakes

46 18 87 2050737/1 May 4, 2018.

Model(s)	Year	VIN Range	Vehicle-Specific Equipment
Q7	2018	000001 - 039706	With disc brakes in front

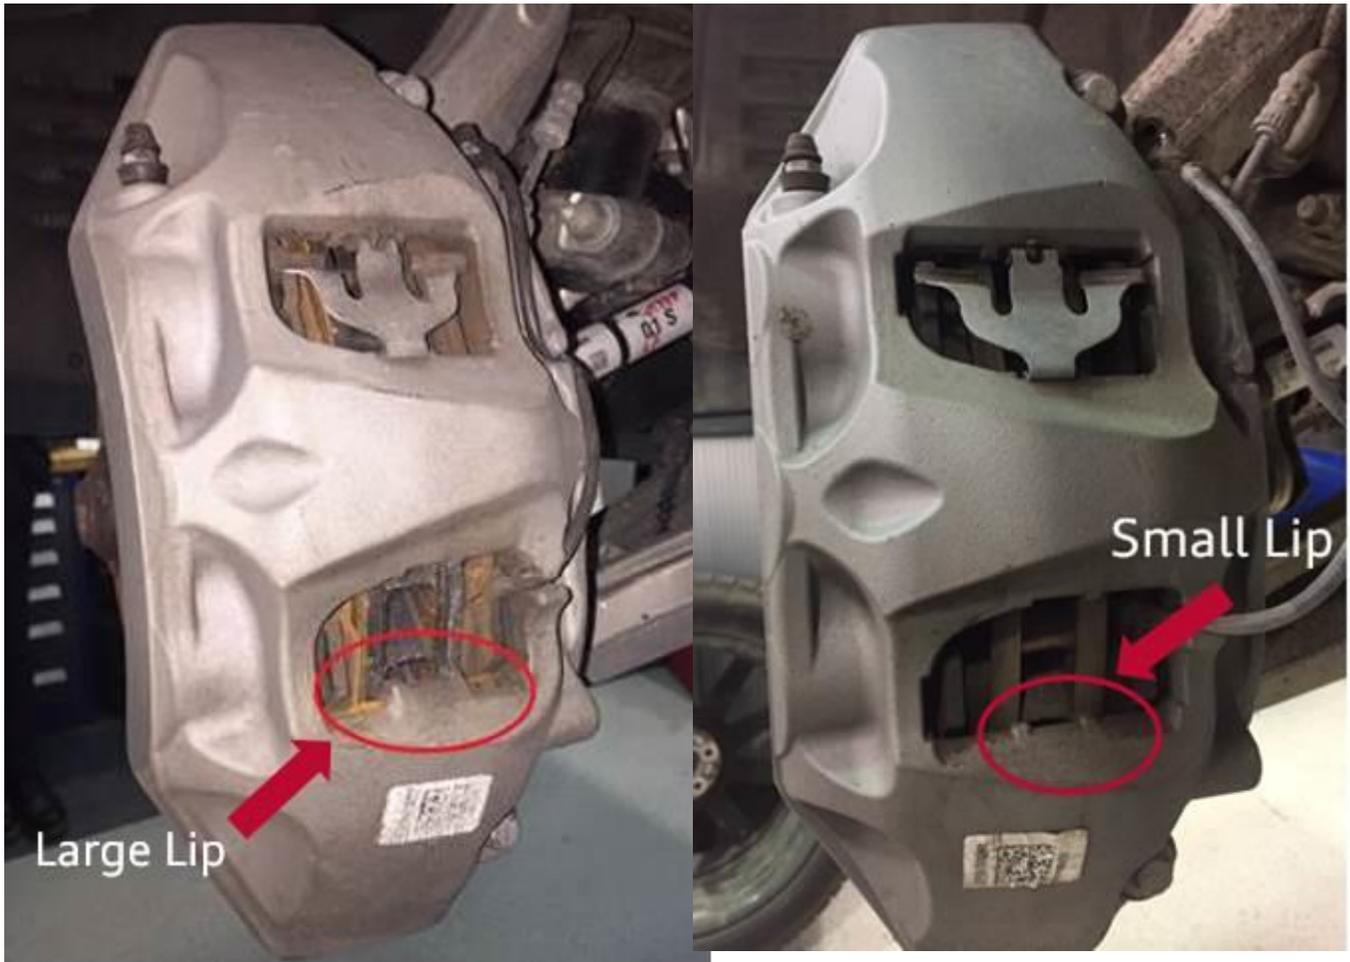
1. Identify the caliper casting lip installed in the vehicle. There are 2 possibilities of lip; large and small. (Figure 1).

Figure 1. Caliper casting lip configurations.

LARGE CASTING LIP >>> INSTALL SPRING 4M0 615 269 C

SMALL CASTING LIP >>> INSTALL SPRING 4M0 615 269

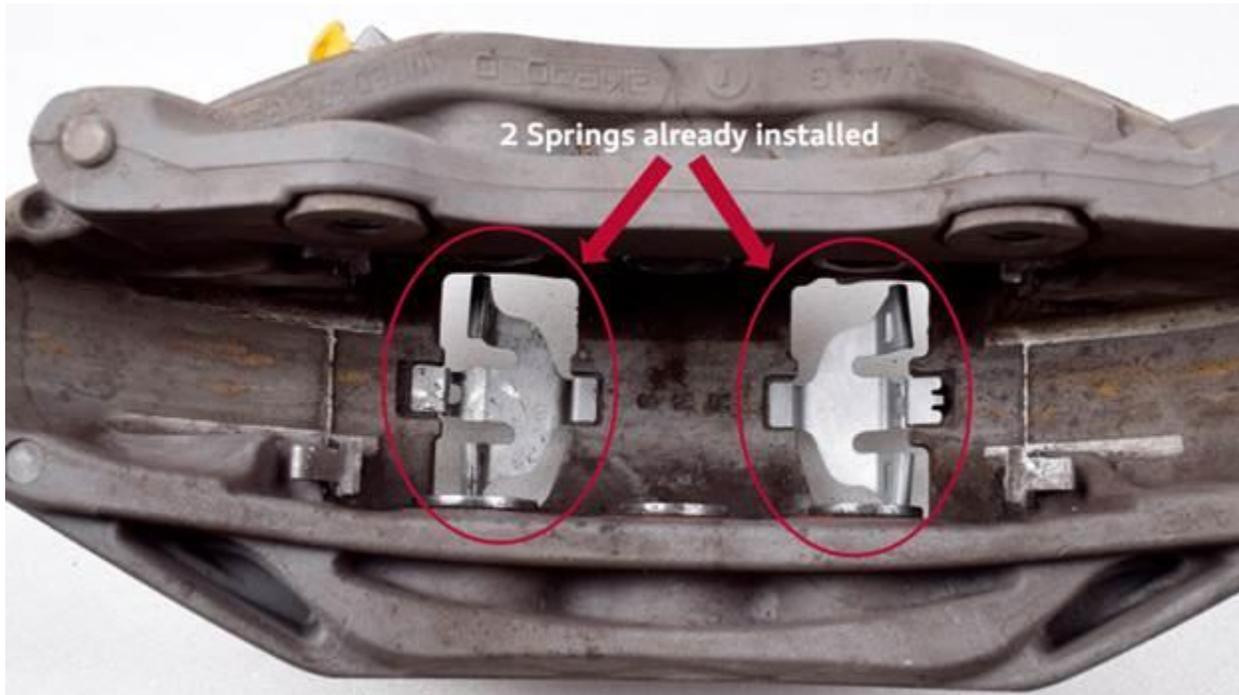
Figure 2. Spring configuration, after installation.

2. Install spring in the caliper. It is mandatory to install 2 springs per caliper as a final configuration (Figure 2). See available spring design (Figure 3).
3. According to caliper casting, a specific type of spring must be assembled, as follows:

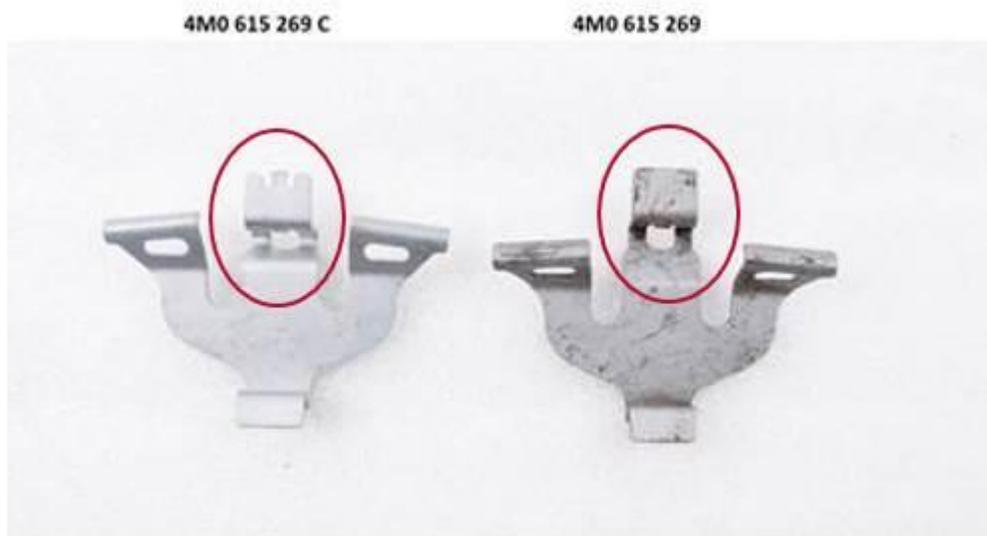
Figure 3. Spring designs.

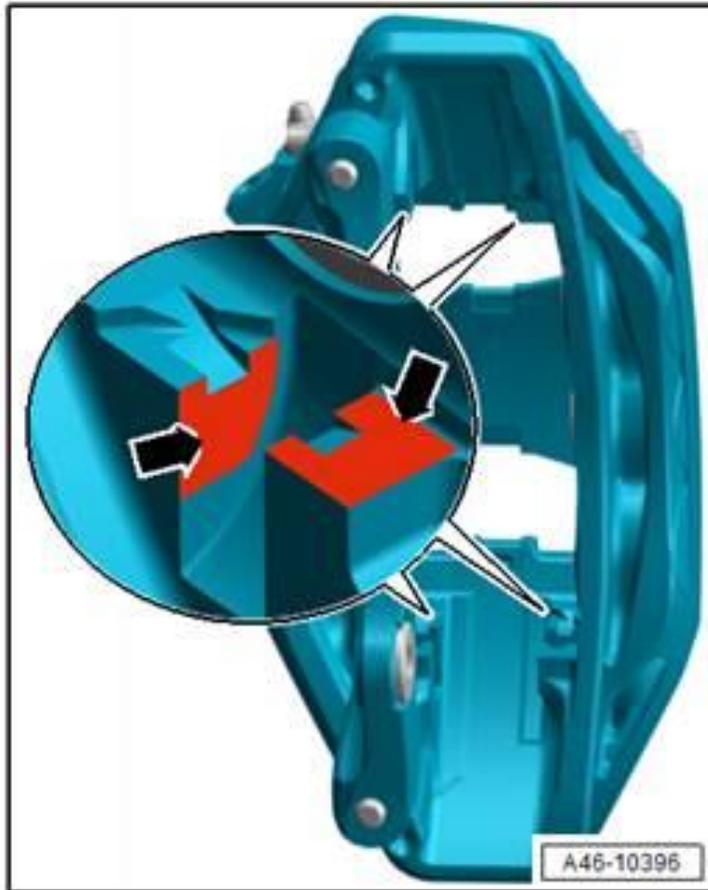
Figure 4. Clean contact surfaces and then coat with lithium grease.

4. It is mandatory to clean the contact surfaces (red marked with arrows) and coat with lithium grease (Figure 4). Also, coat the brake pad plate/guide pins and pad contact surfaces with lithium grease.

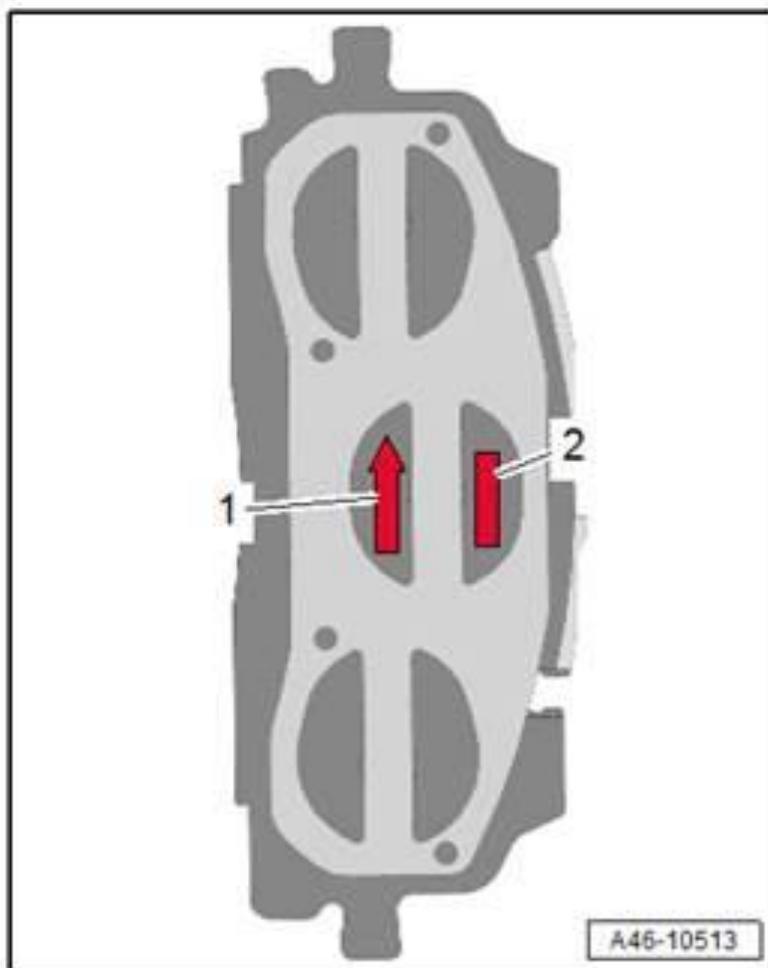
Figure 5. Correct installation positioning for the brake pad.

5. It is mandatory to pay attention to the labeling on the brake pad (Figure 5). In installed position the arrow (1) on the backing plate must point upward (the pads should be installed with the arrows following the forward rotation of the wheel). Labeling (2) indicate correct assembly position (left outer/inner, right outer/inner).

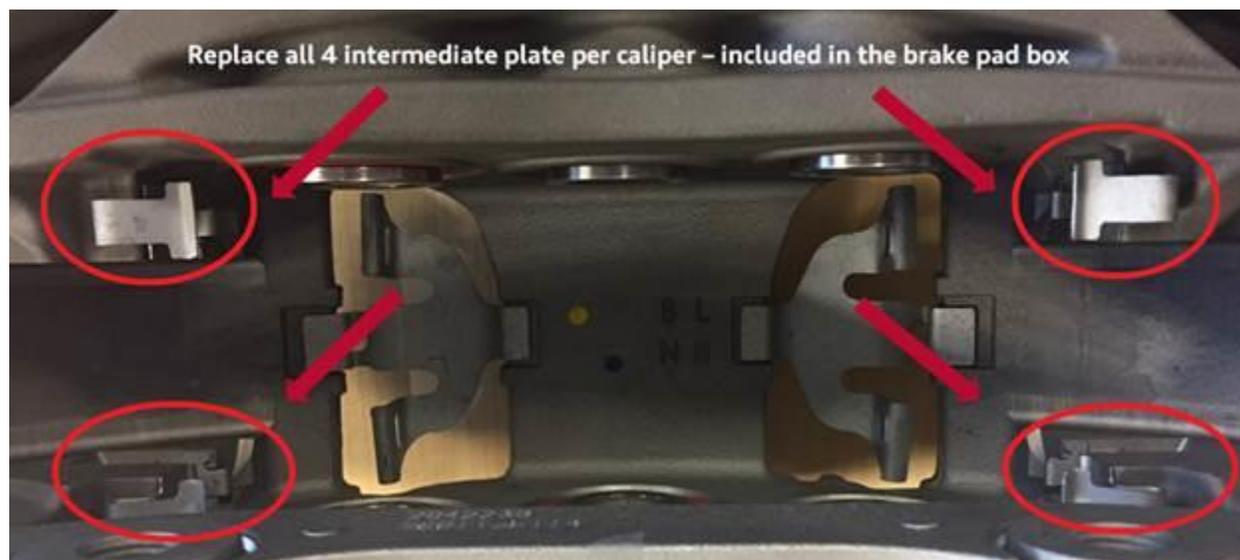
Figure 6. Replace all 4 intermediate plates.

6. It is mandatory to replace all 4 brake pad intermediate plate per caliper – included in the brake pad box (Figure 6).
