46 Q7 MY18 Squeal from front brakes

46 18 88 2050737/2 May 4, 2018. Supersedes Technical Service Bulletin Group 46 number 18-87 dated May 4, 2018 for reasons listed below.

Model(s)) Year VIN Range Vehicle-Spe		Vehicle-Specific Equipment
Q7	2018	000001 - 039706	With disc brakes in front

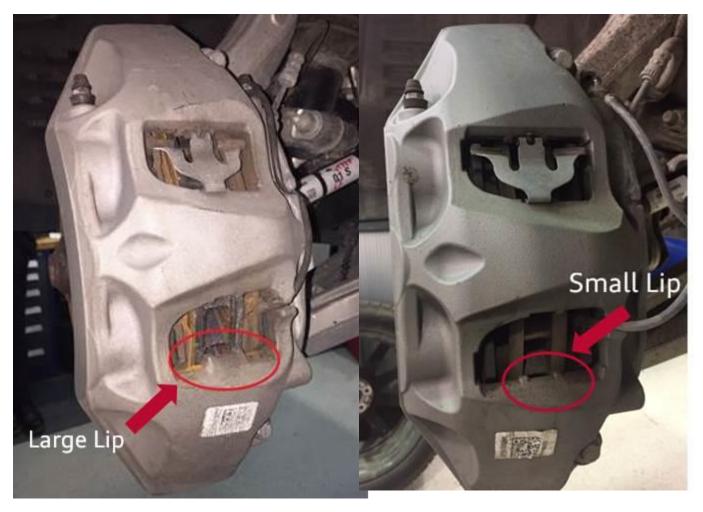
1. Identify the caliper casting lip installed in the vehicle. There are 2 possibilities of lip; large and small. (Figure 1).

Figure 1. Caliper casting lip configurations.

LARGE CASTING LIP >>> INSTALL SPRING 4M0 615 269 C SMALL CASTING LIP >>> INSTALL SPRING 4M0 615 269

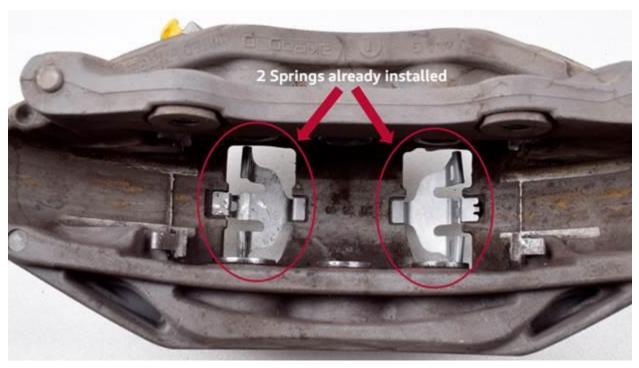
Figure 2. Spring configuration, after installation.

- 2. Install spring in the caliper. It is mandatory to install 2 springs per caliper as a final configuration (Figure 2). See available spring design (Figure 3).
- 3. According to caliper casting, a specific type of spring must be assembled, as follows:

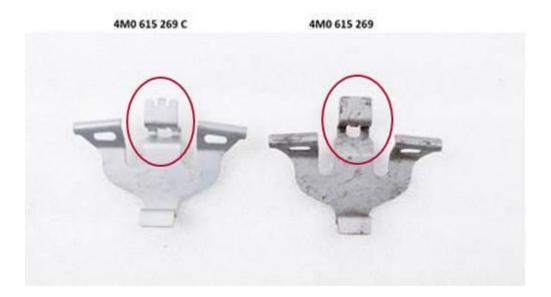
Figure 3. Spring designs.

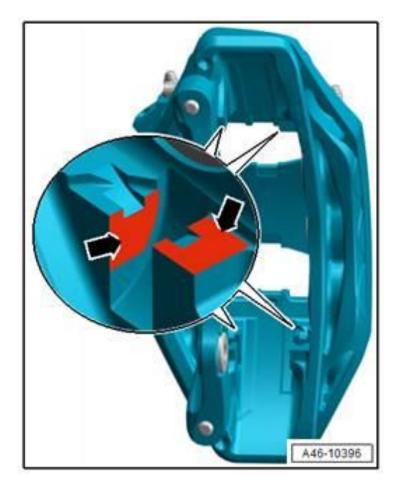
Figure 4. Clean contact surfaces and then coat with lithium grease.

4. It is mandatory to clean the contact surfaces (red marked with arrows) and coat with lithium grease (Figure 4). Also, coat the brake pad plate/guide pins and pad contact surfaces with lithium grease.

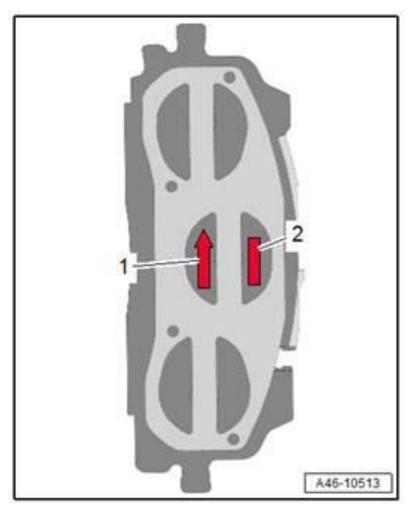
Figure 5. Correct installation positioning for the brake pad.

5. It is mandatory to pay attention to the labeling on the brake pad (Figure 5). In installed position the arrow (1) on the backing plate must point upward (the pads should be installed with the arrows following the forward rotation of the wheel). Labeling (2) indicate correct assembly position (left outer/inner, right outer/inner).

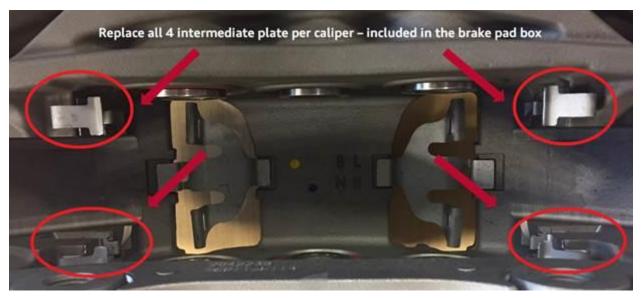
Figure 6. Replace all 4 intermediate plates.

6. It is mandatory to replace all 4 brake pad intermediate plate per caliper – included in the brake pad box (Figure 6).
