# Emissions Recall (Gen 3 - Phase 2)

## Code: 23Y9

| <b>Subject</b> | 2.0L TDI Engine (GEN 3) Phase 2 A & B Emissions Recall – <u>USA ONLY</u> |

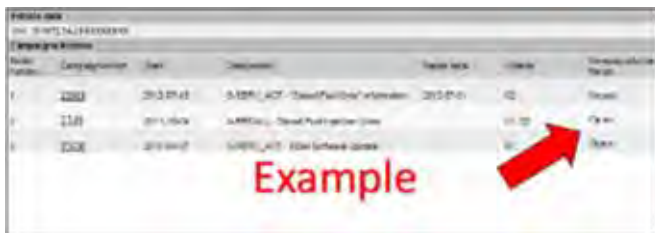
- Confirm the Campaign/Action is open <arrow 1>. If the status is closed, no further work is required.
- Note the Applicable Criteria ID <arrow 2> for use in determining the correct work to be done and corresponding parts associated.
- Check for other Open campaign actions <red arrow above>.
- Other Open campaign actions must be completed prior to releasing the vehicle to the customer.
