46 Clicking noise from front ceramic brakes - R8

46 18 94 2047140/4 June 21, 2018. Supersedes Technical Service Bulletin Group 46 number 17-70 dated April 17, 2017 for reasons listed below.

Model(s)	Year	VIN Range	Vehicle-Specific Equipment
R8	2017	All	Ceramic brakes
R8	2018	000001 - 900030	Ceramic brakes

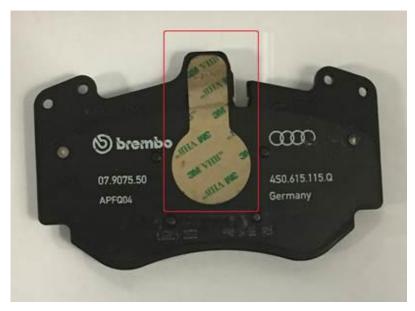
Figure 2. Pull of adhesive foil.

- The brake pistons must be clean. Brake cleaner can be used to clean the brake pistons. Ensure that the contact surfaces are free of dust and grease and they are dry.
- Only remove the protective paper from the adhesive foil on the brake pad immediately before installation (Figure 2), and do not touch the adhesive surface. (Figure 3).

After installing the pads, keep full brake pressure for about 5 seconds to ensure that the pads are properly bonded to the pistons.

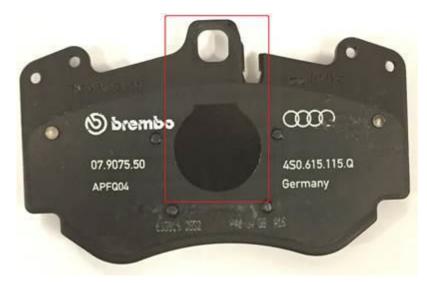
Figure 3. Do not touch the exposed adhesive surface.
