Single Wheel Locks Up When ABS Activates

Year	Model	Trim
2017-18	CR-V	ALL

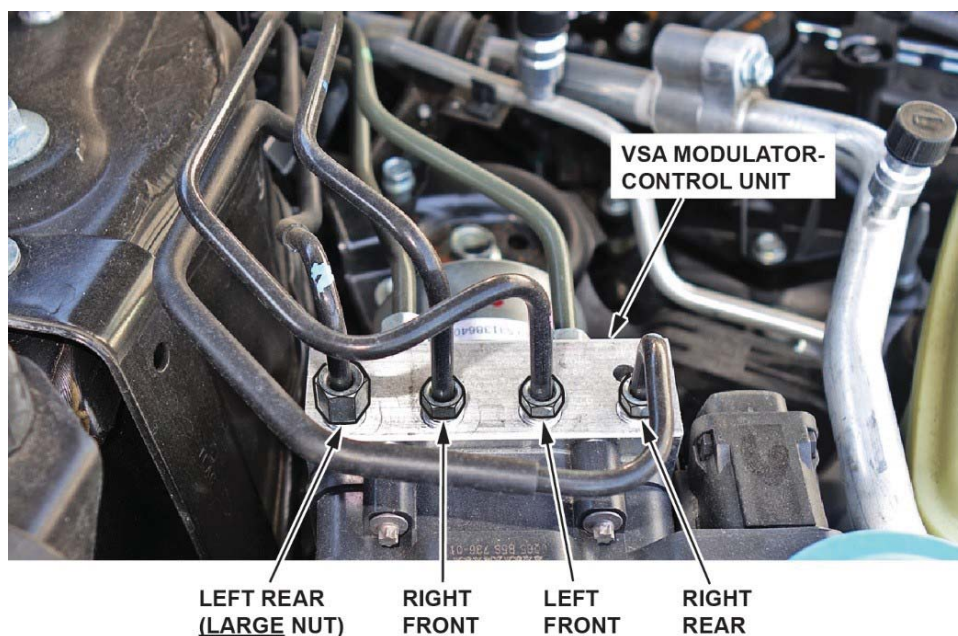
If you connect the brake lines correctly, the brake line with the **large** captive nut (it's for the left rear brake system) will be mounted on the **far left** connector port and all brake lines will be clearly spaced and not touching each other.

To avoid this issue, **always** mark the brake lines before disconnecting them from the VSA modulator-control unit. Each connector port is clearly marked with the name of the brake system it applies to. You'll also find connecting instructions in the service information.
