**Technical Information Bulletin****Fuel Filter May Leak on Certain 3406, 3412, C9, C9.3, C13, C15, and C18Engines {1260, 1261, 1262}**

Media Number -M0097173-00

Publication Date -2018/08/10

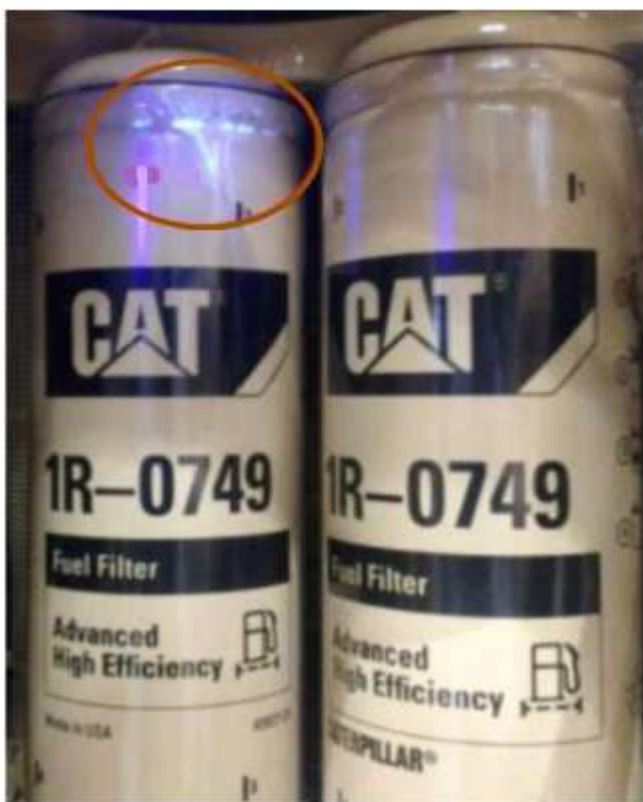
Illustration 1

In certain cases the **1R-0749** Fuel Filter can develop a small leak at the top plate. In most cases if these filters develop a leak the leak will be small and will show shortly after installation.

Inspect and replace with good **1R-0749** Fuel Filter.

Retain failed parts and check "Send It Back" for an open parts return request.
