**Document ID:** IK0800554  
**Revision:** 7  
**Created:** 10/30/2017  
**Last Modified:** 9/7/2018  
**Author:** William Katschke

**Title:** Telematics Installation Guidelines**Applies To:** Units with 500K Data Link

This document will provide the user with guidelines to follow when installing a telematics device.

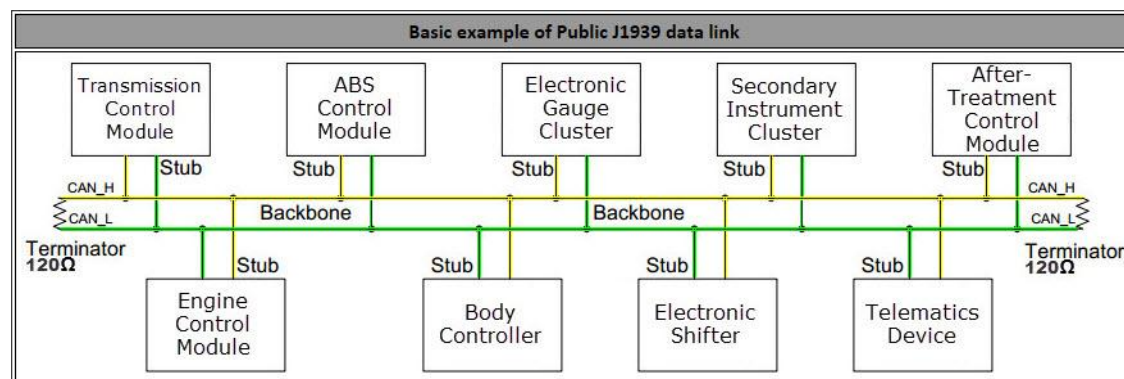
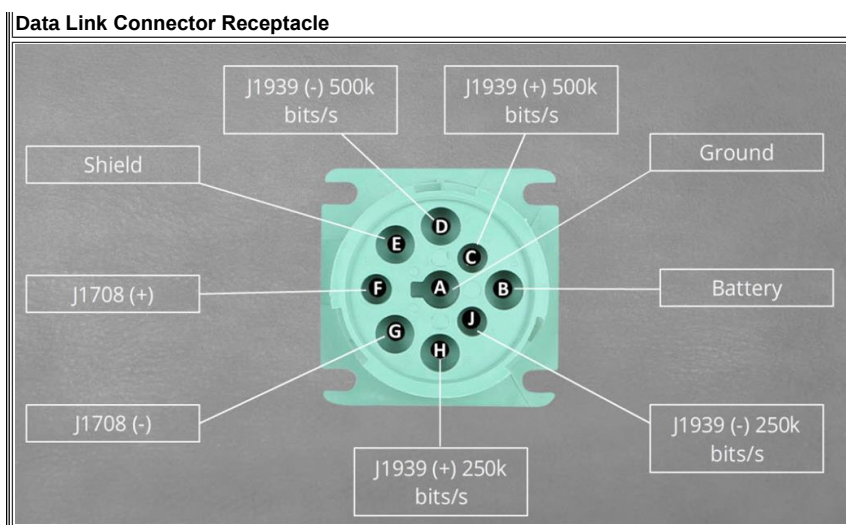
- It is recommended that telematic devices are installed on the Body 250K Data Link and not spliced into the 500K Data Link.
  - Splicing into the data link may result in erroneous fault codes and/or accessories to not operate properly.
- If a connection to the 500K Data Link is required a Y-Cable should be used to make the connection at the 9-Pin diagnostic connector.
- Once telematics device has been installed be sure to verify proper operation of accessories and that no codes become active.
  - If accessories do not operate properly or codes become active contact the telematic manufacturer for assistance.
- It is recommended that only one telematics device be attached the data link, if more then one device is connected it can cause the data link to crash.

09/07/2018 - Added additional information for 08RPC for clarification. Added Y Harness part number for IVG and Bendix cable for Safety Direct.  
07/26/2018 - Added additional information for 08RPC for clarification. Added Y Harness part number for IVG.  
05/22/2018 - Added additional information for 08RLW for clarification. Added image for data link architecture on LT, RH, HV, MV  
11/13/2017 - Added picture of DLC which calls out data link pins  
11/10/2017 - Initial Article Release

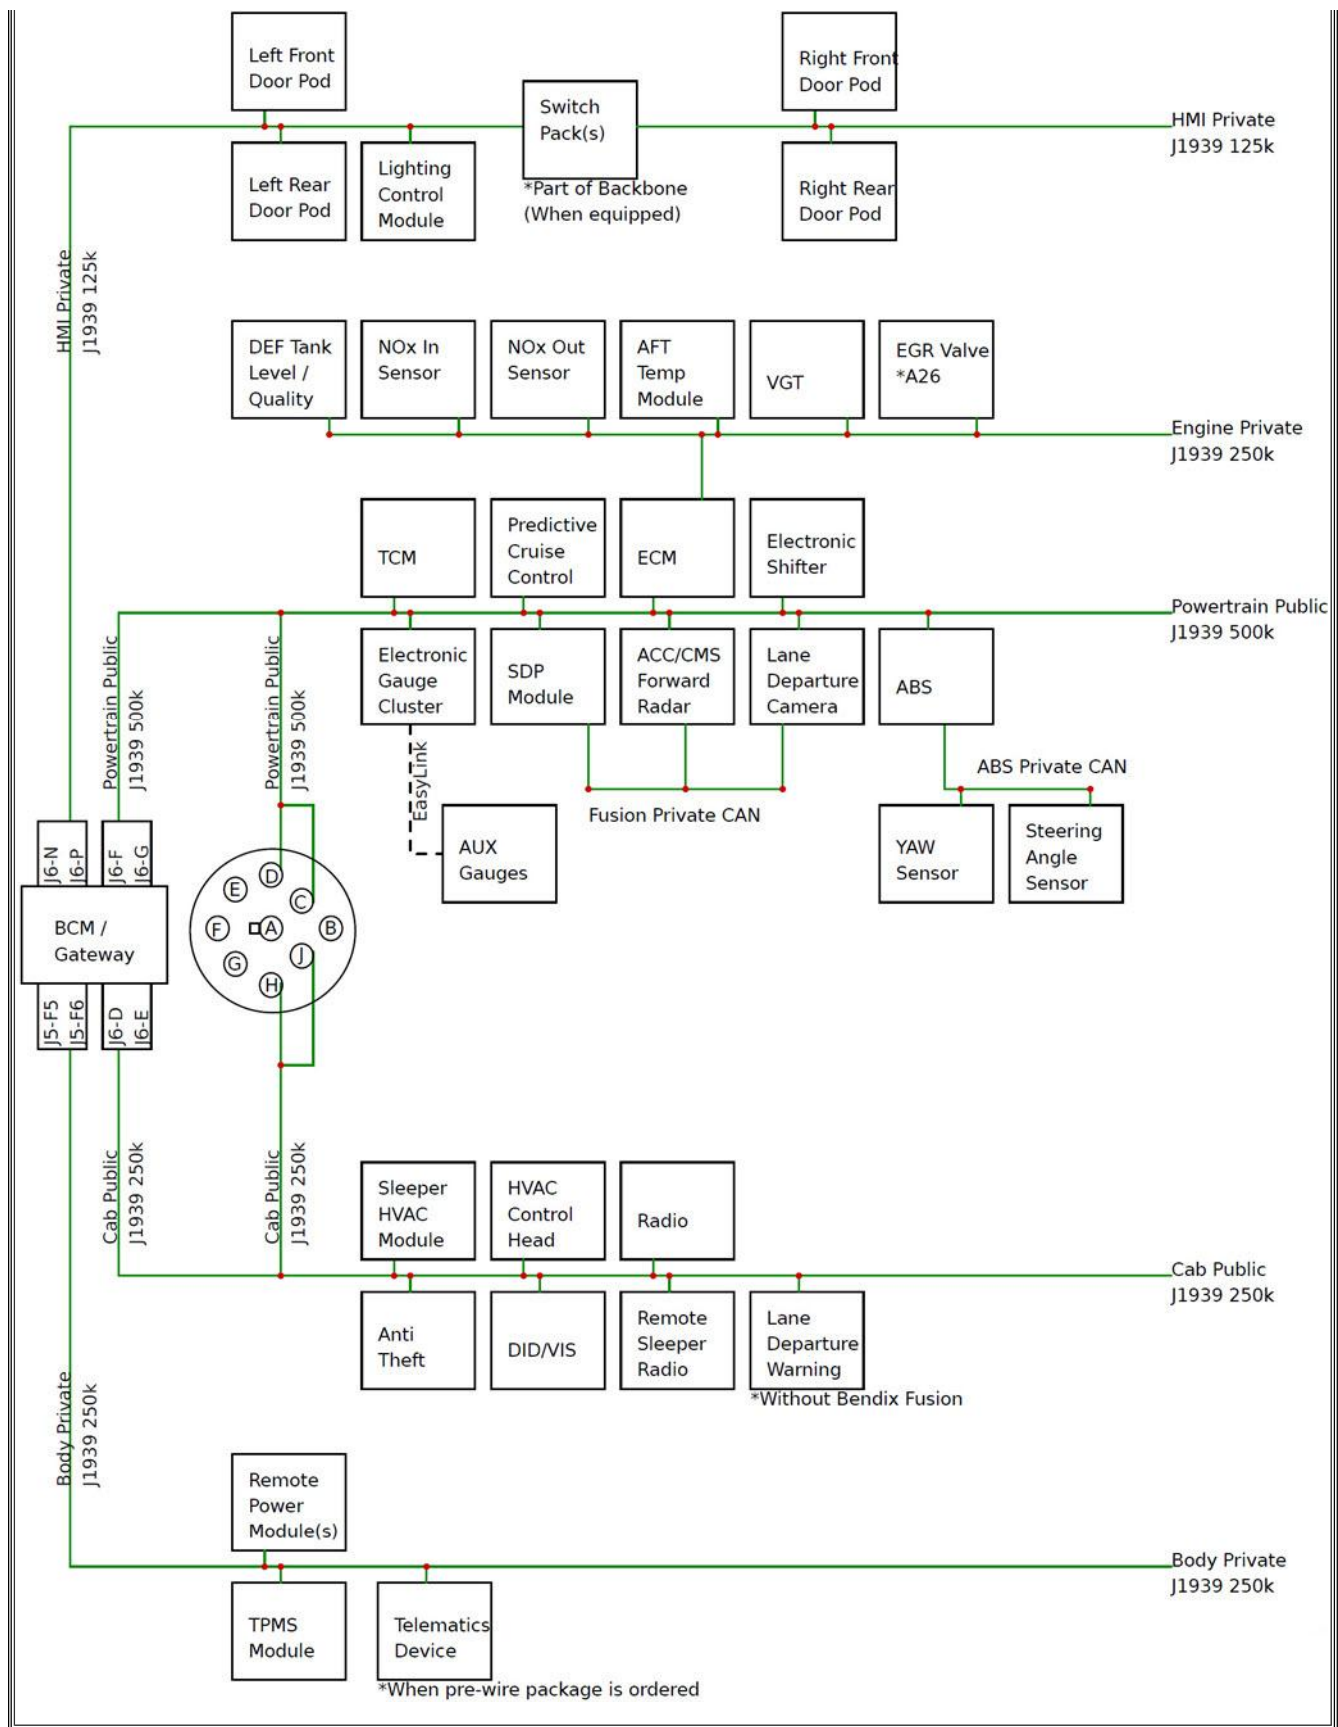
### Data link architecture for LT, RH, HV, MV

By vehicle design, the pre-wire packages listed below are wired into the Body 250k data link. This is not available at the 9-Pin diagnostic connector.
