## DTC B18DA or B1EDA After BSI Radar Unit Replacement

### AFFECTED VEHICLES

Year	Model	Trim	VIN Range
2017-18	CR-V	EX, EX-L, Touring	ALL
2018	Accord	2.0T Sport, EX, EX-L, Touring	ALL

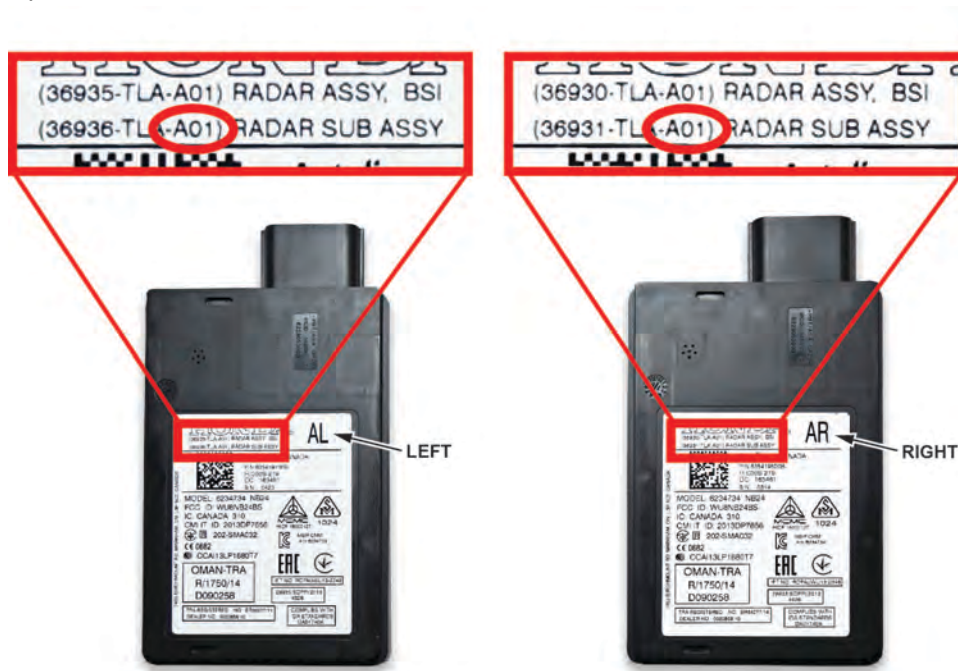
The reason for these DTC's is due to the replacement unit having a different software version. These radar units have specific version numbers, which are found on the radar unit label. Use the part number listed on the radar unit label to identify the correct replacement sensor needed.

A replacement BSI radar unit should be replaced only with one that has the exact same part number. When replacing the unit, make sure that the last three digits of the part number, A01 or A02, are matching on both sides. Even though these units look the same, the parts can't be interchanged without causing problems in the software, which will result in the applicable DTC (B18DA or B1EDA) to set.
