Reference	SSM73995
Models	Range Rover / L405 Range Rover Sport / L494
Title	Dynamic Response high pressure pipe fluid leak
Category	Chassis
Last modified	03-Aug-2018 00:00:00
Symptom	304000 Suspension System
Attachments	Picture 1.JPG

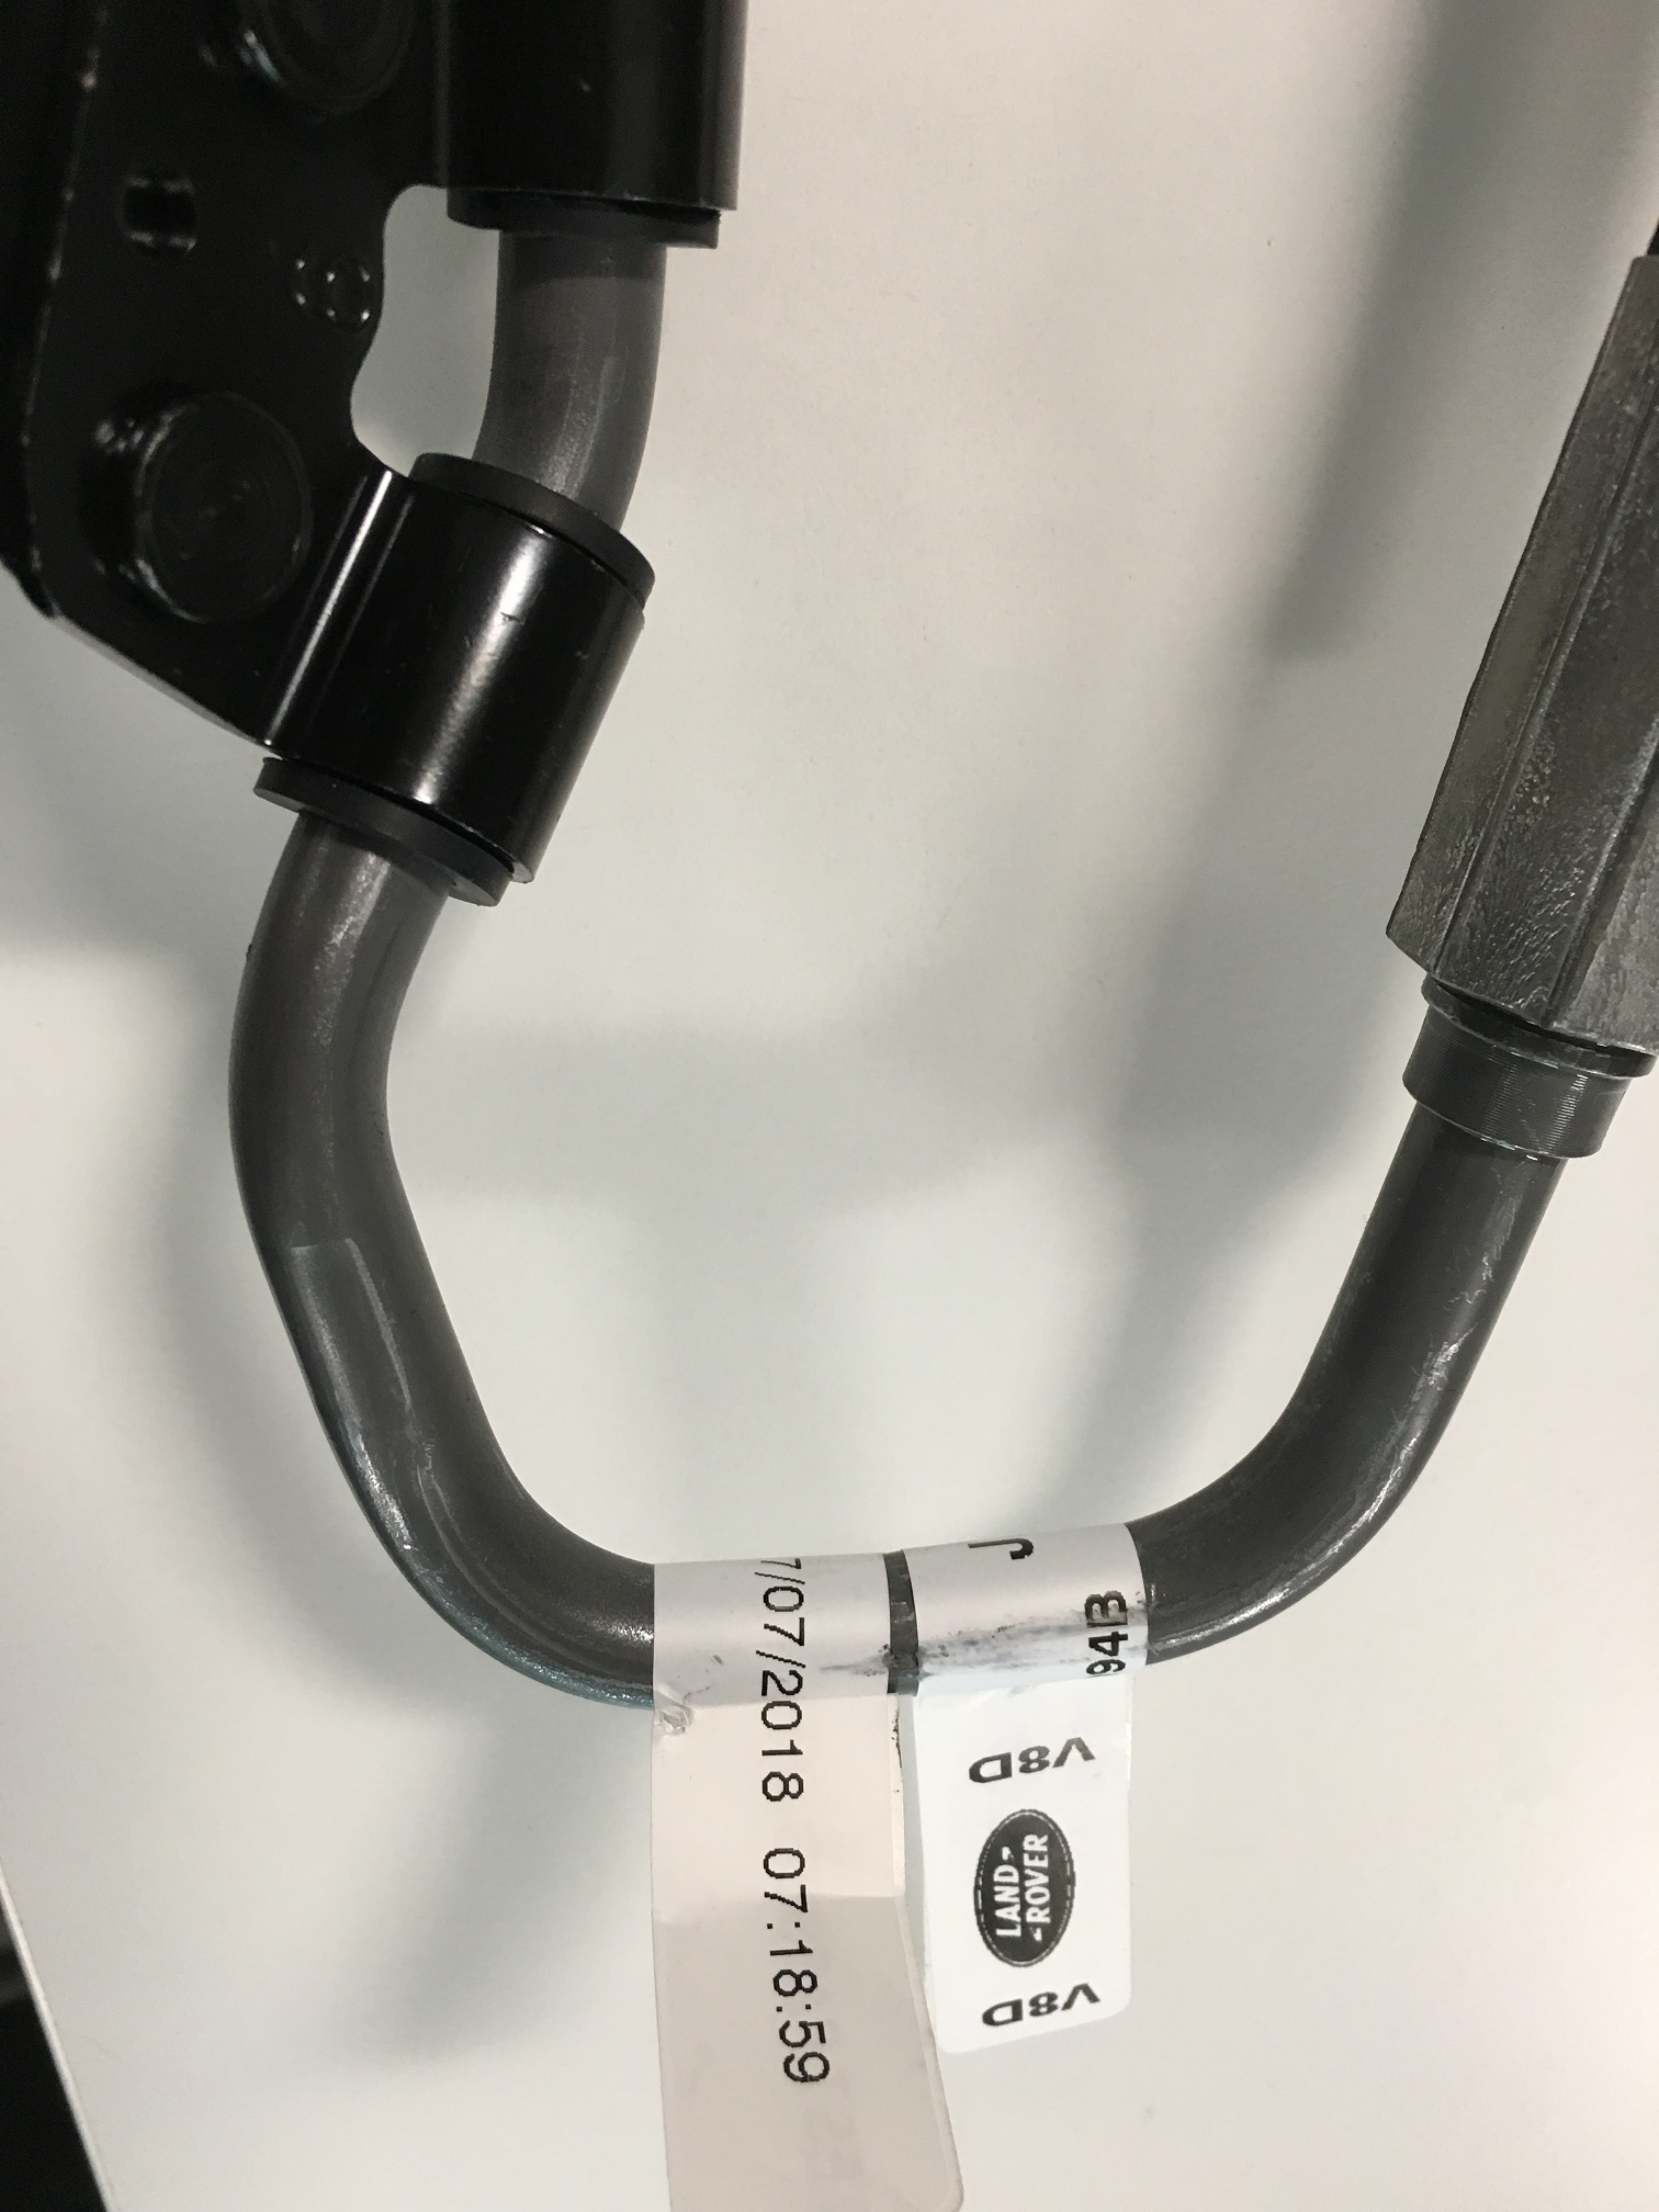
1. Provide close up photographs that identify where the leak is coming from, and the whole pipe to show which connection is leaking
2. Provide a photograph showing the Test Passed time and date label (not part number label). This is located next to the part number label – see picture attached
3. Any other information and observations as to why this leak has occurred
4. Replace appropriate part and hold ready for part return request (PRR)

Submit an ePQR with the following information
