## **ULTIMAAX® Rear Suspension for Kenworth Vehicles**

**SUBJECT:** Service Instructions

**LIT NO:** 17730-301

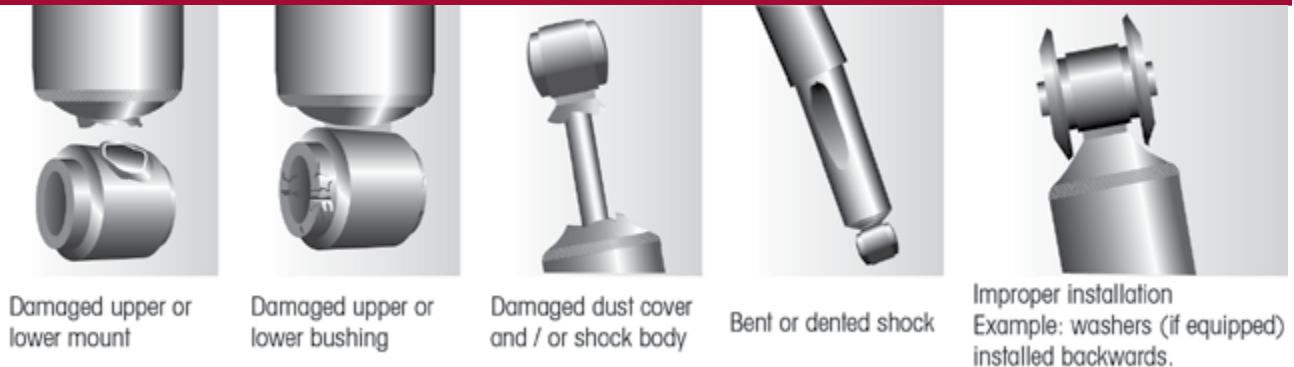
### SHOCK ABSORBER VISUAL INSPECTION - UNACCEPTABLE CONDITIONS

Look for any of the potential problems shown in Figure 6-28 when doing a visual inspection. Inspect the shock absorbers fully extended. Replace as necessary.
