# Replacement of (LPS) Low Pressure Sensor and fuel line P3

REF NO: TJ 33676.2.0	ISSUING DEPARTMENT: Technical Service	CAR MARKET: United States and Canada		
3 US 7	PARTNER: '510 Volvo Car USA	ISSUE DATE: 2018-06-28	STATUS DATE: 2018-07-11	
FUNC GROUP: 2346	FUNC DESC: Fuel line	Page	1 of 3

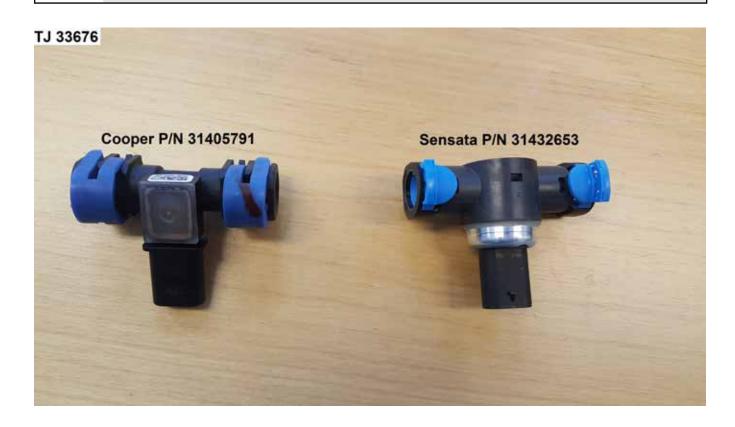
File Name	File Size
TJ33676-Cooper VS Sensata.jpg	3.0338 MB

\*If the car is equipped with a Cooper LPS P/N **31478293/31405791**, replace it with a new Sensata sensor P/N **31432653** that is included in a kit P/N **32242867** together with the appropriate feed line packed in a plastic bag. Follow the instructions on how to replace the involved parts in VIDA **VCC-412342-4**.

\*Please notice that the fuel line P/N **31405778** included in the Kit always needs to be replaced when replacing the LPS.
