LTB01208NAS2

# TECHNICAL BULLETIN

Hood Release Inoperative

MODEL:	MODEL YEAR:	VIN:
Discovery (LR)	2017	000004-046517

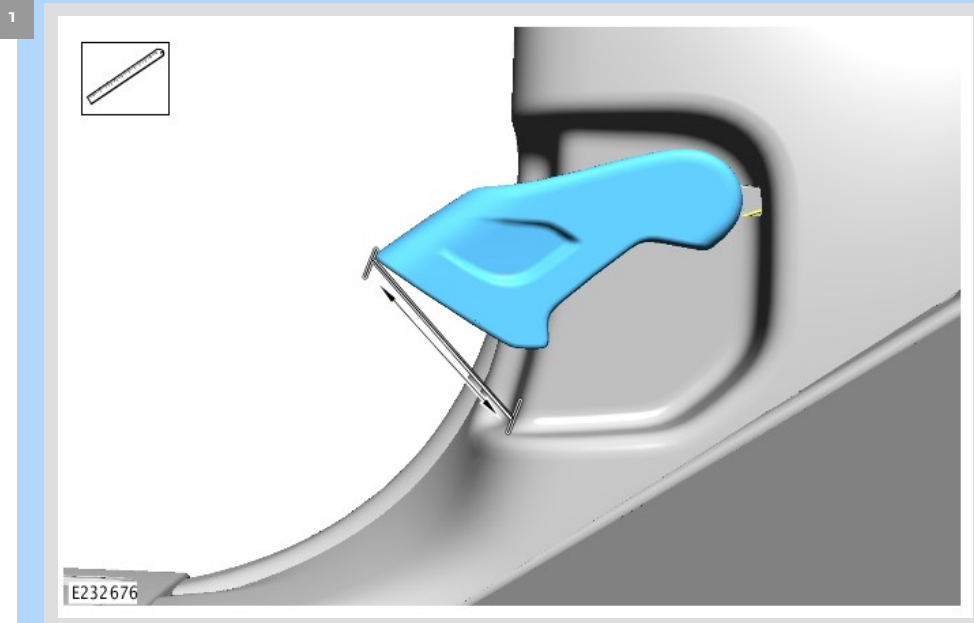
Open the hood and use a steel rule or similar engineer's scale to record the distance the interior release lever travels to operate the hood latches.

- If the hood interior release lever does operate the hood latches, the hood can be opened, and the distance is less than 120mm, release the vehicle.
  - No further action required.
- If the hood interior release lever does operate the hood latches, the hood can be opened, and the distance is more than 120mm, go to Step 5.
- If the hood interior release lever does not operate the hood latches and the hood cannot be opened, go to Step 2.

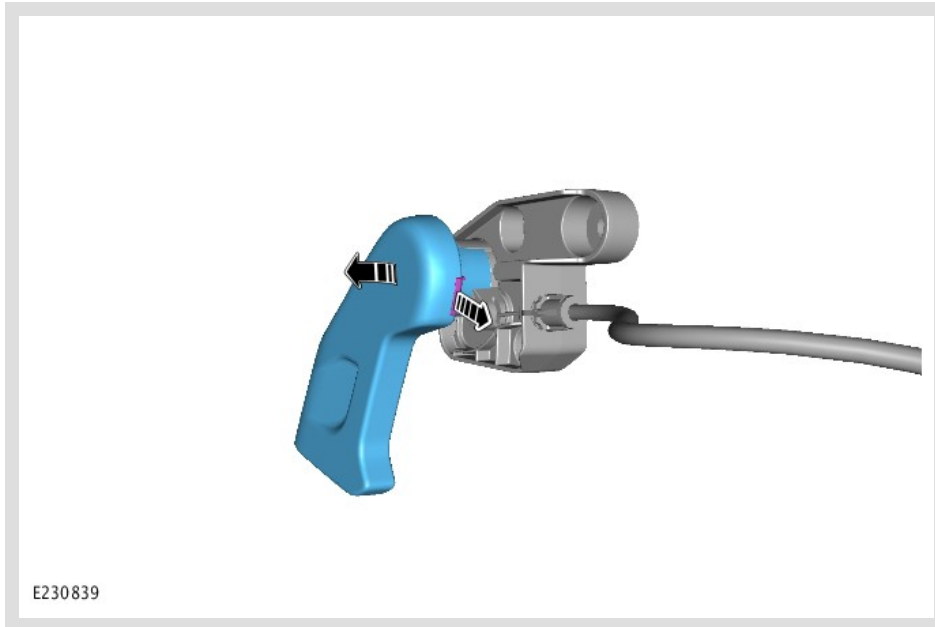
2

Components shown removed from the vehicle for clarity.

Remove hood interior release lever from the hood release mechanism.

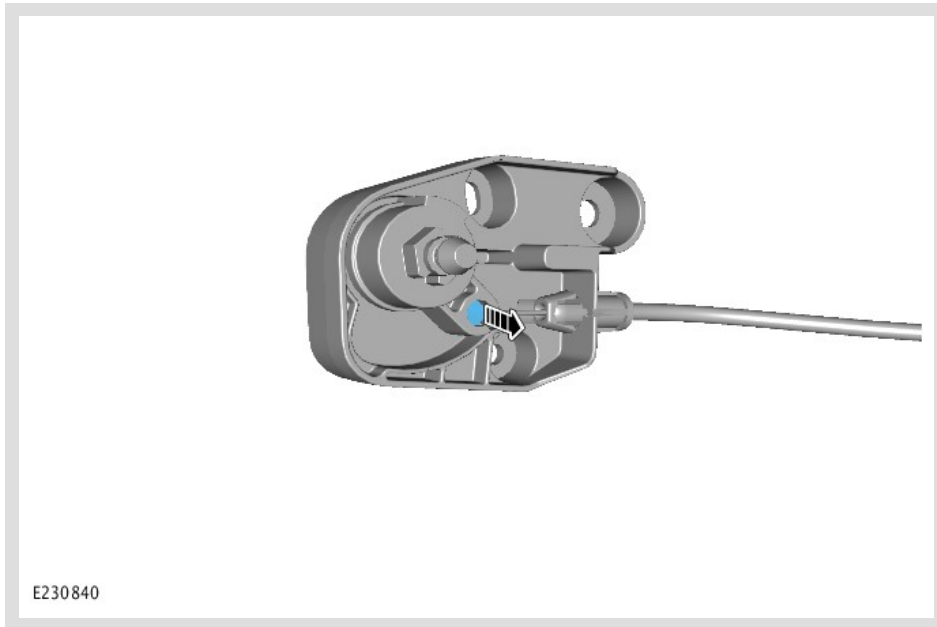
3

Components shown removed from the vehicle for clarity.

Release the hood release cable from the hood release mechanism.
