**Campaign code.**L62X-A.04.18**Campaign description.**Wheel badge upgrade**Model.**Huracan Performante Coupè and Spyder**Model year.**2018**Special or Limited Versions.**Only with central single nut with standard wheel badge;  
(no carbon fibre).**Markets.**All.**VIN identification**From JLA06599 to JLA09015**Warning:** before starting with the repair, log to the Warranty portal and check through VIN Info:

As a result of the continuous monitoring of the product, Automobili Lamborghini Spa introduced a new O-rings of increased hardness and a hole on the hubcaps to prevent accidental loss of the hubcaps.

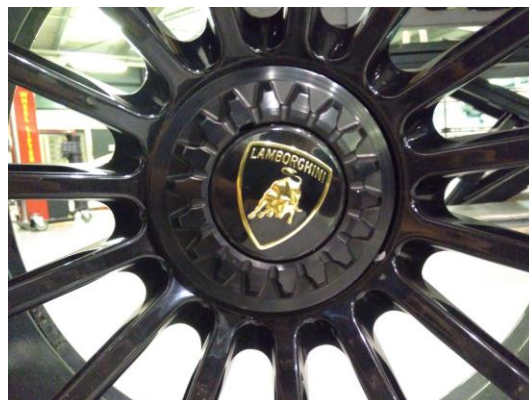
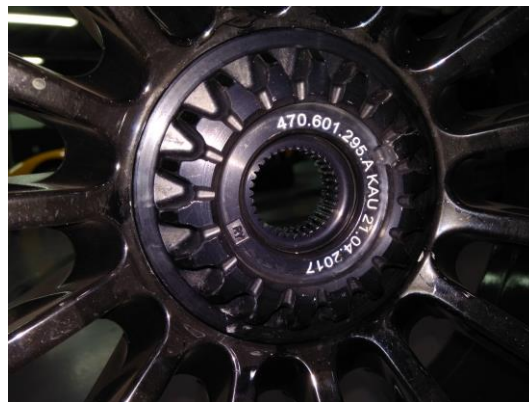
1. Remove the wheel hub cover.

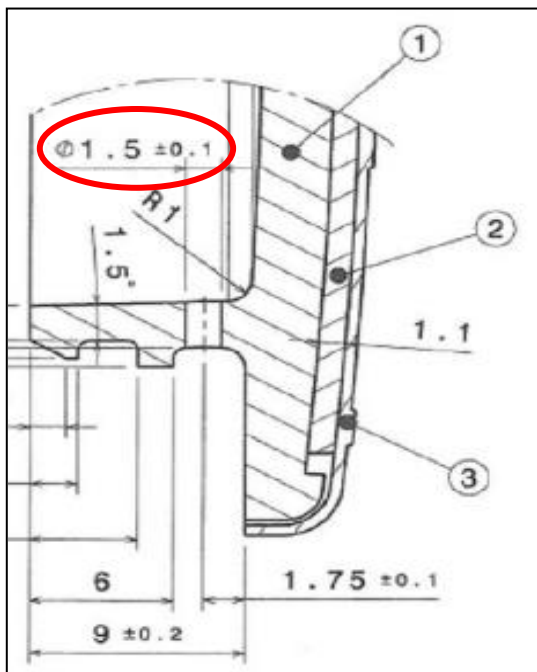
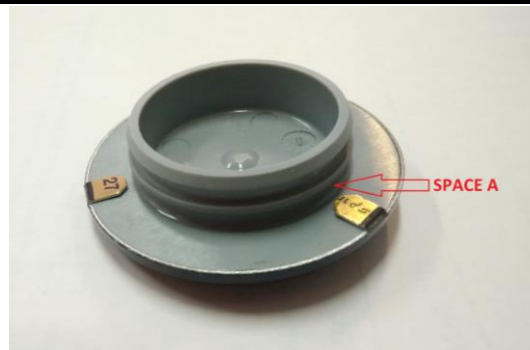
4. Follow the technical drawing specifications to make the 2 holes ( $\varnothing 1,5$  mm) in the correct position of the badge (Space A in the figure).

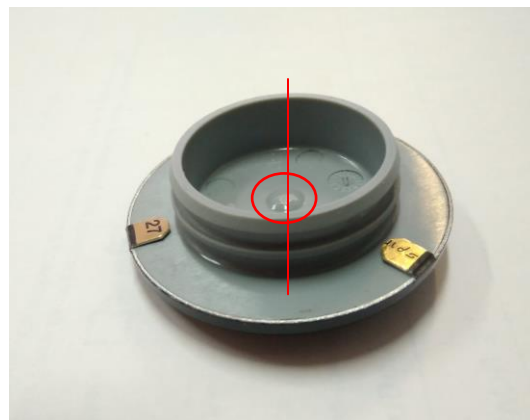
5. To find the correct position of the holes Automobili Lamborghini recommend using the circled point in the image as a reference (in order to obtain two alligned holes). Using like a reference the circled point in the figure and mark the 2 points where you will need to drill the holes.

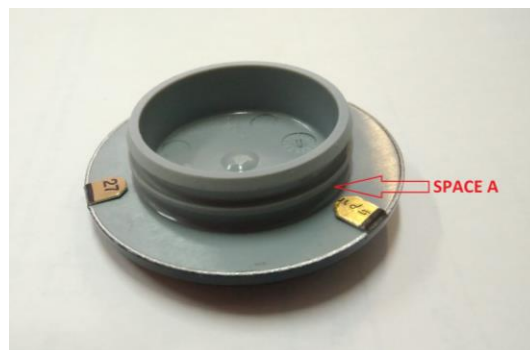
The points must be marked in the space A (see image below).

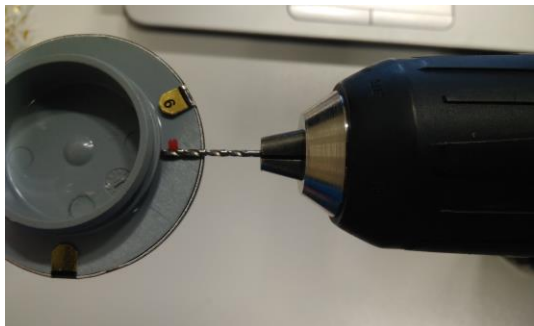
6. Make the holes in the two points marked.

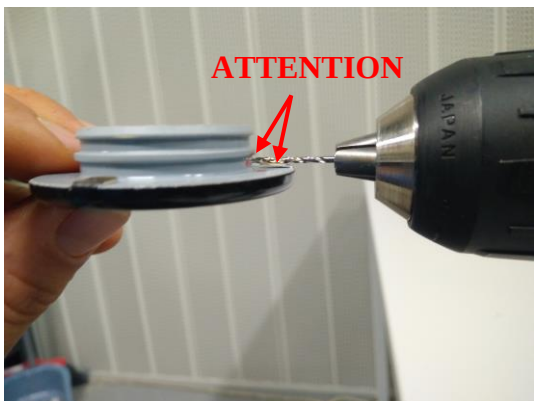
To avoid damaging of the badge, be careful not to touch the points shown in the following figure during the drilling operation.

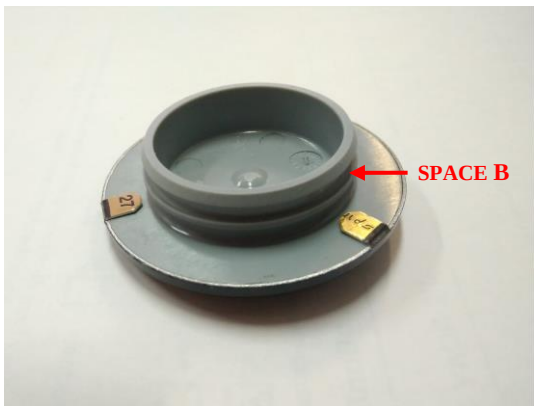
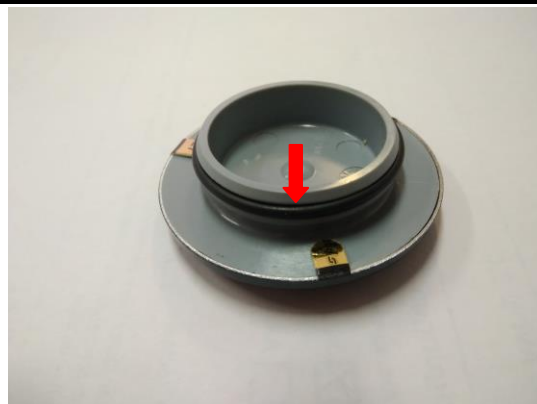
7. Install the new O-ring ( part number 470698009) in the space B (see the figure), pushing in the direction of the arrow.
