## Technical product information

| Topic | Front Brake pads with Part Number 3W0 698 151AA |
| Brand | Bentley |

### Continental Series - Flying Spur

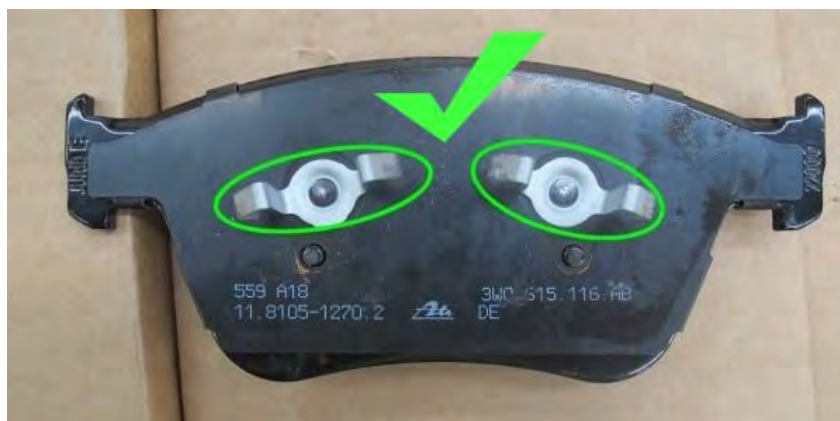
Referring to Figure 1 - Check the brake pad retaining tangs are fitted in the position shown

▪  
**The check is only required to brake pads within the kit which have the tangs as shown**

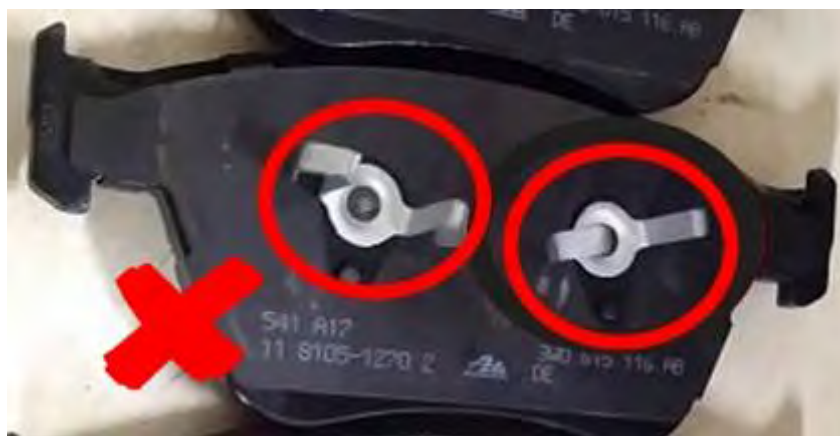
Figure 2 shows an example of a brake pad with the tangs located in the incorrect position

▪  
**The pad tangs shown in Figure 2 will not line up with the calliper location points correctly**

▪  
**Should the tangs be as Figure 2, the retailers should return the pads using the Dealer Returns System (DRS) please quote this TPI number within the (DRS)**

**Retailers should then reorder a set of replacement brake pads 3W0 698 151 AA**

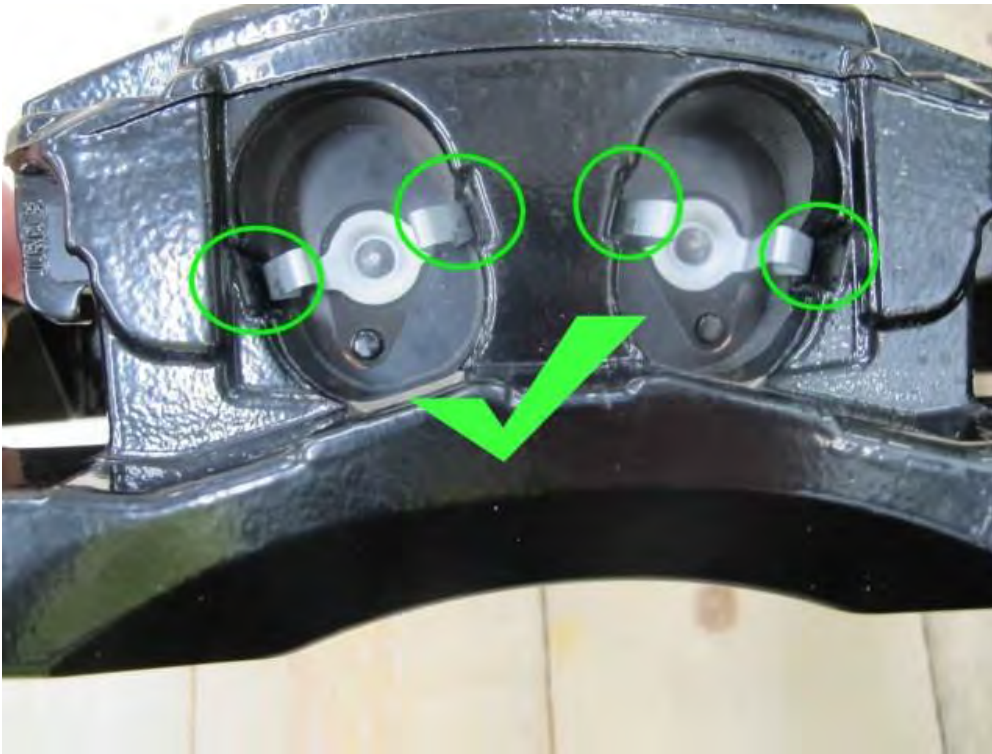
Figure 3 shows a brake pad with correct tang location NOTE: The position of the tangs in relation to the front brake calliper location points
