# Technical Service Bulletin

## 40 Creaking/squeaking noises from front end on uneven roads

40 18 85 2043424/7 August 27, 2018. Supersedes Technical Service Bulletin Group 40 number 18-80 dated May 31, 2018 for reasons listed below.

Model(s)	Year	VIN Range	Vehicle-Specific Equipment
A3	2015 - 2019	All	Not Applicable

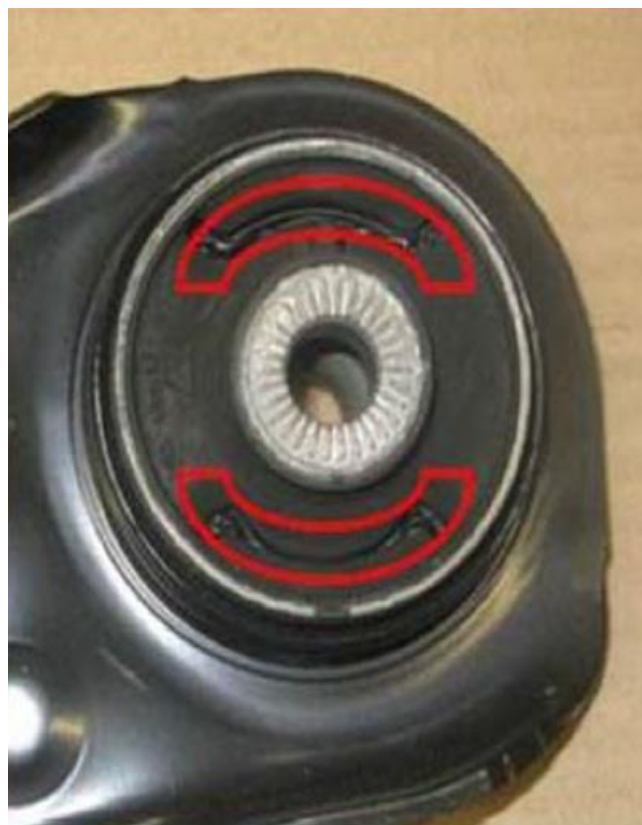
**Figure 3.** Lithium grease is applied on the red highlighted area only.

2. Evenly grease the kidney-shaped slits of the bonded rubber bushing (Figure 3, the area shown red) from above with 0.1g of lithium grease (part number G 052 150 A2). Use a paint brush to apply the grease.

The lithium grease must only be applied to the areas shown in red (Figure 3).

3. Reinstall all components according to Elsa.
